PACIFIC SOUTHWEST FOREST AND RANGE EXPERIMENT STATION MISCELLANEOUS PAPER No. 56) MARCH - 1961

RESEARCH AND A LAND MANAGEMENT MODEL

FOR SOUTHERN CALIFORNIA WATERSHEDS

Miscellaneous Paper 56

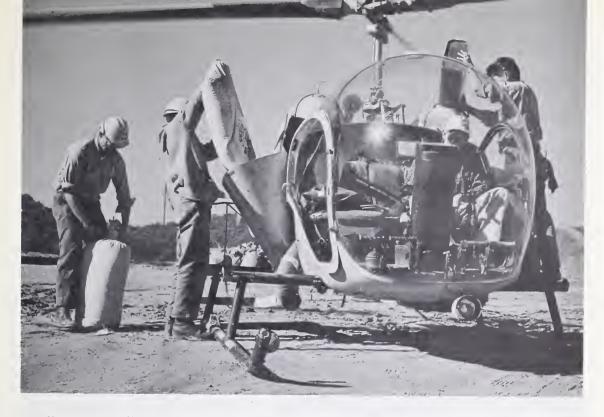
"First aid" in action--loading a helicopter for emergency watershed revegetation. Except for control areas designated for no artificial seeding, the entire experimental forest was sown to selected annual or perennial grasses in the fall of 1960.

Helicopter costs for sowing large areas with 10 pounds of seed per acre, were about \$1.00 per acre. For small watersheds and plots, the cost of aerial application was about doubled. Seed cost about 60 cents an acre for common ryegrass and mustard, and \$2.00 to \$7.00 for the perennial grass mixtures.

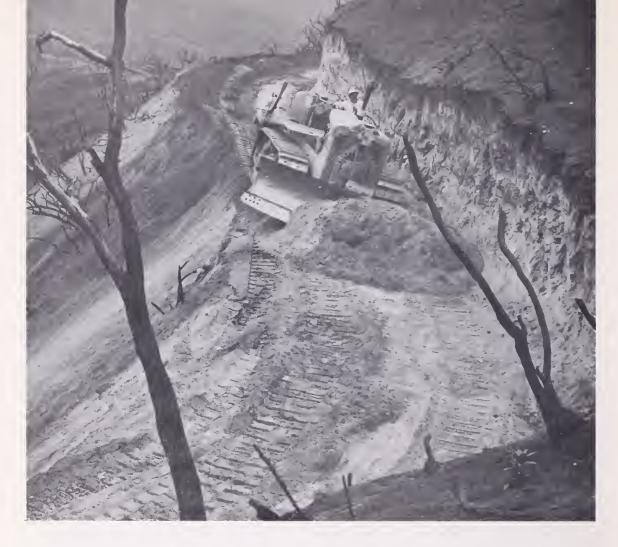
Building contour terraces. In addition to revegetation, physical measures aimed at retarding runoff and erosion are being tested in experimental watersheds.

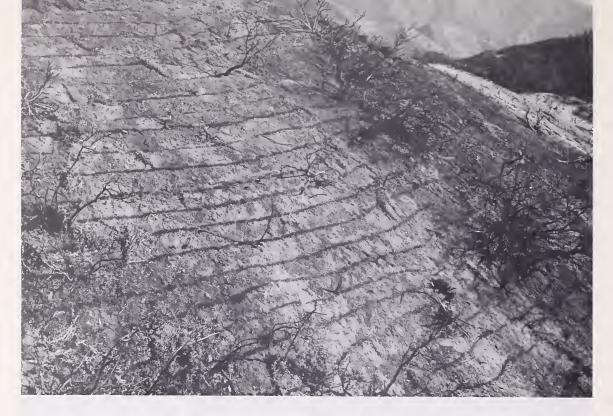
Side slope stabilization. Barley planted in furrows on close contours.

2. <u>Side slope stabilization</u>. --To impede overland flow of water and sediment on side slopes in 9 of the small experimental watersheds, barley seed and fertilizer were placed in furrows to form dense rows on 2-foot contour intervals. Barley was chosen because it grows more vigorously than most species during cool winter weather. The fertilizer was included to promote earlier and heavier growth.

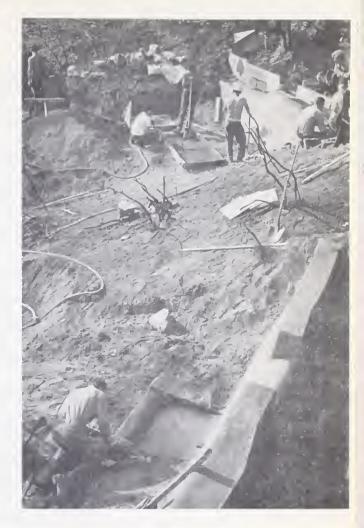
5. <u>Broadcast sowing of annual grasses</u>. --Nine other watersheds were sown with annual grasses--5 at 20 pounds per acre and 4 at 2-1/2 pounds. The mixture was composed of 4 parts Wimmera ryegrass and 1 part Blando brome. Constructing channel checks. Soil cement channel checks to reduce downcutting, stabilize side slopes, and spread streamflow are under test in nine experimental watersheds.

3. <u>Stream channel checks.</u> --Small dams were constructed of cement combined with soil and rock available at the dam sites in 9 of the watersheds. Purpose of these dams is to prevent channel downcutting, to stabilize side slope soils, and to spread out streamflow, thereby reducing its velocity and erosive power.

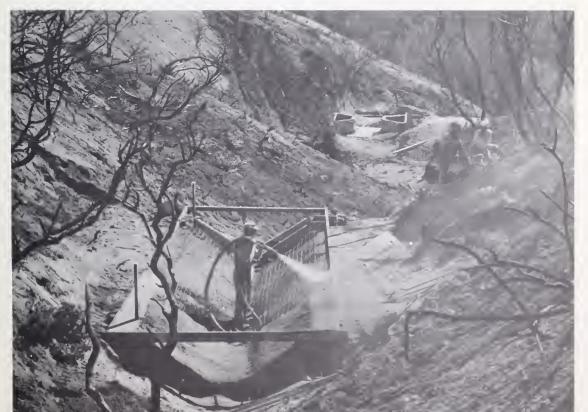
Constructing watershed flume to measure storm flows and suspended sediment. Note debris basin and spillway downstream and in background.

Twenty-five small watersheds varying in size from 2 to 8 acres have been established near the Tanbark field headquarters. Each has a flow measurement flume and debris basin, and except for an untreated control watershed to be used as a basis for comparison, each has one of, or combinations of, the following physical or vegetative treatments:
