FLOOD PLAIN MANAGEMENT STUDY

TOWN OF UNION
KNOX COUNTY, MAINE

Prepared by:
U.S. Department of Agriculture
Soil Conservation Service
Orono, Maine

February 1986

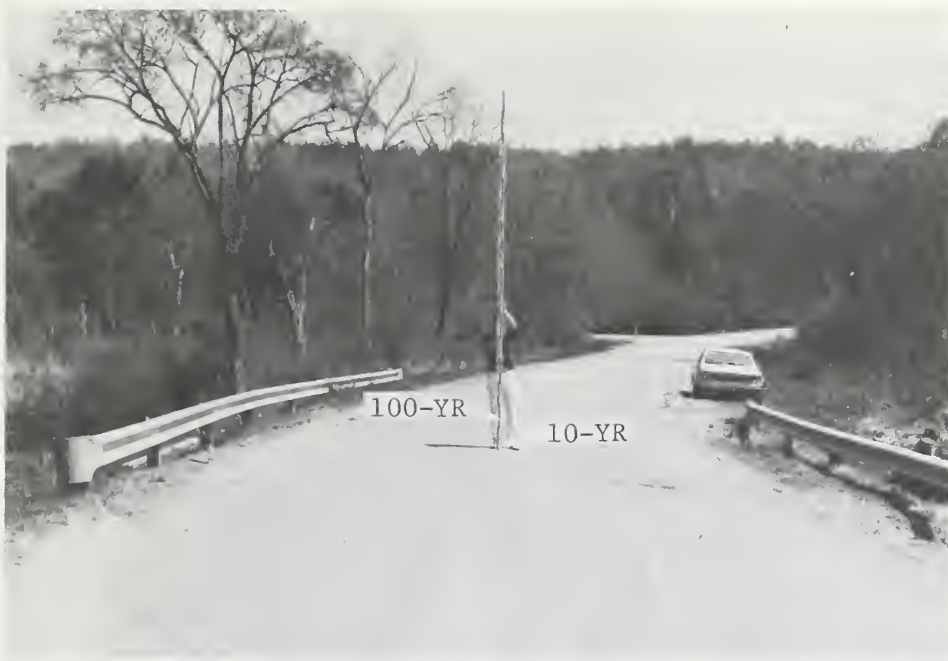
Medomak River, Shepard Hill Road, cross section M14B - The 100-year flood is estimated to be at elevation 149.4 feet NGVD or 1.3 feet over the road. (SCS photo)

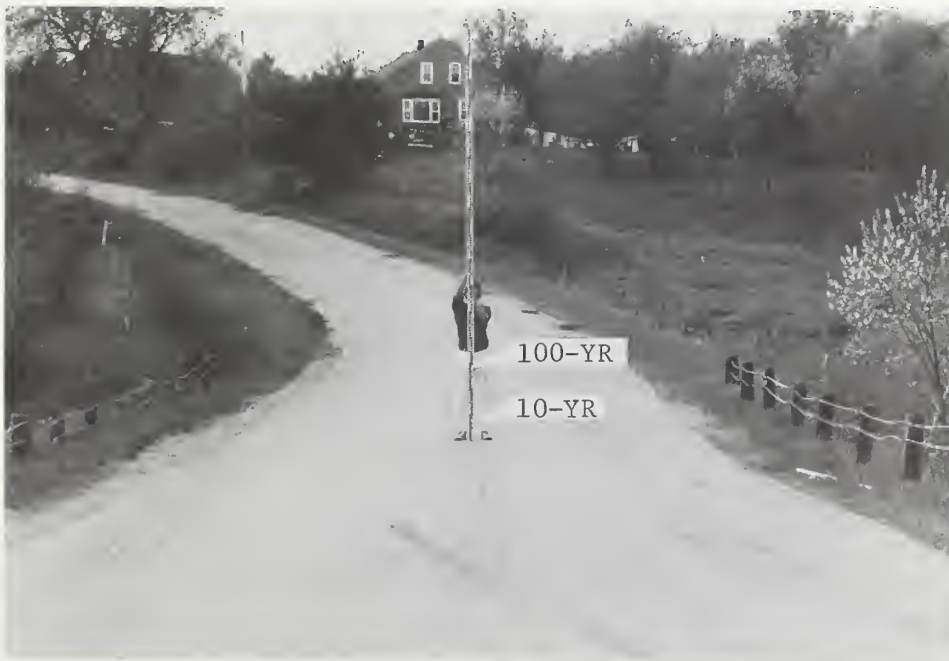
Medomak River, North Union Road, cross section M26C. The 100-year flood is estimated to be at elevation 181.8 feet NGVD or 2.9 feet above the road. This crossing has washed out on several occasions. (SCS photo)

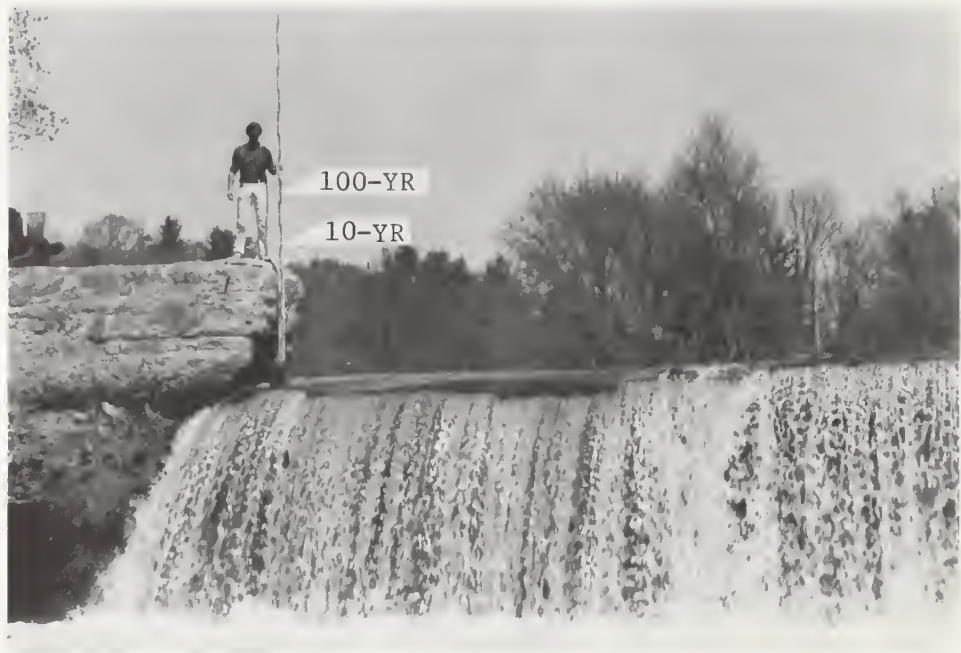
Sennebec Pond Dam, cross section 23D - The estimated level of the 100-year flood above this dam is 91.9 feet NGVD or 2.8 feet above the point where the person holding the board is standing. (SCS photo)

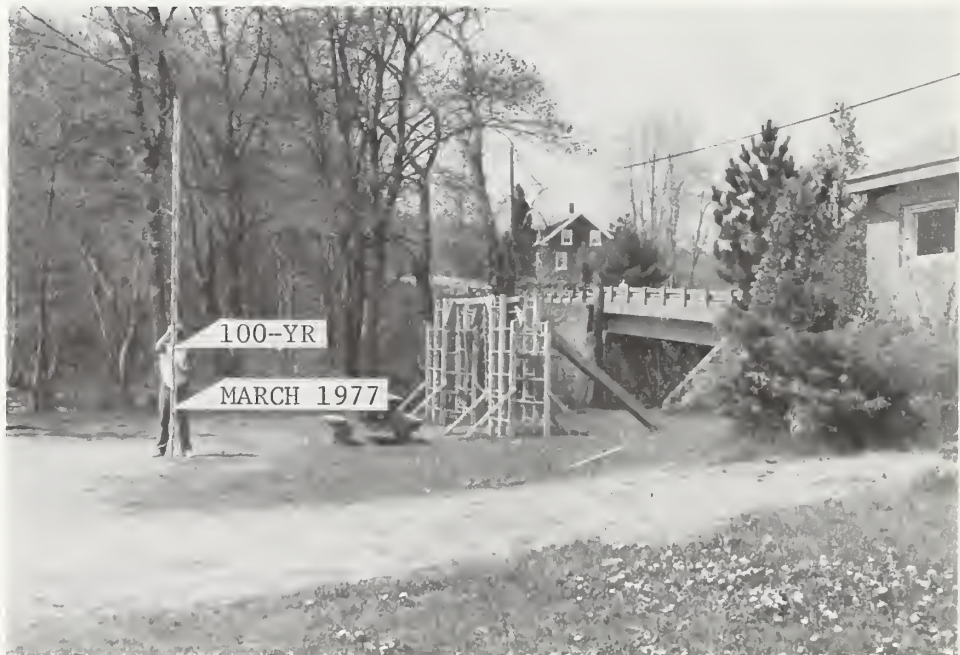
Ayer Park, on Seven Tree Pond - The estimated elevation of the 100-year flood is 45.4 feet NGVD or 4.9 feet above the ground at this point. The March 1977 flood shown has an estimated frequency of 25-years. (SCS photo)

discourage flood plain development is the erection of flood warning signs in flood prone areas or the prominent posting of previous or predicted high water levels. This could be done in Union at the fairground, Ayer Park, etc. These signs carry no enforcement, but simply serve to inform the public that a flood hazard exists.

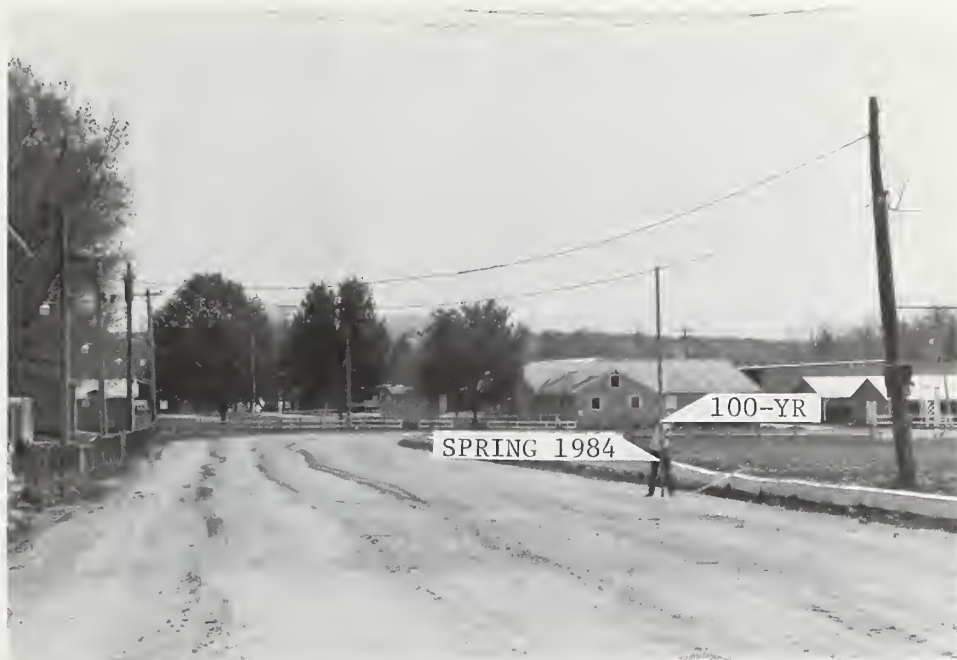
Union Fairgrounds - This area suffers quite frequent flood damage. The top photo, taken in front of the grandstand, shows the estimated elevation of the 100-year flood to be 45.4 feet NGVD or 5.3 feet above the track. The lower photo shows damage to the track caused by the spring 1984 flood, estimated to be approximately a 20-year event. (SCS photos)

Dikes would have very little practical application in the town of Union. However a dike has been built behind the grandstand at the Union Fairground. While the dike does not prevent backwater flooding from Round Pond, it does reduce damage at the fairground by keeping the flood flows of the St. George River from crossing the grounds.

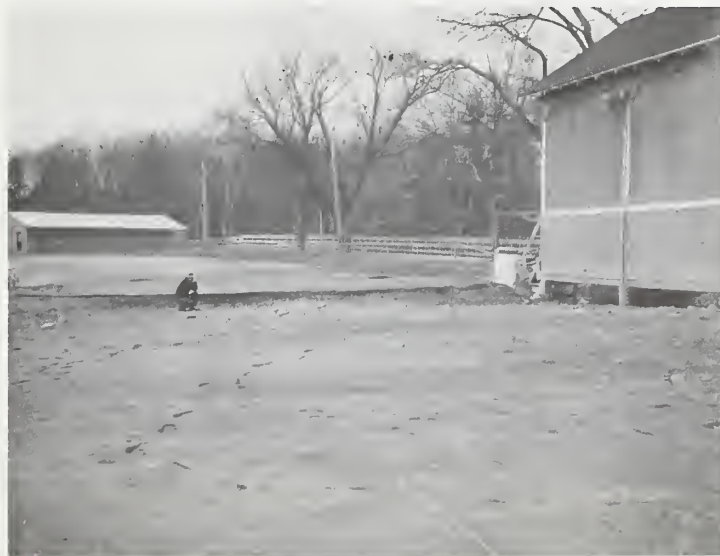
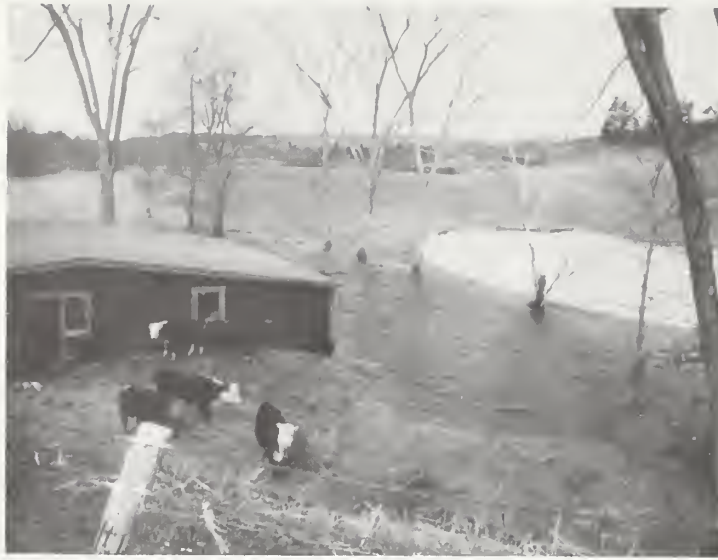
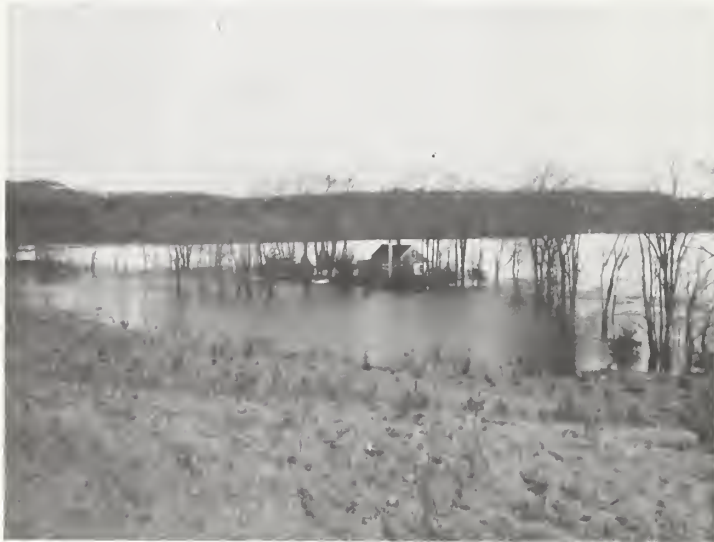
The above photos were taken during the flood of March 1977, which is estimated to have a frequency of 25 years. The top photo is at the outlet of Round Pond and the lower is of Seven Tree Pond. (Bill Cross photos)

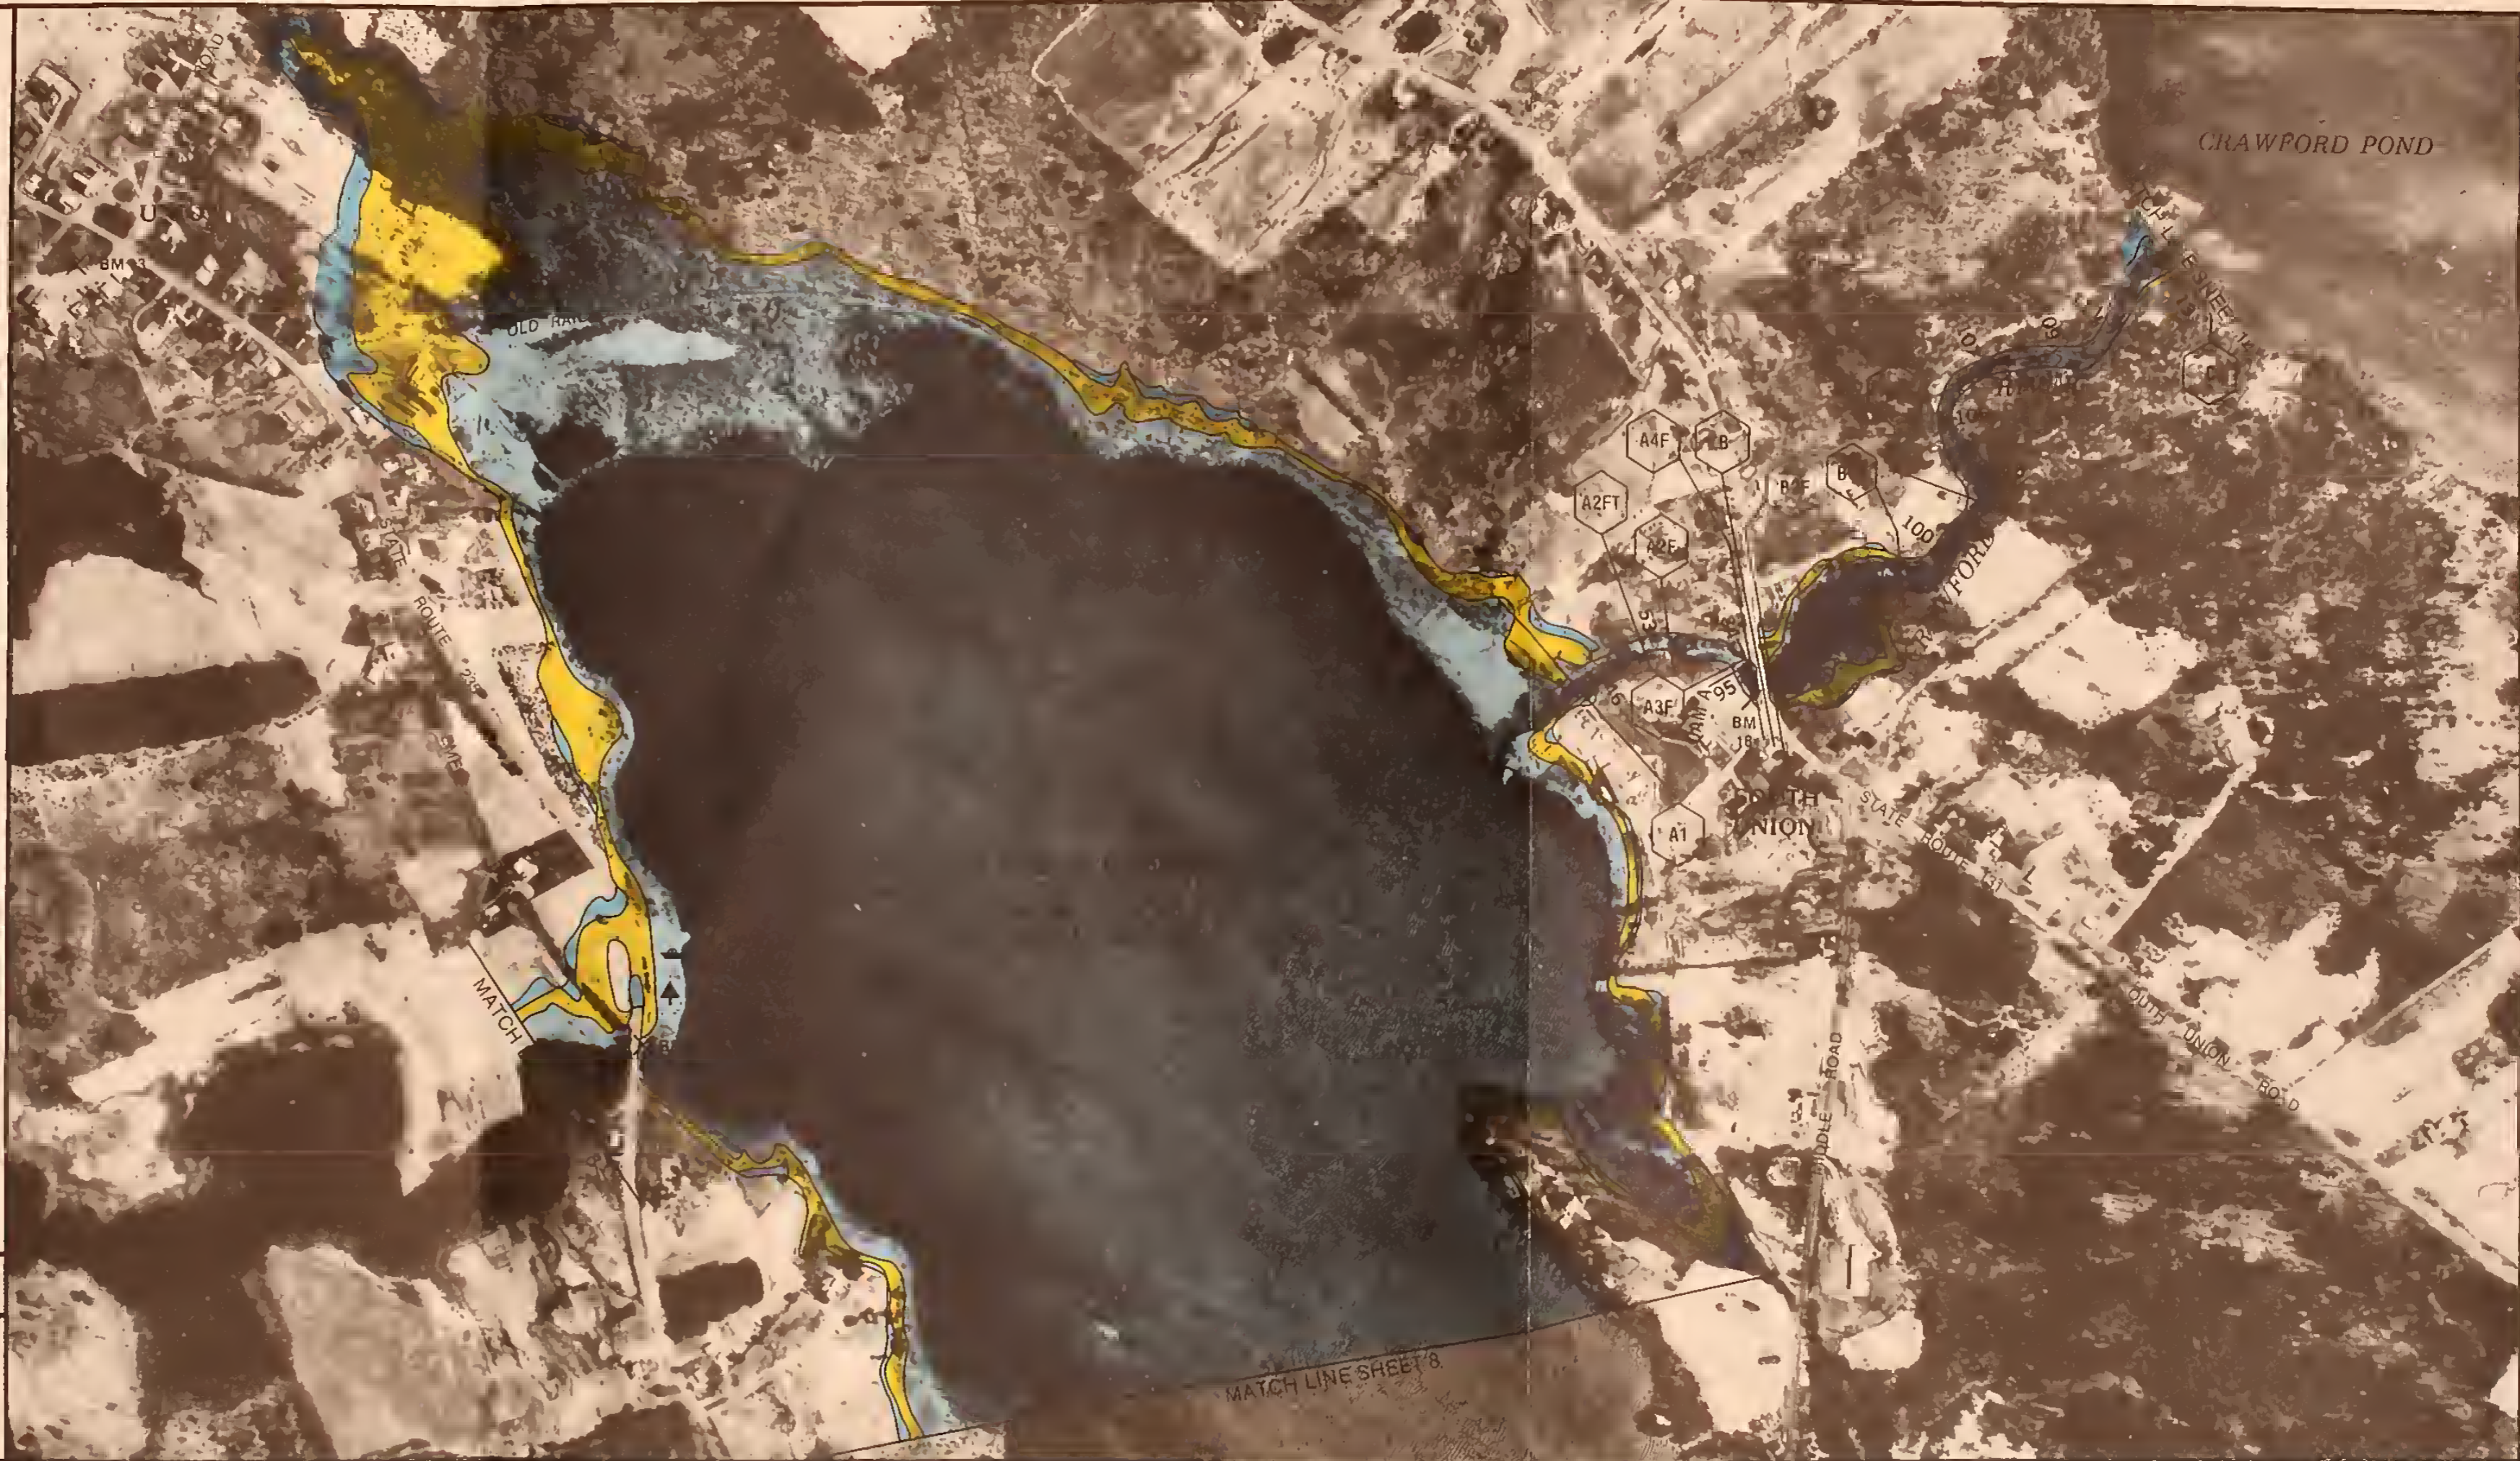
SHEET 9 OF 16

SEVEN TREE POND
 FLOOD ELEVATIONS
 500 YEAR ELEV. 46.9
 100 YEAR ELEV. 45.4
 50 YEAR ELEV. 44.0
 10 YEAR ELEV. 41.2

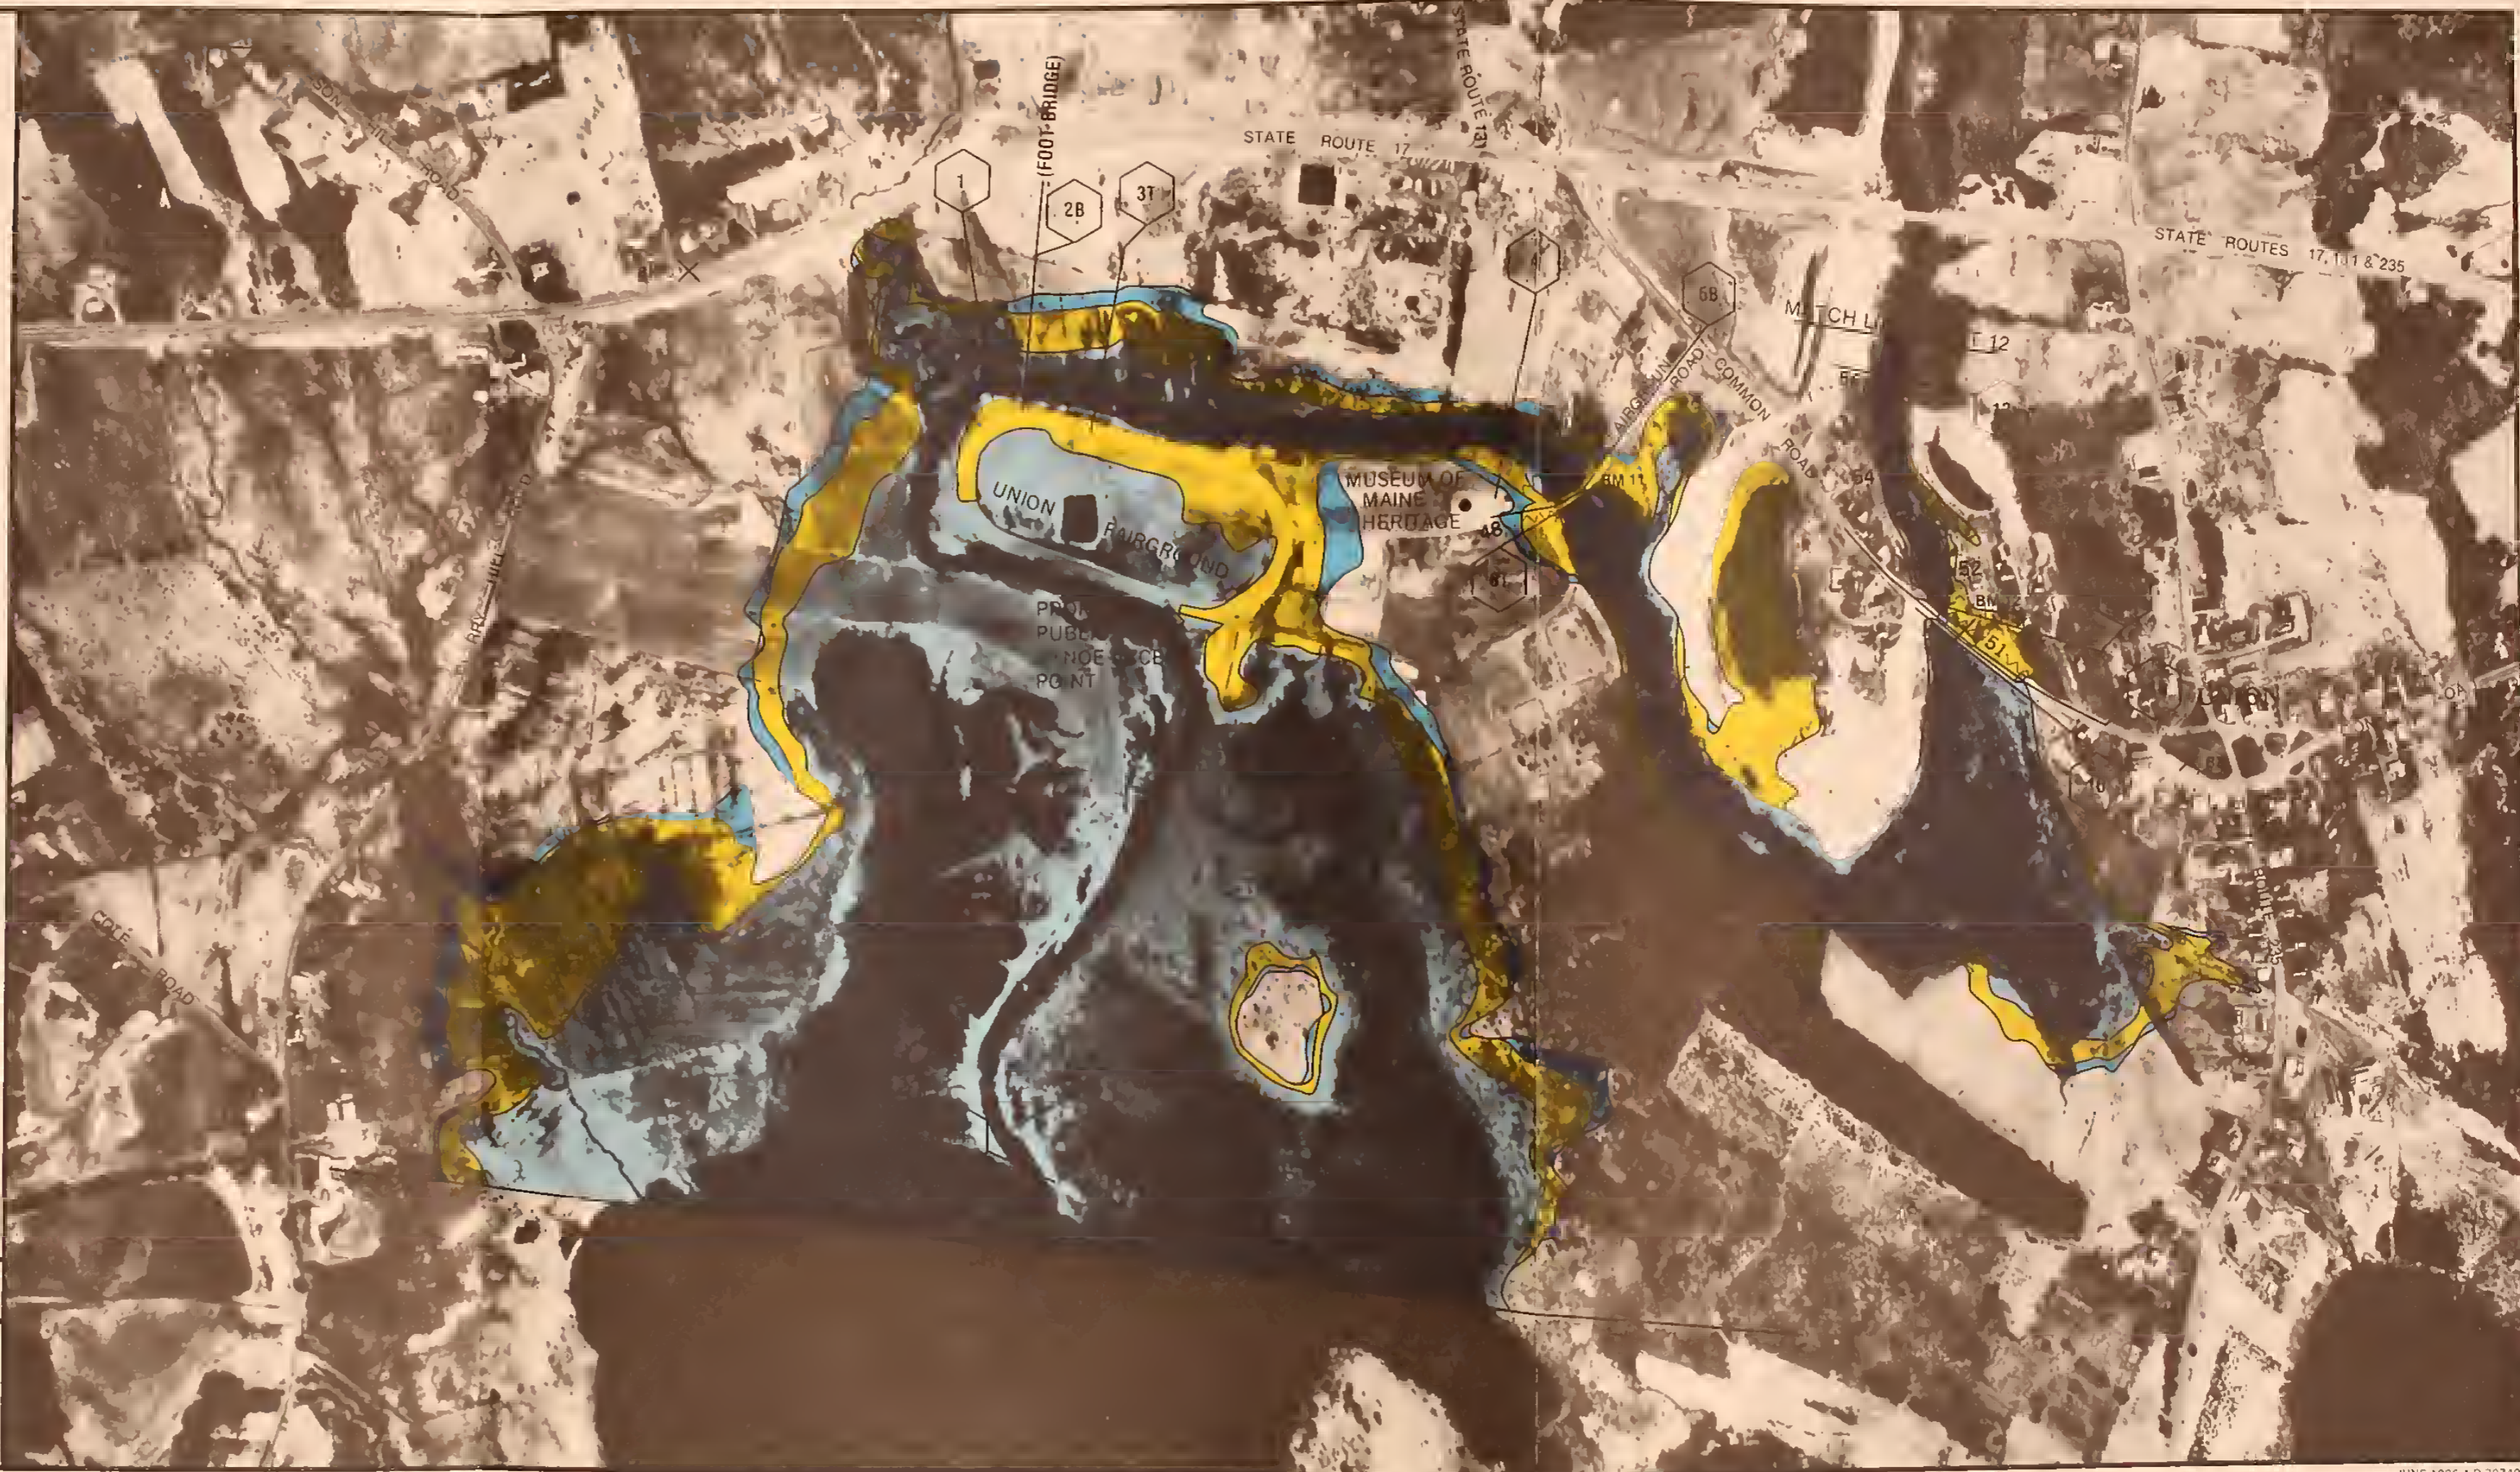
SHEET 11 OF 16

ROUND POND
FLOOD ELEVATIONS
500 YEAR ELEV. 46.9
100 YEAR ELEV. 45.4
50 YEAR ELEV. 44.0
10 YEAR ELEV. 41.2

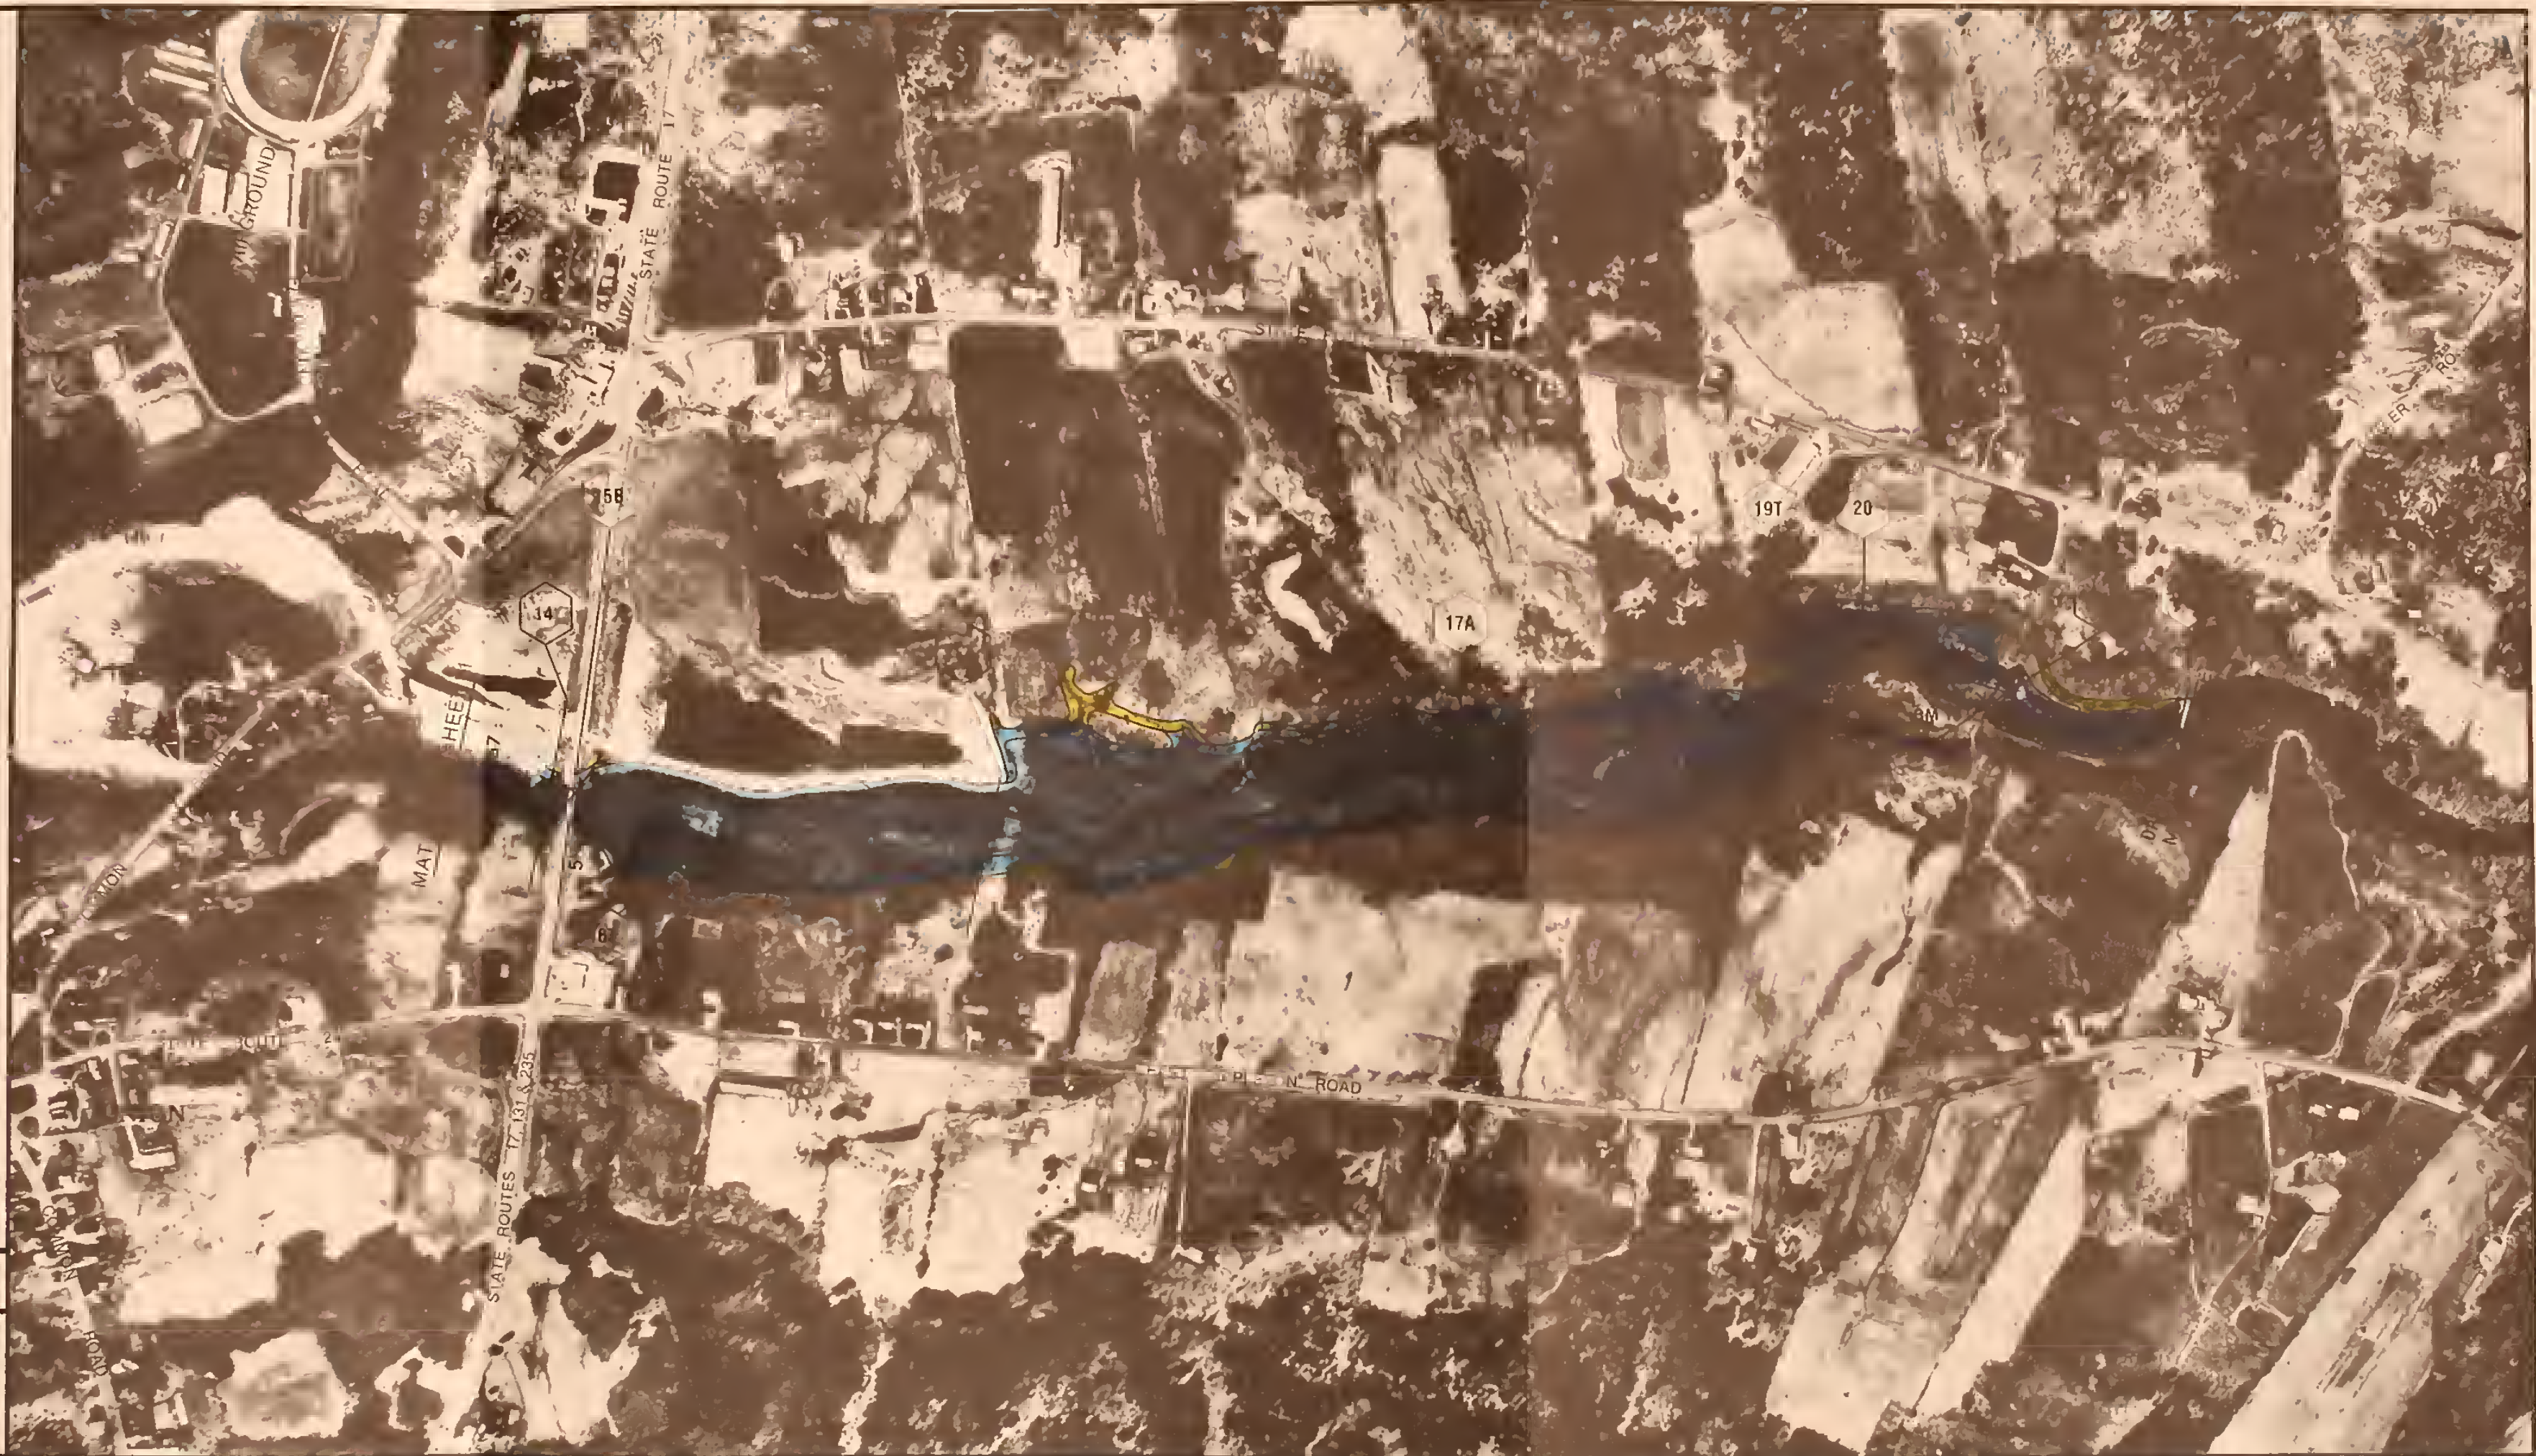
SHEET 12 OF 15

**SENNEBEC POND
FLOOD ELEVATIONS**

500 YEAR ELEV.	92.5
100 YEAR ELEV.	91.9
50 YEAR ELEV.	91.2
10 YEAR ELEV.	89.7

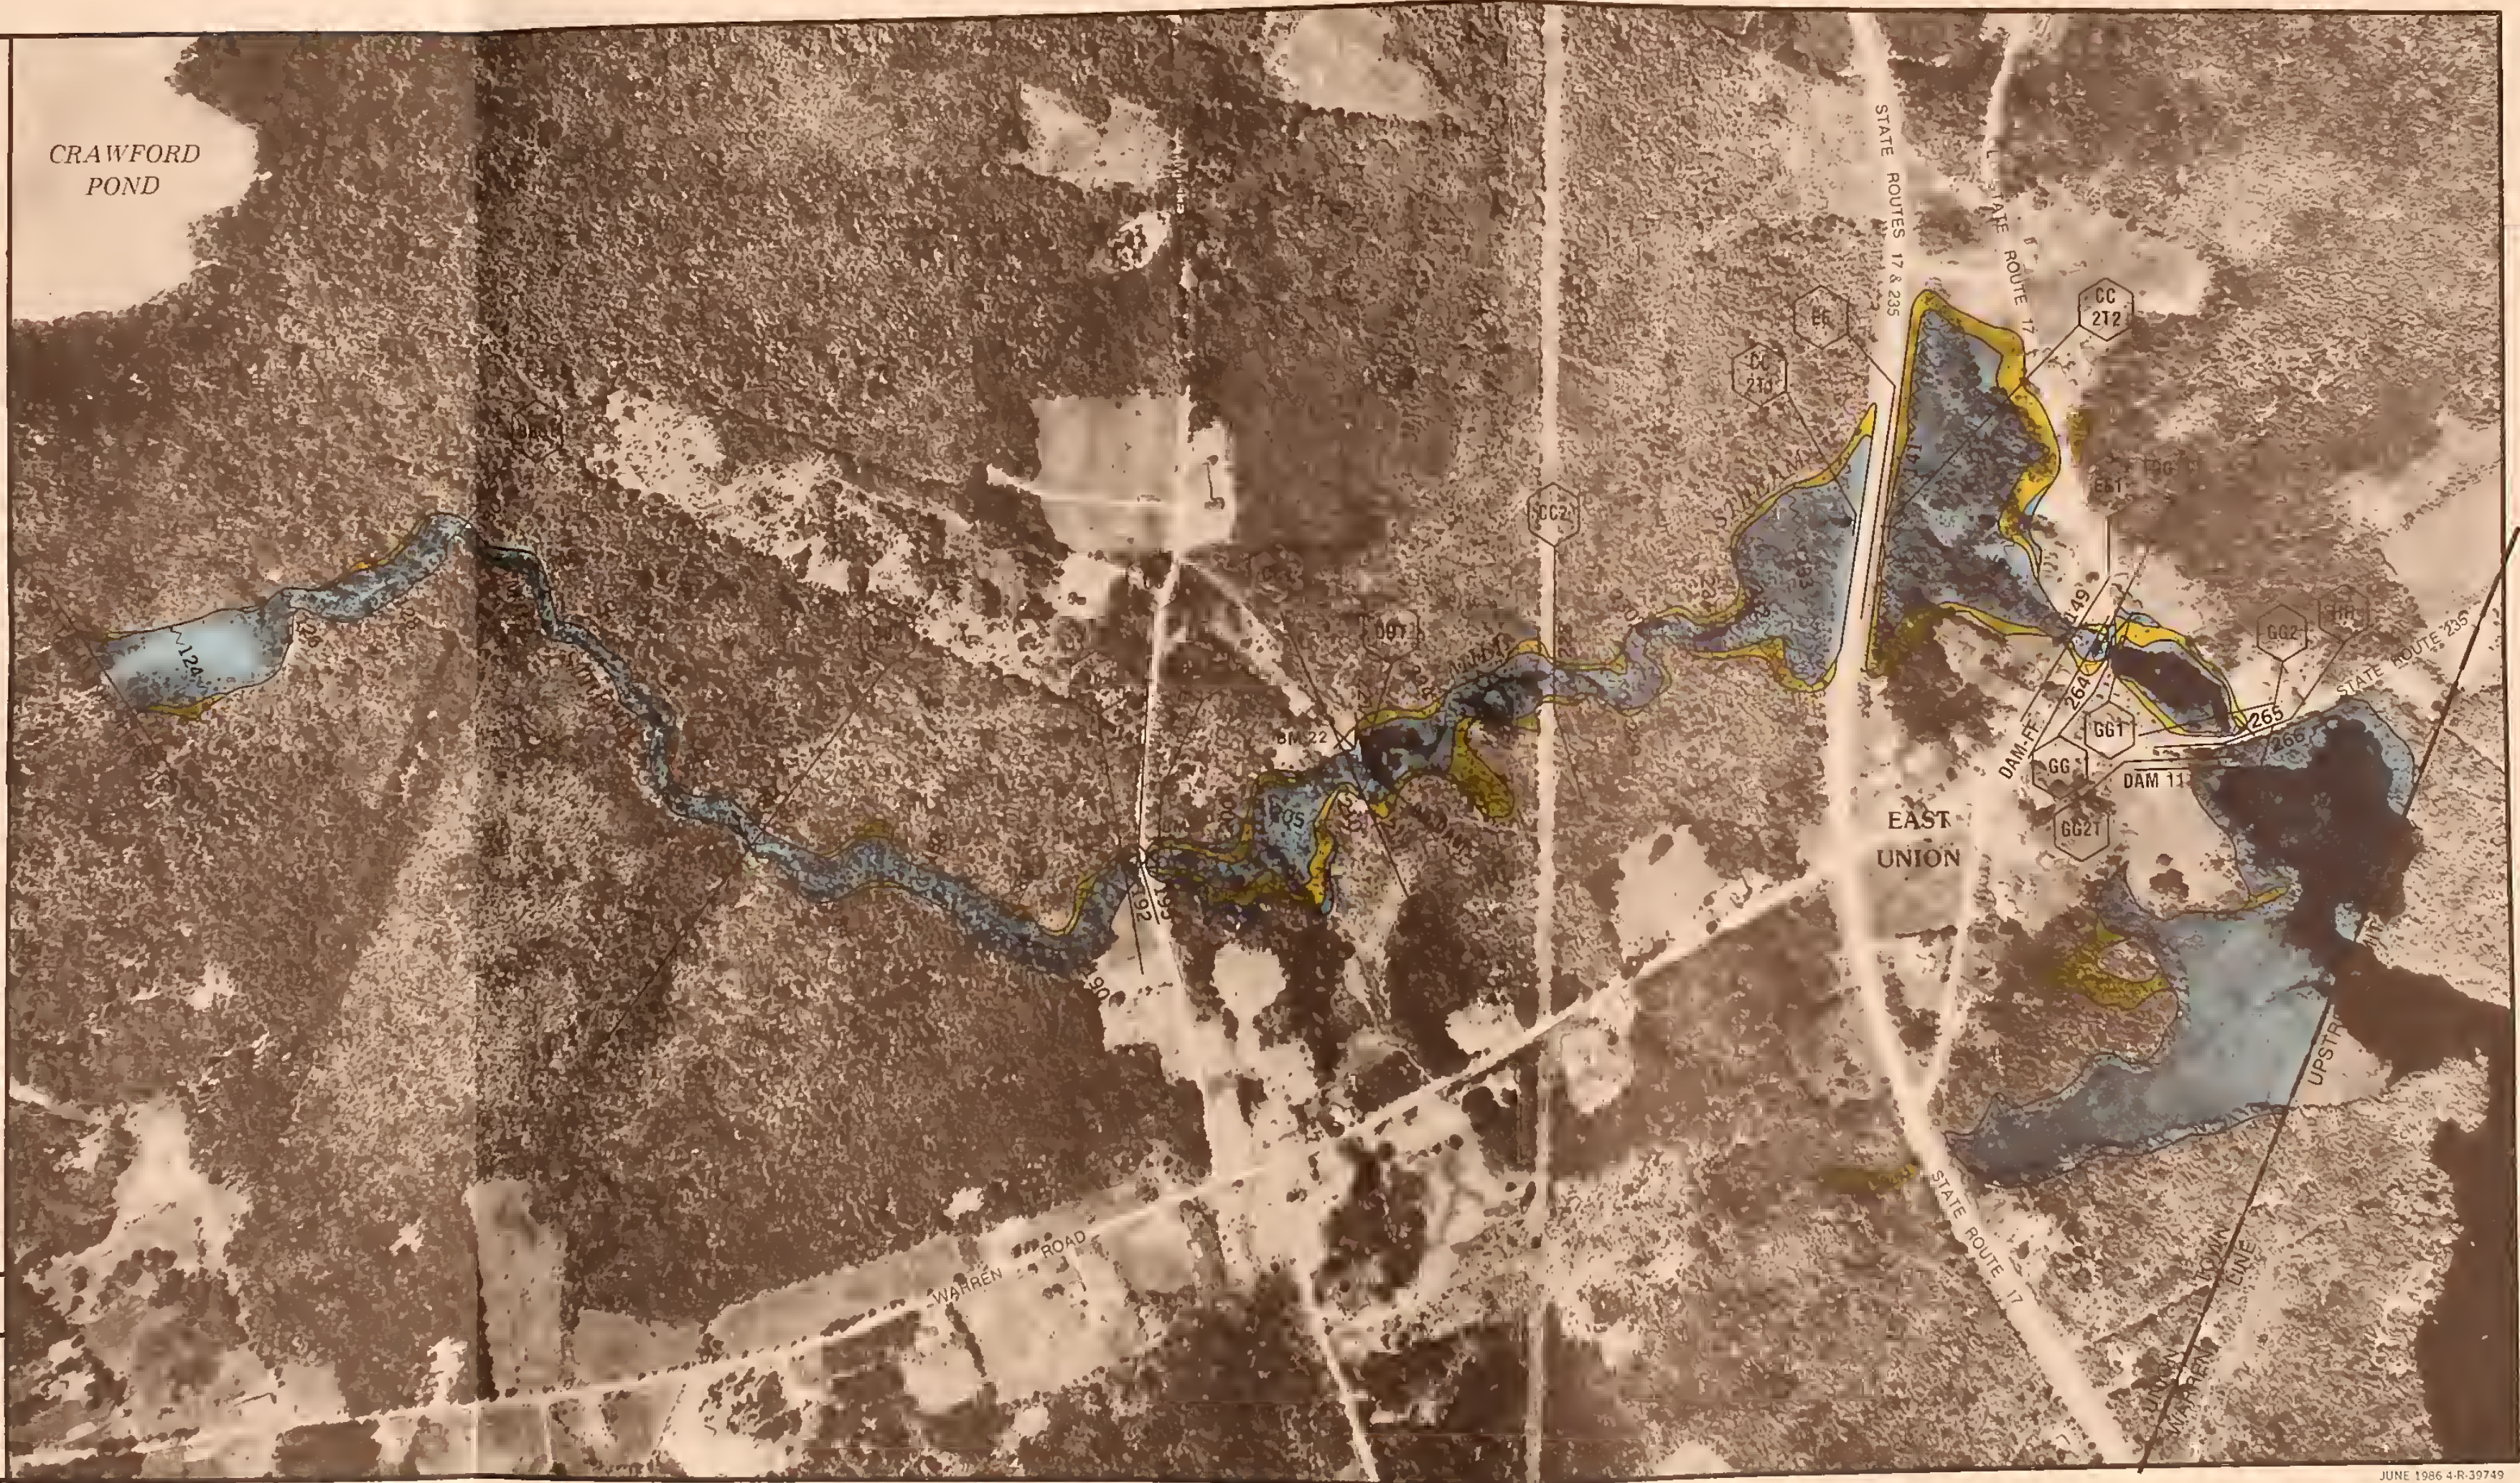
SHEET 16 OF 16

**LERMOND POND
FLOOD ELEVATIONS**

500 YEAR ELEV. 269.6
 100 YEAR ELEV. 269.5
 50 YEAR ELEV. 269.4
 10 YEAR ELEV. 269.0
