Charles H. Smith

Associated Factory Mutual Fire Insurance Companies

**SALEM CONFLAGRATION  
AND  
DESTRUCTION OF THE MILLS OF  
NAUMKEAG STEAM COTTON CO.  
JUNE 25, 1914.**

**THE CONFLAGRATION AT SALEM, MASS.,**  
**AND THE DESTRUCTION OF THE**  
**MILLS OF THE NAUMKEAG**  
**STEAM COTTON CO.**  
**JUNE 25, 1914.**

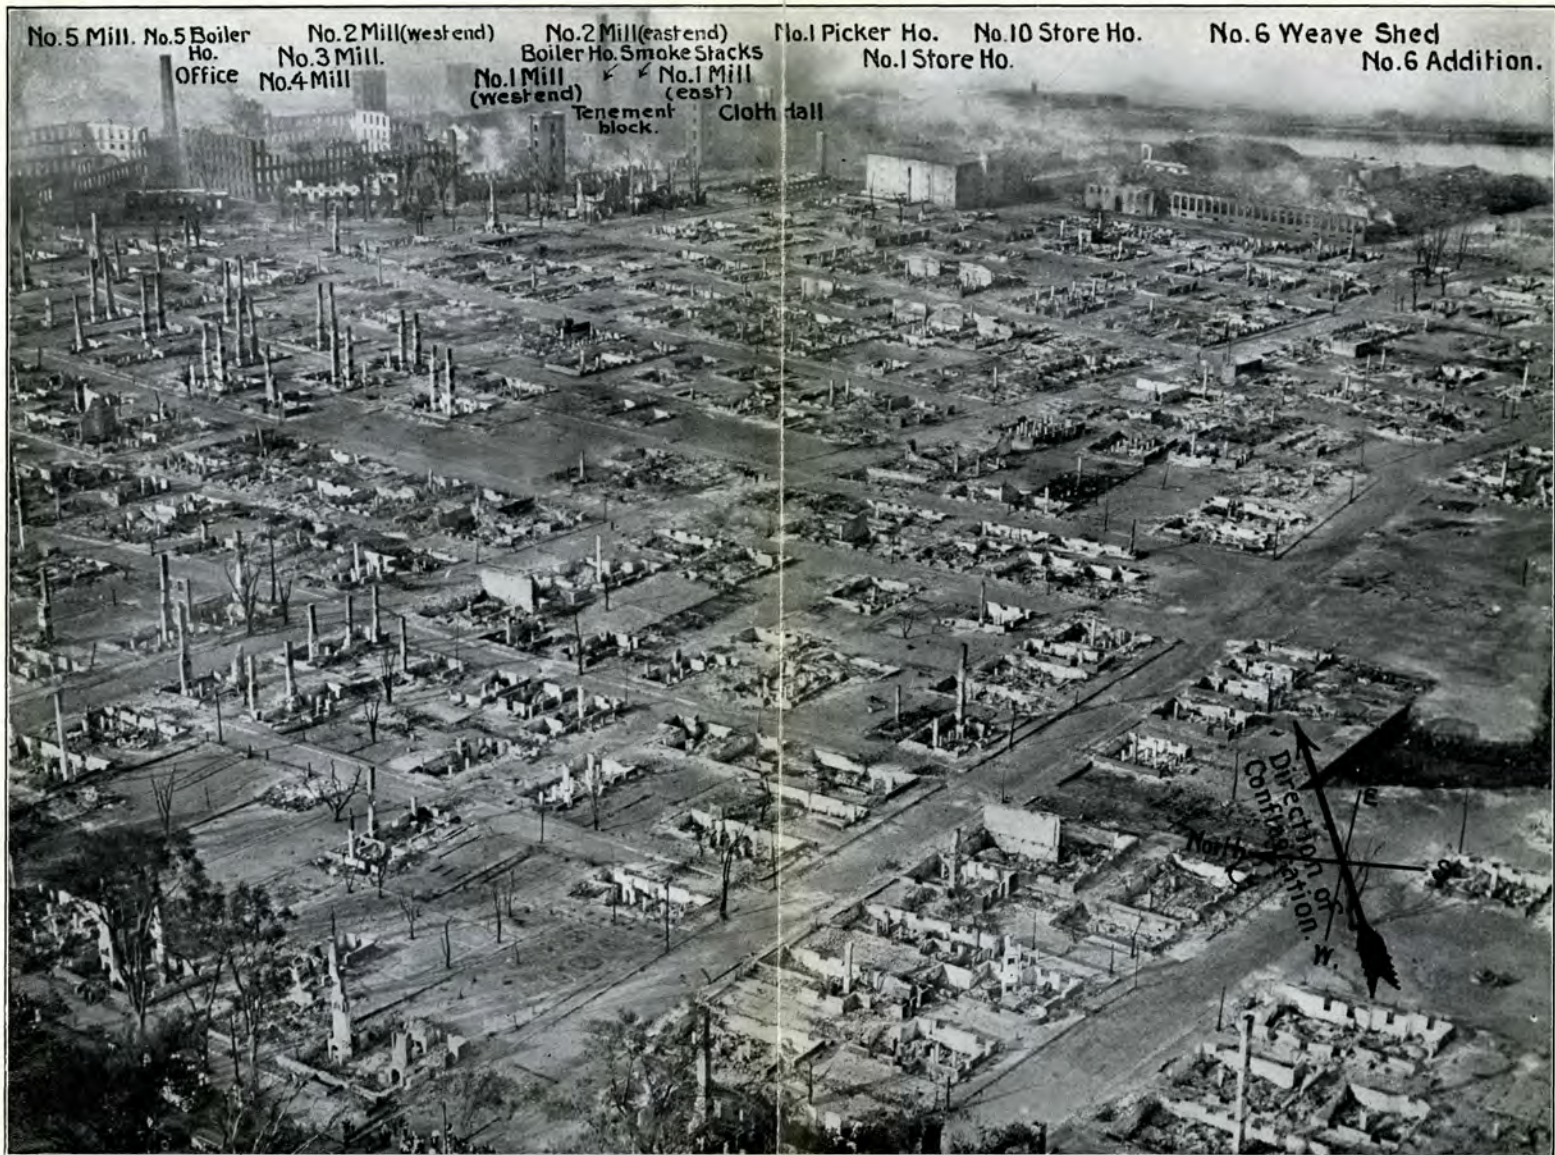
A PORTION OF THE AREA OF SALEM BURNED OVER.

Reproduced from Aeroplane view taken by the Photographer of the Boston Journal. The ruins of the Naumkeag Mills are in the distance at top of picture. Note undamaged concrete Storehouse in the middle of background.

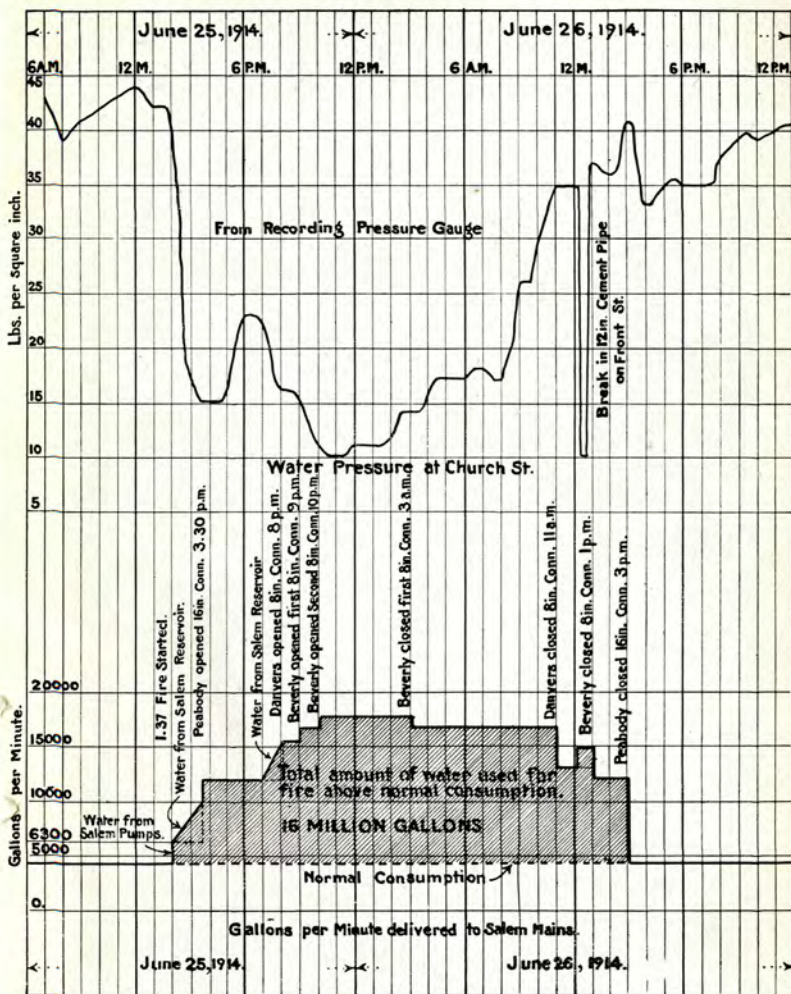
CURVES SHOWING WATER PRESSURE  
AND  
APPROXIMATE QUANTITY DELIVERED TO SALEM MAINS  
Conflagration of June 25-26, 1914.

The supply comes from Wenham Lake and Longham Meadows. Water is pumped from the lake by two 5,000,000-gallon pumps, directly into the mains or to the distributing reservoir in Beverly, 20,000,000 gallons capacity. The usual static pressure in Salem is about fifty pounds. A record of pressures obtained during the fire from the recording gage in the Water Works Office on Church Street is appended. This gage is at a slightly higher level than the Naumkeag yard. During this fire the pumping was directly into the mains against check valves at reservoir. The reservoir contained 19,500,000 gallons the morning of the fire, and lost 500,000 gallons during the fire. From the pumping station and reservoir there are two pipes, 30-inch and 20-inch, which reach the city by independent routes. The Beverly system is connected with both of these mains by 8-inch connections from 12-inch mains. Danvers has an 8-inch connection from

a 12-inch main to the 30-inch Salem pipe. Peabody has a 16-inch connection to a 16-inch Salem main that ties into the 20-inch and 30-inch pipes. These several connections were all opened during the progress of the fire to reinforce the Salem supply. The times at which these several connections were opened and closed is shown on the diagram of pressures attached to this report, the same diagram also showing an estimate of the amount of water that was furnished. There is also a 6-inch connection with the Marblehead Water Works, and this was opened, but was almost immediately closed to conserve the water in the Marblehead standpipe, as the Marblehead pump, which is operated by electricity from Salem, was soon obliged to shut down.

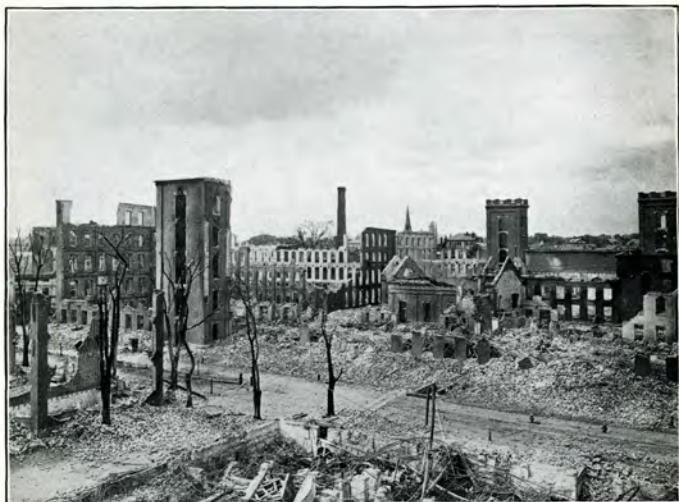
General View of Ruins. From roof of No. 1 Store House looking northwest.

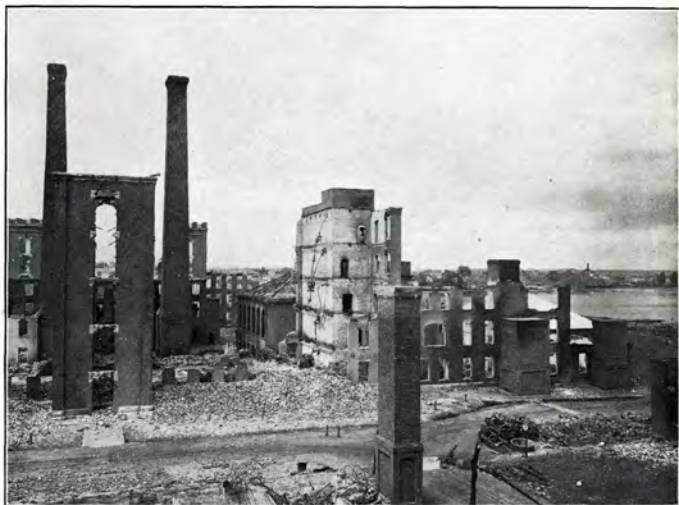
General View of Ruins. From roof of No. 1 Store House looking northeast.

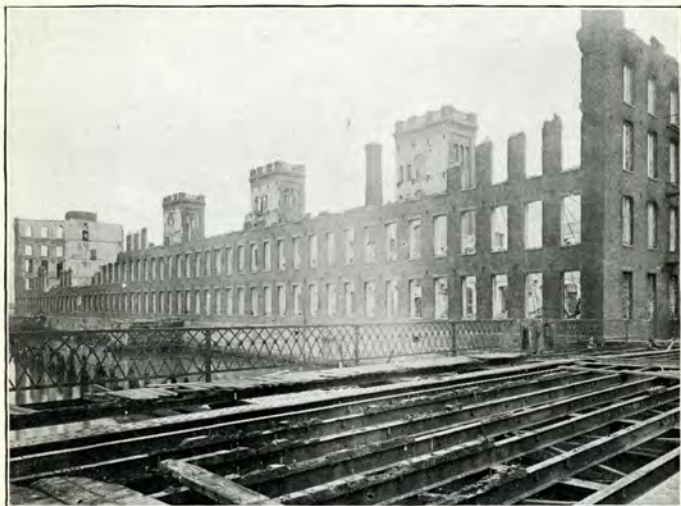
North Side of No. 2 Mill. Burned bridge in foreground.

Up to now (about 9.30 P. M.) the men engaged in fighting the fire in the mill yard had an avenue of escape across the bridge over South River, but with property burning on both sides of the bridge, the Chief Engineer decided that the safety of his men depended on immediate retreat. There were not boats enough for all the party to escape by water, but five or six men remained with the Chief Draftsman and the two Mutual men, and steam was kept up on the boilers, and the pumps were kept running in the hope that the remainder of the property might be saved by maintaining

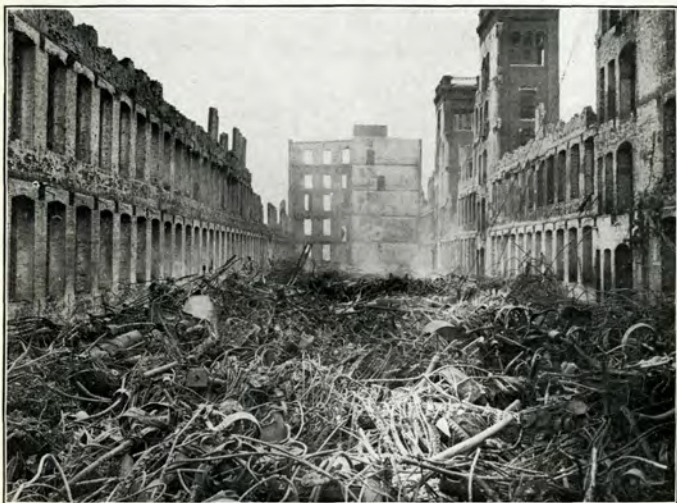
Interior of No. 2 Mill, showing wreckage of machinery.

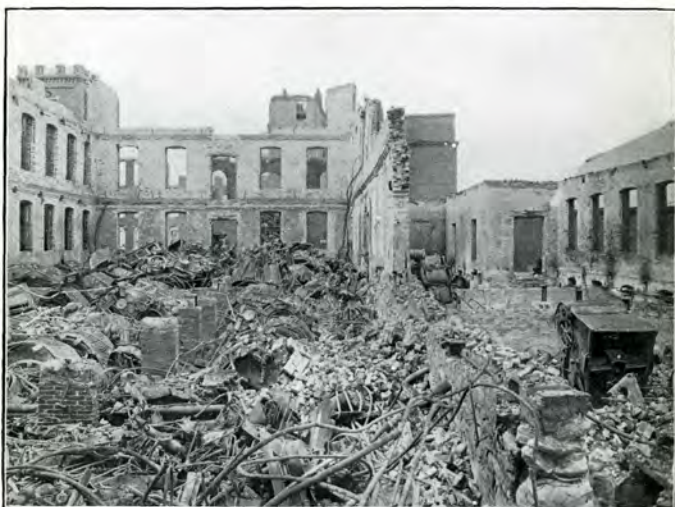
Wreckage. Interior No. 1 Picker House.

pressure on the sprinkler system. A boat was held on the water-front for the escape of this party. Soon after 10 o'clock, the increasing heat and smoke made breathing difficult in the Boiler House and the Pump Room. Fire in No. 1 Picker House threatened the line of retreat, and with a good fire under the boilers and the pumps left running under full speed, the men were forced to leave. Later the fire attacked No. 2 Mill, No. 3, and then No. 5, the fire in No. 5 apparently starting at the east end and burning back against the wind.

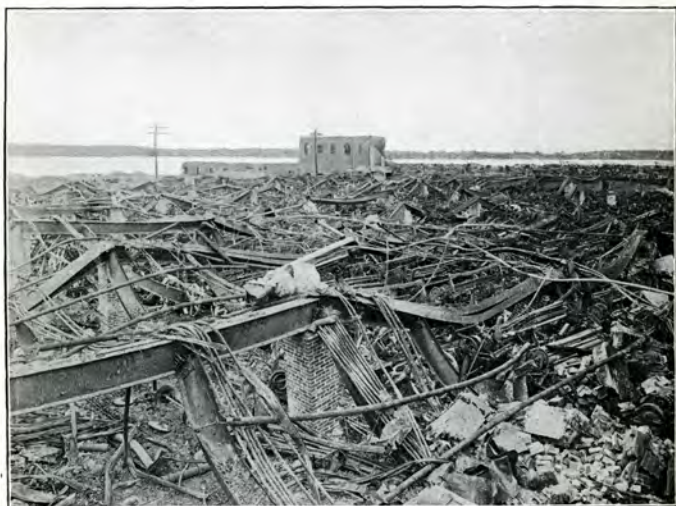
Wreckage. Floor beams, etc., No. 6 Weave Building.

Weave Shed construction, the expansion of which pushed over the brick walls.

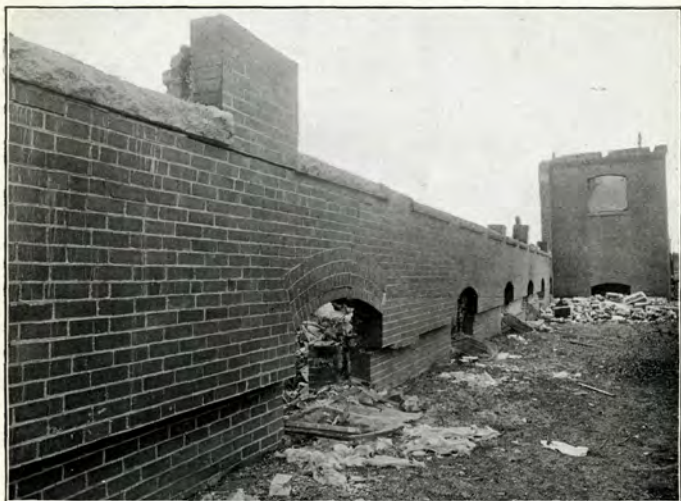
West Wall, No. 6 Weave Building, as pushed out by expansion of steel floor beams.

This is forcibly demonstrated by the experience with the concrete Storehouse No. 1 and the non-combustible Salem Electric Light Plant, both of these buildings being in the zone swept by fire, and practically escaping unharmed. In contrast were the vulnerable wooden cornices and window-casings of the mills, which offered an easy point of attack, and the unprotected steel beams in the

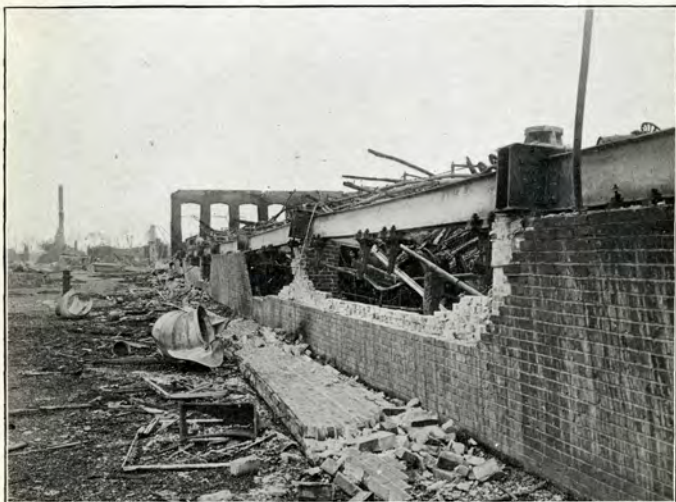
South Wall, No. 6 Weave Building, thrown over by expansion of steel floor beams.

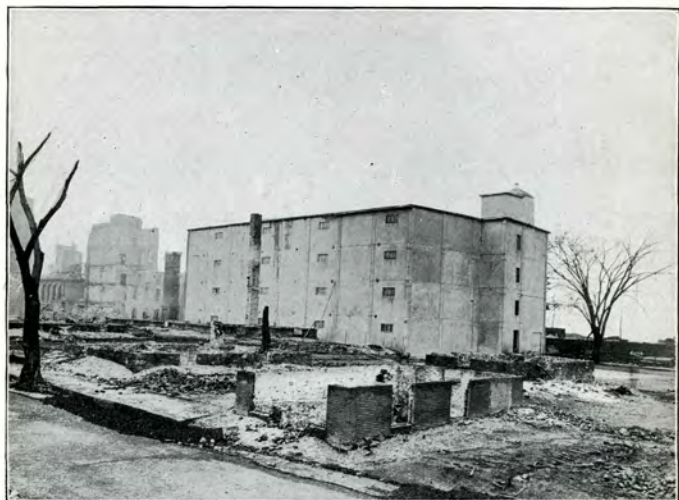
No. 1 Store House. Reinforced concrete construction.  
Practically uninjured though severely exposed.

Number 1 Storehouse is of reinforced concrete construction, walls, roof, and floors. There are some small wired glass windows in metal sash, mostly fixed, which are protected in addition by wood tin-clad shutters on the inside of the building, hinged at the top and swinging vertically, and these were held open normally by fusible links. These links all melted and allowed the shutters to close. Two stories of this building contained finished goods in cases, but although

the building was exposed to the full force of the conflagration on its west side, so completely did the window protection do its work, and so well did the concrete walls stand up against the flame that fire did not enter the building. Not a sprinkler opened, and the contents are intact. The damage to the building is so slight as to be almost negligible, and while the wired glass windows in several cases suffered so much heat that they softened and bulged out at places, and in one case completely melted out, yet the interior shutters withstood the attack, and did not allow the fire to enter the building.

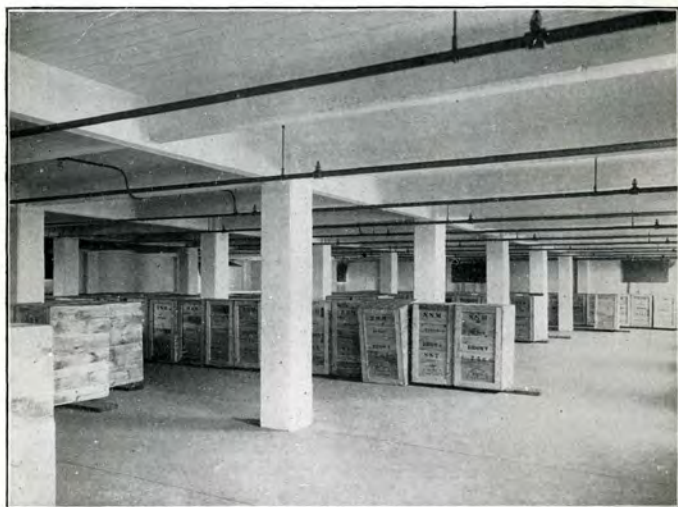
Interior of No. 1 Store House. Note perfect condition  
of building and contents.

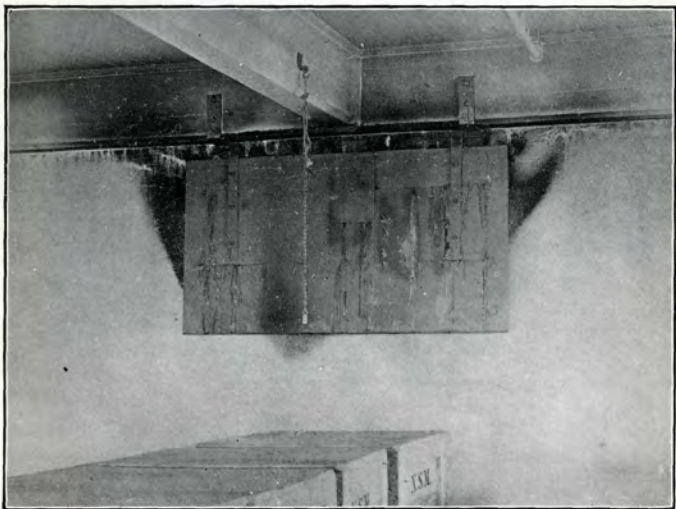
Interior No. 1 Store House. Fire shutter closed automatically by melting of fusible link.

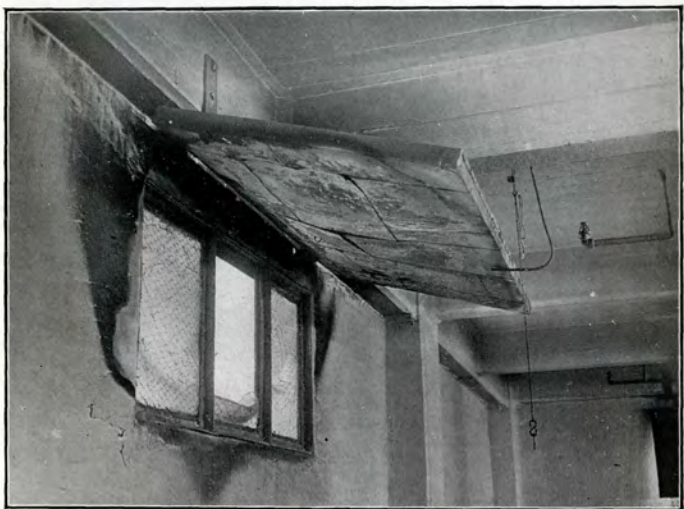
Interior No. 1 Store House. Fire shutter in open position. Note collapsed wired glass and effects of heat on the shutter.

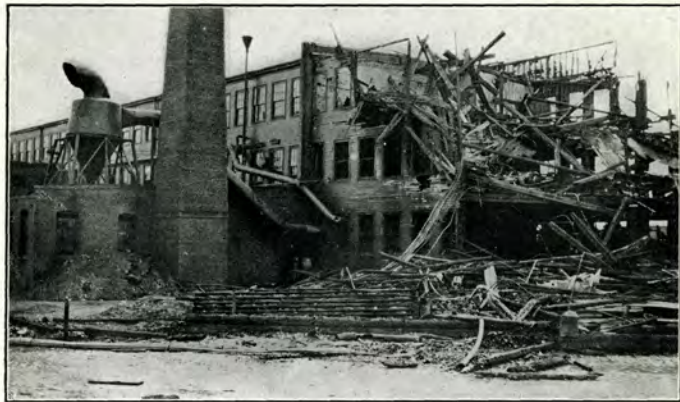
E. S. WOODBURY CO., CANAL STREET

Three-story wooden shoe factory subdivided by 12-inch brick parapeted fire wall. Door openings protected by fire doors on each side of wall. Equipped with automatic sprinklers supplied by city water and 11,000-gallon tank. Water supplies for sprinklers failed, but fire was stopped at the fire wall with the assistance of the fire department.

These two views are inserted to illustrate the value of sprinklers and fire walls under less severe conditions of heat and flame than attacked the Naumkeag Mills. **THESE FACTORIES WERE NOT INSPECTED BY THIS DEPARTMENT OR INSURED BY THE COMPANIES CARRYING THE NAUMKEAG MILLS.**

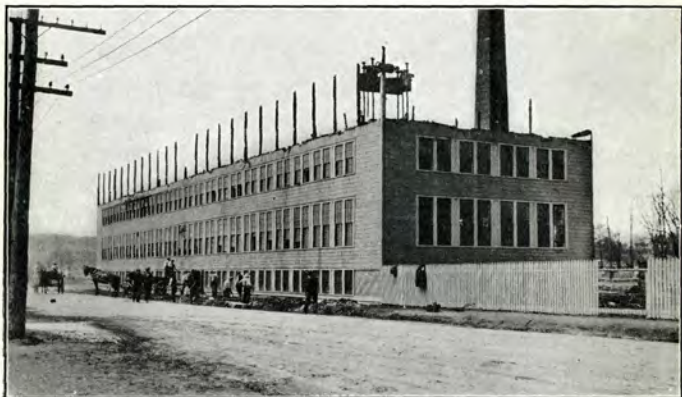
WILKINSON COUNTER CO., JEFFERSON STREET

Three-story wooden shoe factory, walls slate-covered. Equipped with sprinklers supplied by city water and 30,000-gallon tank. Top story burned off after tank water was exhausted, but city pressure was sufficient to save the lower stories. No assistance from the fire department.
