WATERSHED MANAGEMENT RESEARCH IN ARIZONA

PROGRESS REPORT 1959

ROCKY MOUNTAIN FOREST AND RANGE EXPERIMENT STATION

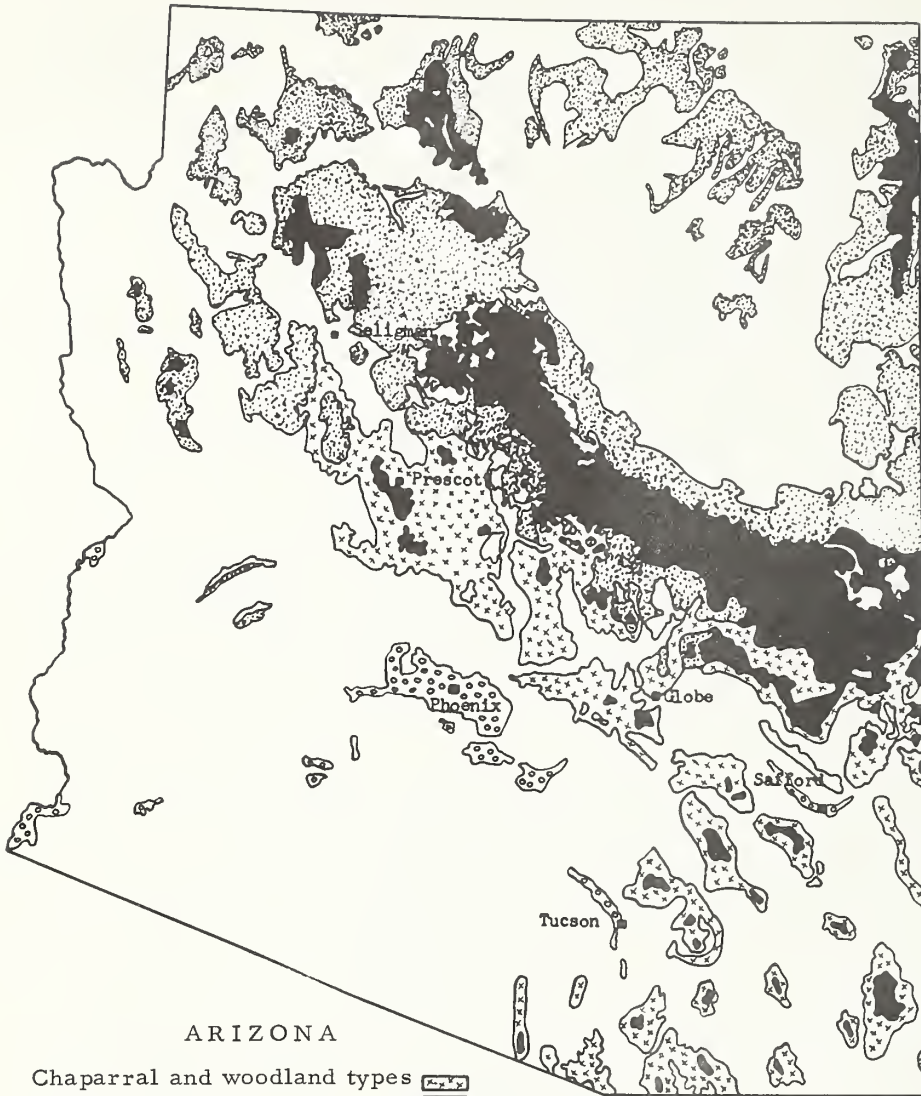
Figure 1. --Distribution of some major types of vegetation in Arizona. In general, the mixed conifer type occurs at the highest elevation along the Mogollon Rim, on San Francisco Mountain, and north of the Colorado River on the Kaibab Plateau. The ponderosa pine type, shown in black along with mixed conifer, occupies a broad belt along the Mogollon Plateau. The pinyon-juniper type lies at a slightly lower elevation and completely surrounds the ponderosa pine type. The chaparral type forms a band across the Mogollon front. Stream-bottom vegetation occurs at all elevations, though research activities at present are concentrated in tamarisk-seepwillow-arrowweed types along Salt River near Phoenix.

Areas for recent intensive research have been established in five major vegetation types in Arizona. This grouping is desirable because of the great differences in environmental conditions and plant species among the various types.^{3/} General characteristics of the vegetation types are shown in table 1 and their distribution is given in figure 1.

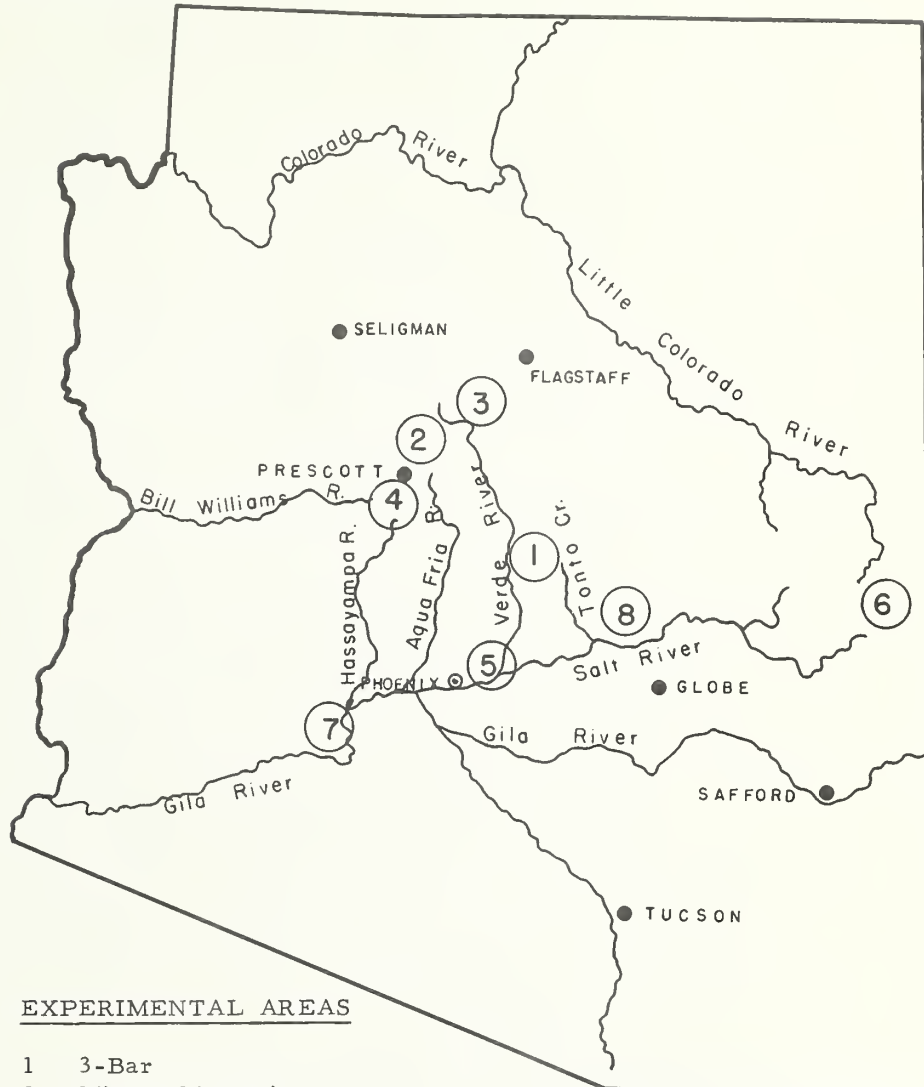
- 1 3-Bar
- 2 Mingus Mountain
- 3 Beaver Creek
- 4 White Spar
- 5 Granite Reef
- 6 Castle Creek, Willow Creek,
Campbell-Blue
- 7 Arlington Refuge
- 8 Sierra Ancha Experimental Forest:
Workman Creek
Parker-Pocket Creeks
Natural Drainages
Base Rock
Summit

Figure 2. --Location of experimental areas in Arizona where watershed management research is being conducted.

Detailed information on individual experimental areas is given in figure 2 and table 2.

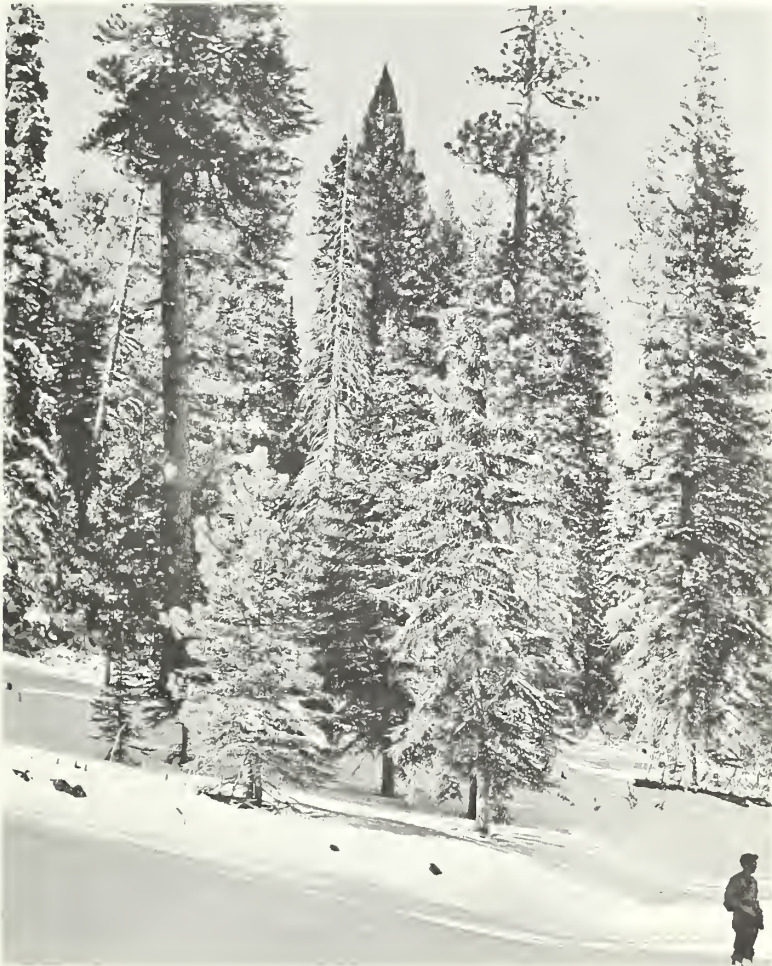
Figure 3. -- Typical mixed-conifer cover in the headwaters of the Salt River. The scene is on a southeast slope of the East Fork of Willow Creek 33 miles south of Springerville, Arizona. The main trees shown are Douglas-fir, ponderosa pine, Engelmann spruce, and blue spruce.

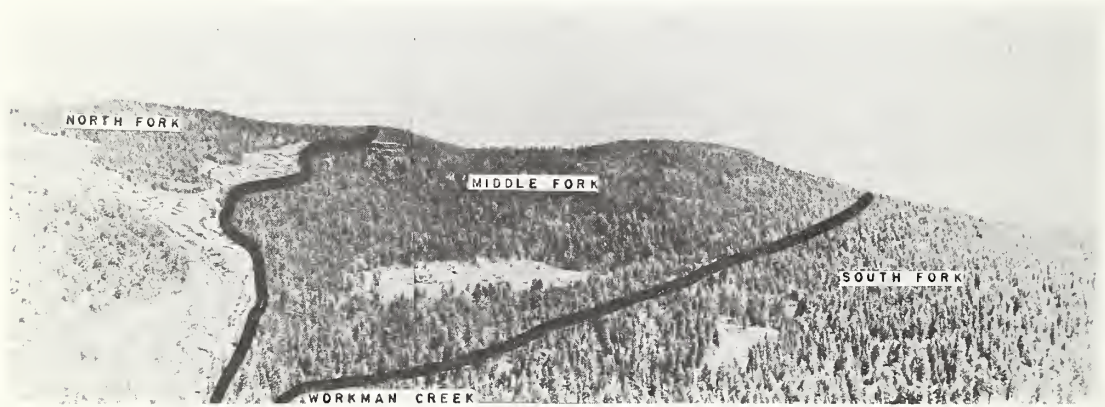
Figure 4. --Workman Creek experimental watersheds. This picture was taken just after the cutting of all trees on 80 acres of North Fork. The openings in Middle and South Forks are meadows.

Timber harvest and timber removal were started on Workman Creek in 1953 in cooperation with the Salt River Valley Water Users' Association. The period 1938 to 1953 was used to characterize water and sediment yields from the North, Middle, and South Forks of the 1,087-acre Workman Creek watershed (fig. 4).

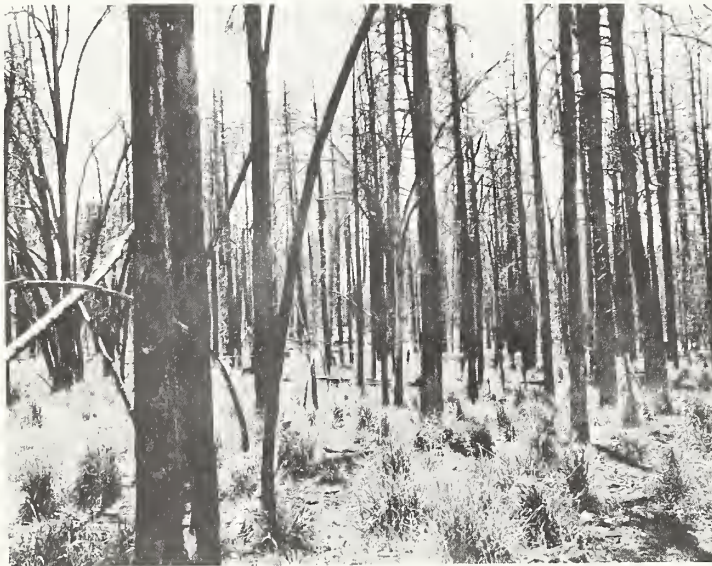
Figure 5. --Effective seeding of a burn on the South Fork of Workman Creek. This 60-acre area was burned by wildfire on July 6, 1957. Prior to this time disturbance of the watershed from felling, skidding, and yarding had no measurable effect upon sediment at the gaging station, even though some sediment moved into stream channels from roads and other disturbed areas. After the wildfire, considerable soil movement followed the first summer rains. The most intense storm on record occurred on July 16, 1957. Rainfall totaled 3.41 inches in 3 hours, with 2.20 inches falling in a 30-minute period. After the summer rains, which totaled 10.62 inches, soil loss averaged 0.016 foot from 1,600 profile points, or nearly 1 acre-foot of sediment. The burned area was seeded to grass, and good establishment is protecting the area from further heavy erosion.

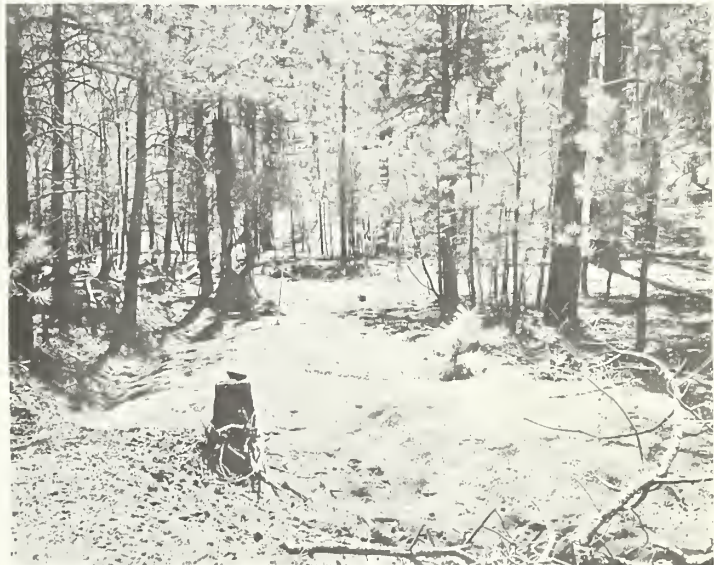
Figure 6. --During the spring runoff of Castle Creek in 1958, the East Fork weir pond trapped nearly 44 cubic yards of sediment, mostly coarse sand. The peak flow was 43 cubic feet per second. The watershed is not dissected by side channels nor is there evidence of extensive erosion. This stream channel, like many others in the pine-

fir area of Arizona, flows through flat meadows and wide-bottomed forest areas. Often these channels are paved with coarse sediments, which are gradually moved downstream by high water.

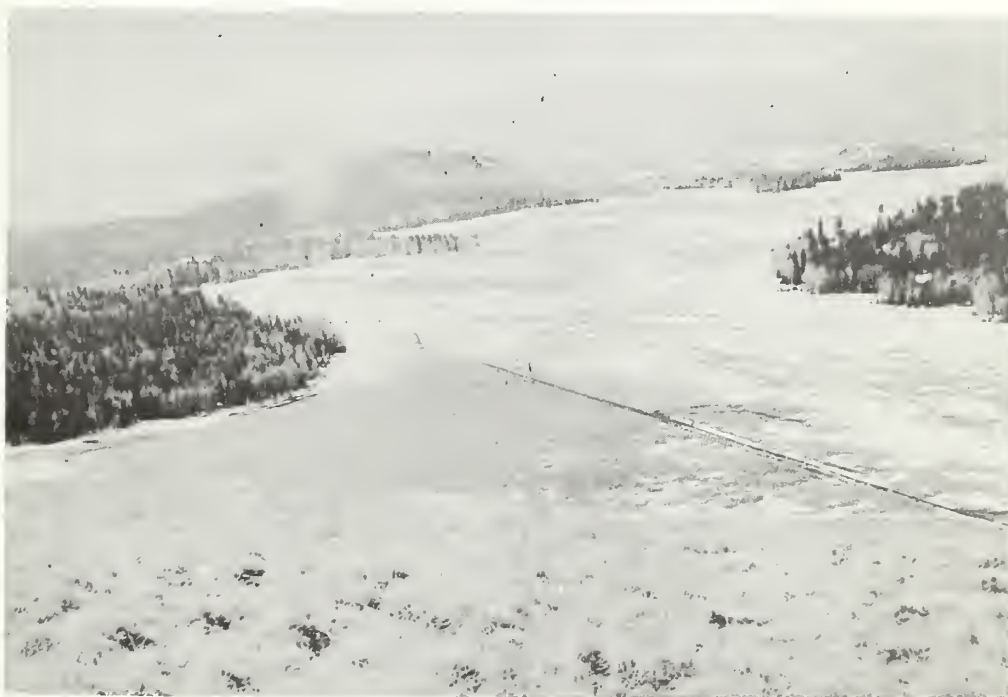
Figure 8. --Snow cover from Greens Peak on March 19, 1959. On the Salt River, below this headwaters region, high daily peak for the spring (350 second feet) was on April 11, 1959. The peak seemed to be related to the start of snow disappearance from north-facing conifer timber areas and general disappearance of snow from other timber areas.

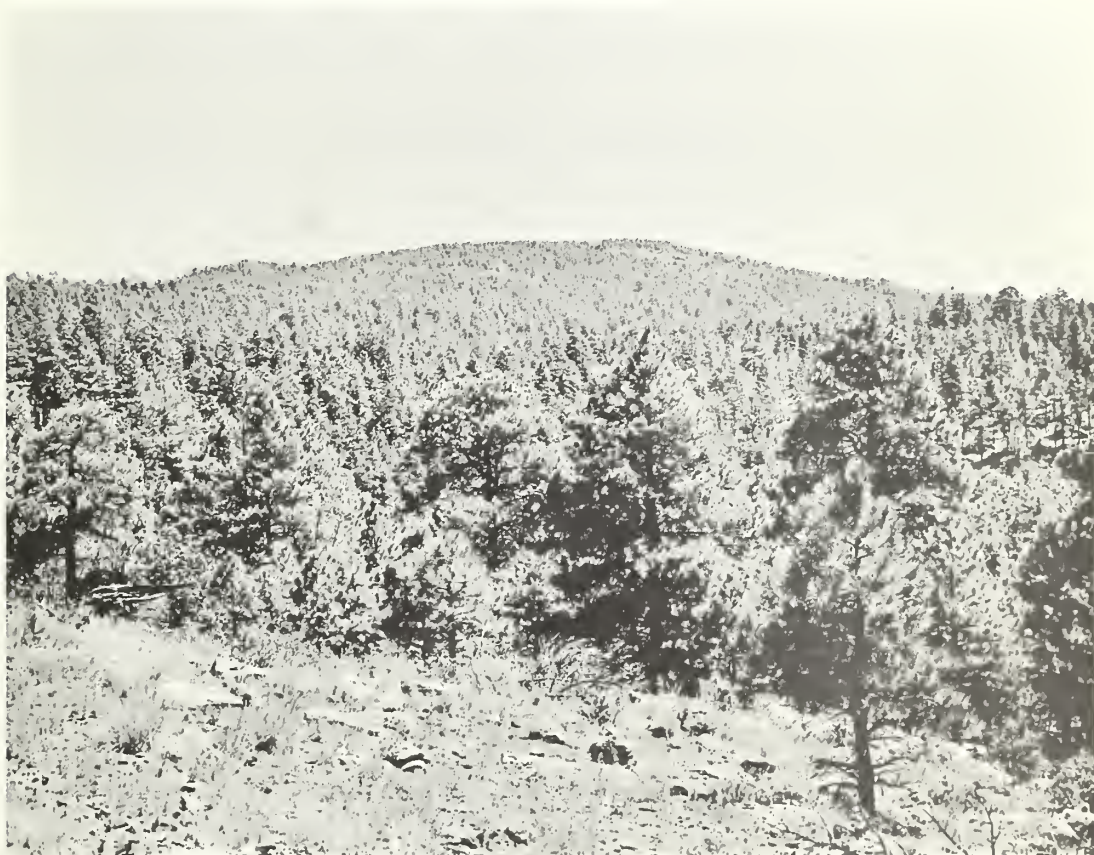
Figure 9.--Ponderosa pine watershed on the Beaver Creek Pilot Project, Coconino National Forest.

Ponderosa pine is found between elevations of 6,000 and 7,500 feet on and to the south of the Mogollon Plateau (fig. 9). The type occupies about 7.5 percent of the State. Ponderosa pine is the dominant tree and is highly valued for lumber and pulp. Beneath the pine is a woody understory consisting of Gambel oak, New-Mexican locust, and a number of smaller shrubs; and where sufficient light filters through the canopy, perennial grasses such as Arizona fescue, mountain muhly, and muttongrass may be abundant. The understory vegetation, as well as the vegetation in parks and openings, is used by livestock and game. Where there is running or impounded water, recreation use is high and increasing rapidly. Annual rainfall averages 20 to 30 inches.

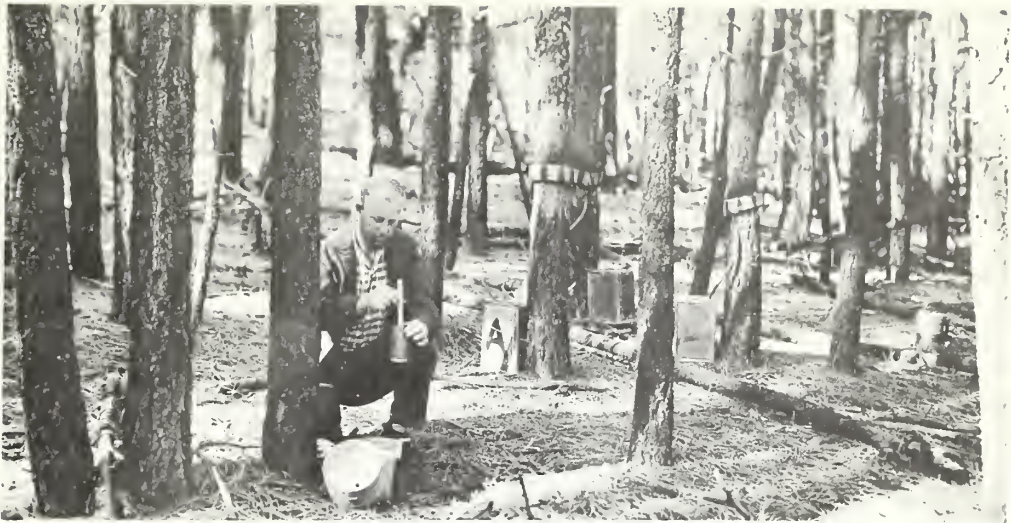
Figure 10. --Measuring rainfall under canopy of pole-sized ponderosa pine. The rain caught in the cans on the forest floor is called "through-fall." Bands around the trees in the center are troughs to catch rain flowing down the trunks (stemflow). In this stand through-fall was 71.4 percent of gross rainfall and stemflow was 8.3 percent. Thus 20.3 percent less rain reached the ground here than in a nearby opening.

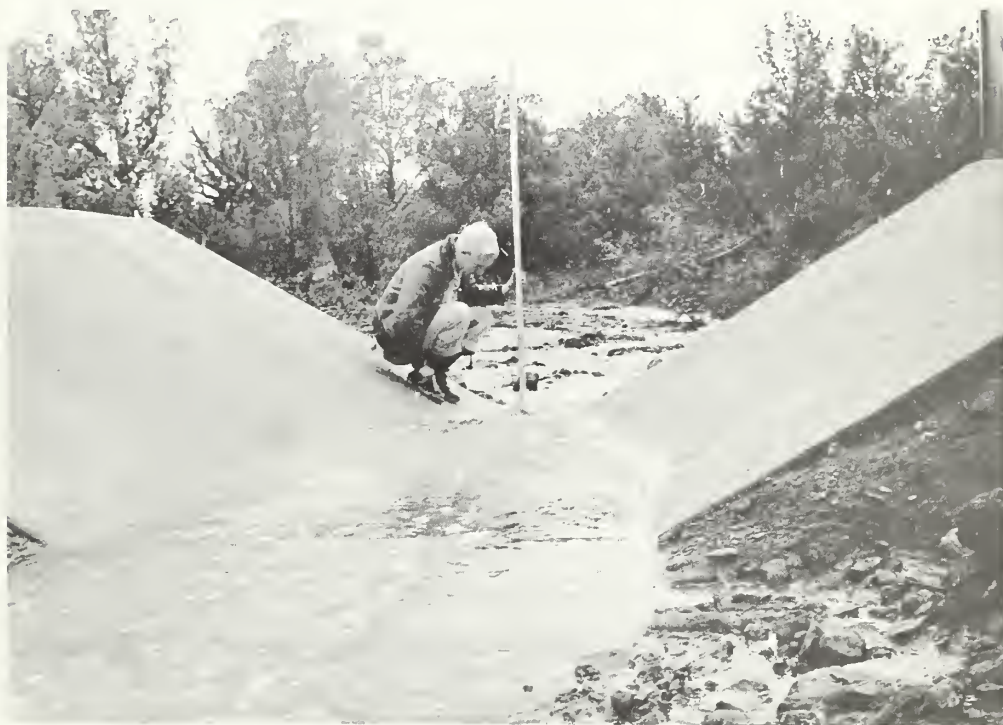
Figure 12. --Flow measurements in a flume on Beaver Creek. The operator is using a velocity head rod to measure water depth and velocity. Flumes of this type are located on 14 small watersheds where various land treatments are underway or planned. To date the flumes have carried discharges up to an estimated 380 cubic feet per second. The flume will measure a wide range of flows and carry large debris loads. Rating of the flume is based on tests in the Colorado State University Hydraulics Laboratory and flow measurements in the field.

Streamflow is being measured on the tributaries of Beaver Creek as part of the study of hydrologic characteristics of the ponderosa pine and pinyon-juniper types. Flow is gaged by flumes of the type shown in figure 12. In 1957-58 flow occurred on ponderosa pine watershed No. 9 during October through April; in 1958-59 lower flow was observed during the February-April period. Thus far, highest streamflow has coincided with the period of rapid snowmelt. Peak flows have been high.

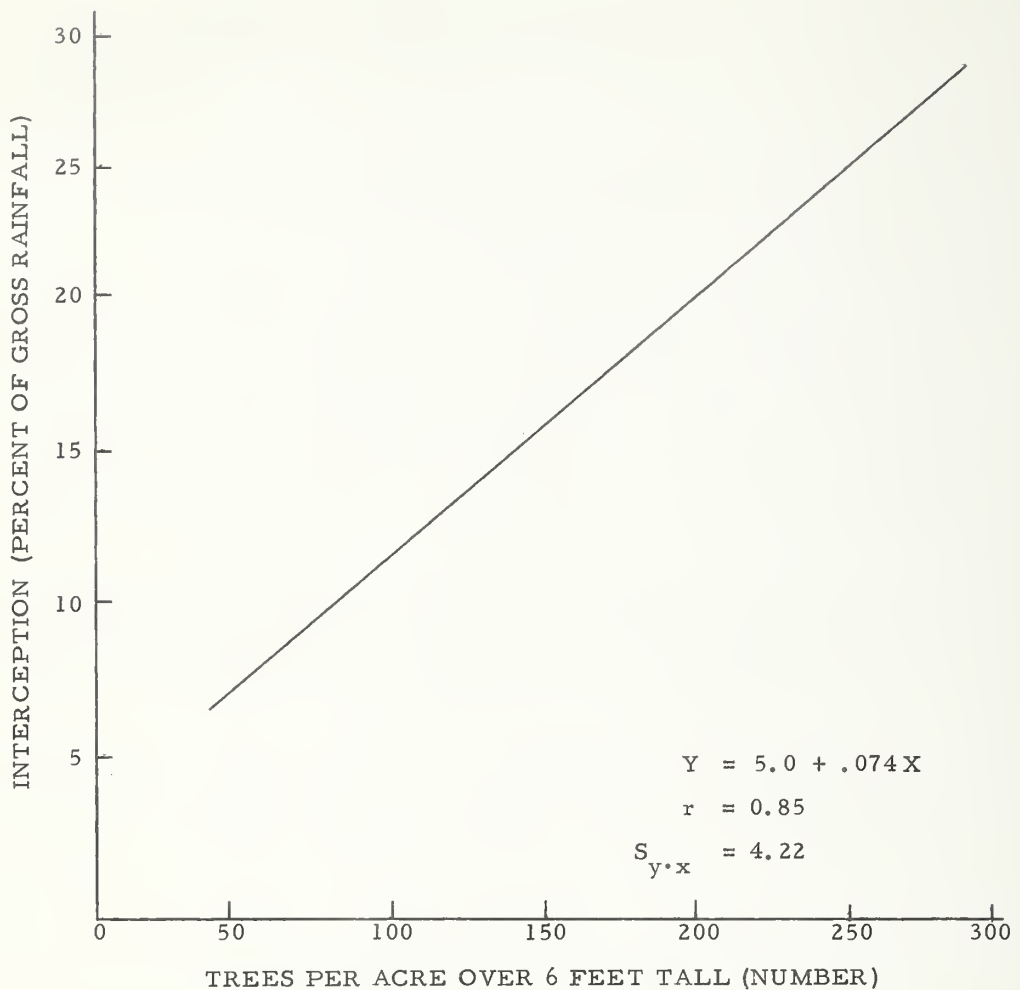
Figure 13. --Relation between density of Utah juniper and rainfall interception. Interception between April 1958 and April 1959 accounted for 1.8 to 24.1 percent of gross precipitation.

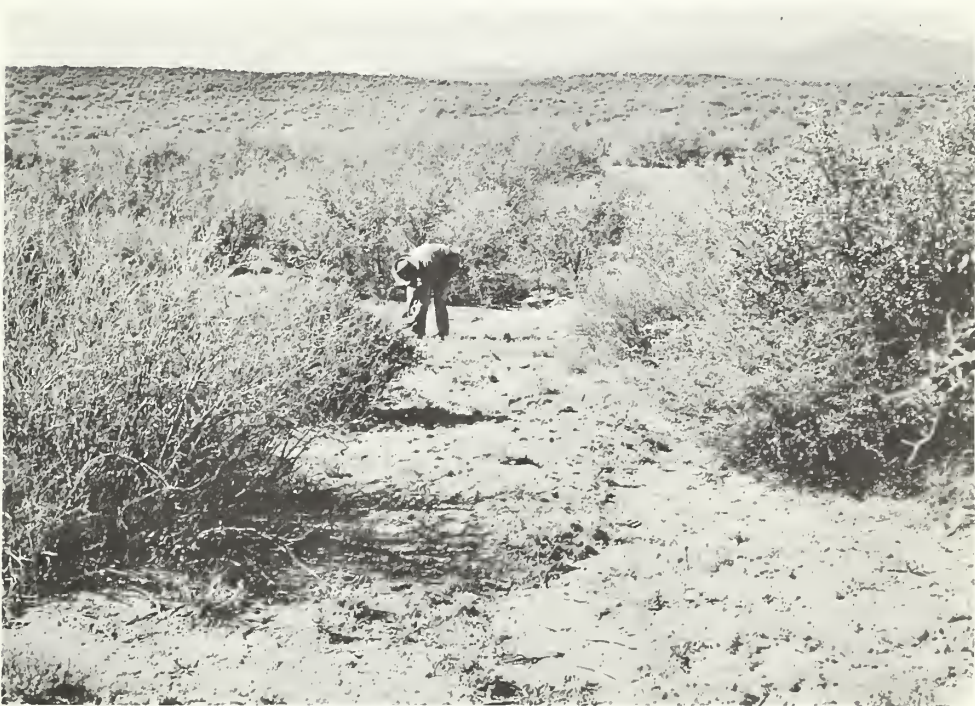
Figure 15. --A typical chaparral stand in central Arizona.

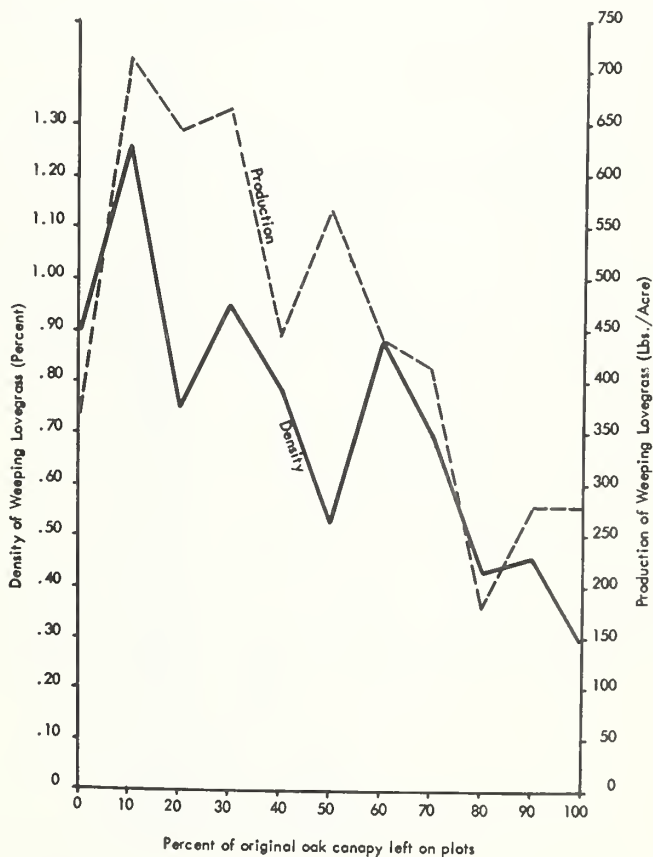
Figure 17. --Relation of weeping lovegrass to amount of oak. Both cover and herbage production of the 1-year-old weeping lovegrass decrease as residual oak canopy increases.

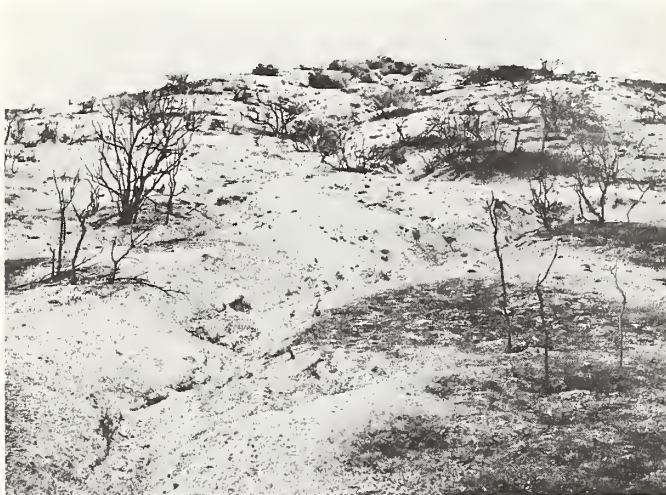
Figure 19. --Part of the 3-Bar watersheds following the Boulder fire in June 1959. Area was completely burned and tops of shrubs were destroyed. Water and sediment measurements will be continued to learn what changes have been caused by the fire. Burned areas seeded to grass will be compared with those allowed to recover naturally.

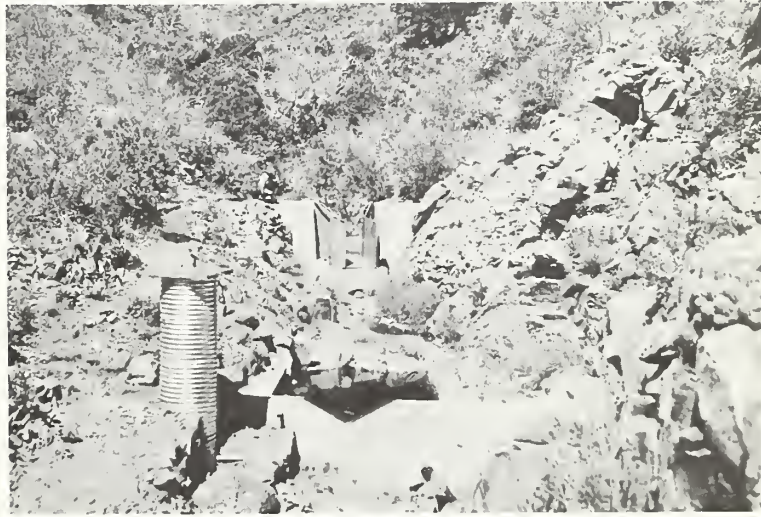
Figure 20. --Stream-gaging station on Whitespar watershed B. Water stage recorders on 120° V-notch weirs were installed by June 1958 on two Whitespar watersheds and continuous records of precipitation and streamflow have been obtained since that time. San Dimas flumes with stage recorders for measuring high flows were completed in June 1959.

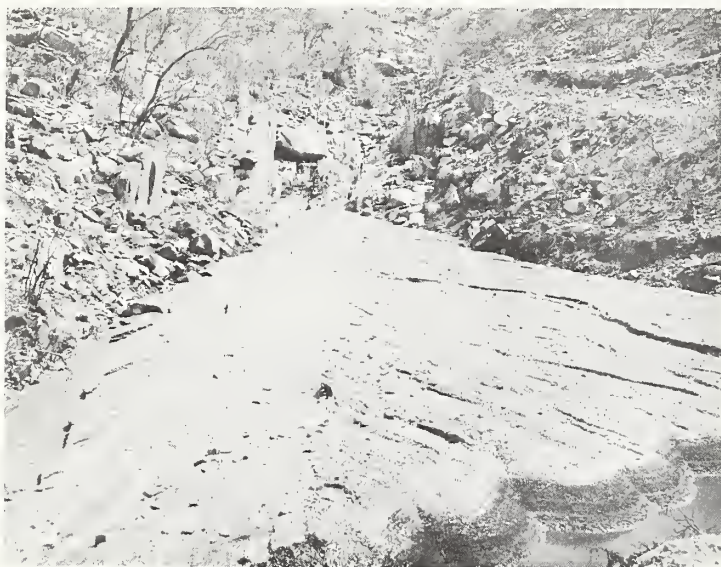
Figure 21. --After each major rain, following the wildfire of June 1959 on the 3-Bar area, weir ponds were filled and large volumes of sediment were captured in auxiliary basins. This delta, approximately 100 feet long and up to 5 feet deep, contains 4,187 cubic feet of material and represents a sediment yield of 2,100 tons per square mile from the 77-acre watershed C after the 2.15-inch rain of August 4, 1959.

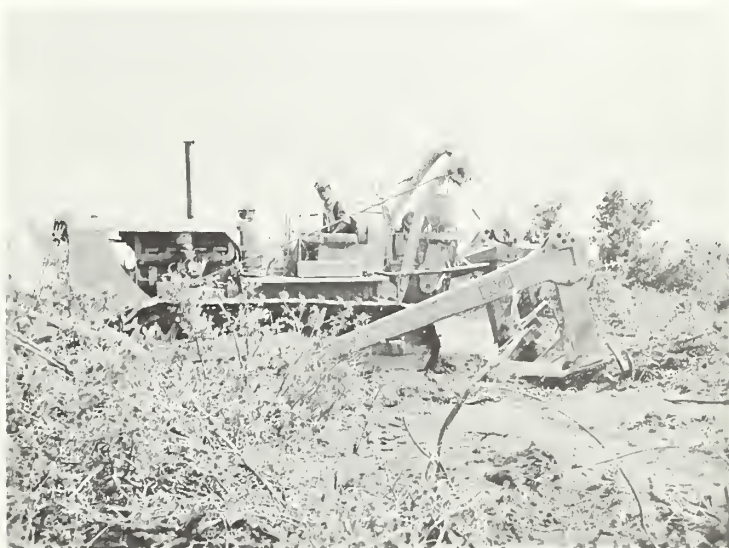
Figure 22. --Root plow being tested as means of controlling shrubs and preparing seedbed on mixed oak site near Prescott, Arizona.

Chemical control of chaparral is being studied (see next two sections) as well as control by root plows and fire. First-year observations indicate that the root plow was highly effective in killing all species of shrubs, including shrub live oak. So far attempts at prescribed burning during low-hazard periods have not been successful.

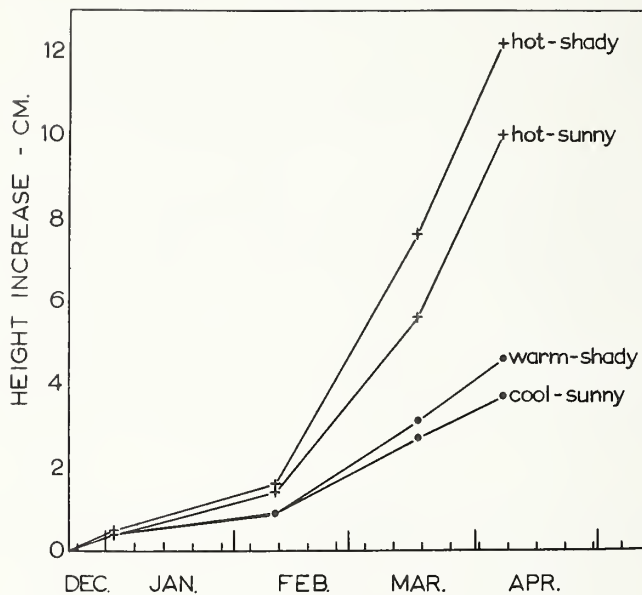
Figure 24. --Typical growth curves of shrub live oak seedlings illustrating the rhythmic growth pattern.

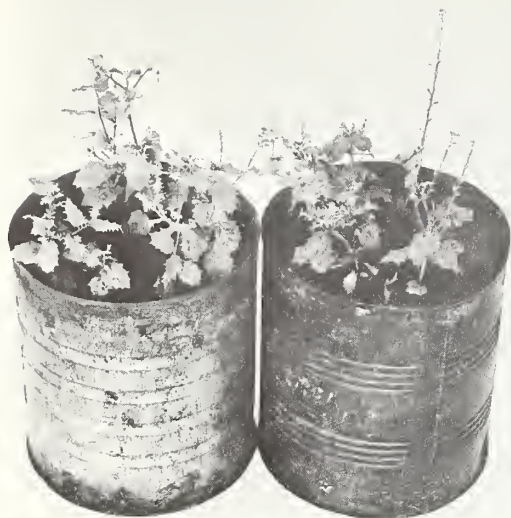
Figure 26. --Malformation of shrub live oak seedlings 22 weeks after a granular application of 2, 3, 6-TBA at the rate of 2 pounds of active ingredient per acre.

The 2, 3, 6-TBA stunted growth. For many weeks rates as low as 2 pounds per acre inhibited growth completely. Eventually the seedlings that received the 2-pound rate commenced to grow. Branching was profuse as the result of injury to the terminal buds and the developing shoots were severely malformed (fig. 26).

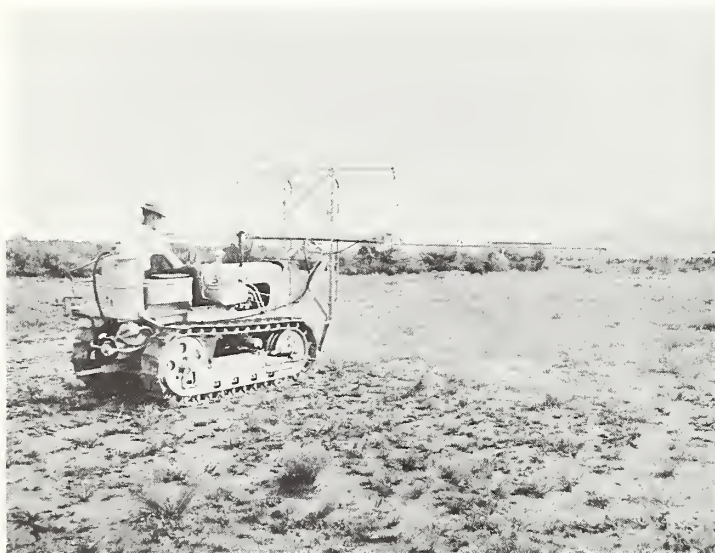
Figure 27. --Foliar applications of herbicides to plot areas were made by a 25-foot spray boom mounted on the crawler tractor. This sprayer was designed to provide critical control of pressures. Variation of the operating pressure along with ground speed and nozzle-orifice size allowed a wide selection of application volumes; however, in these experiments all applications were made at a volume of 20 gallons per acre.

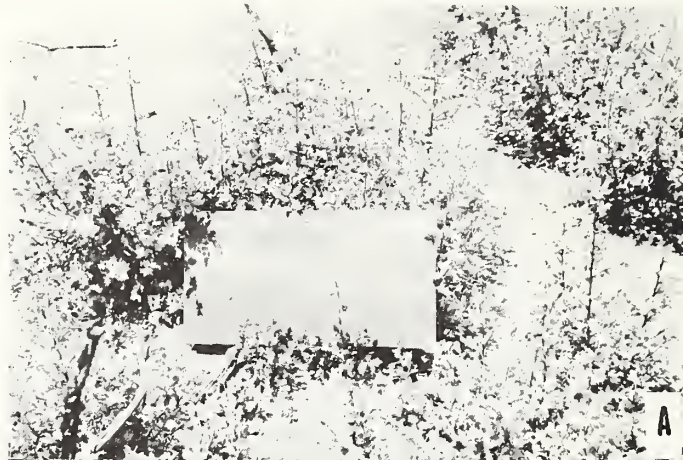
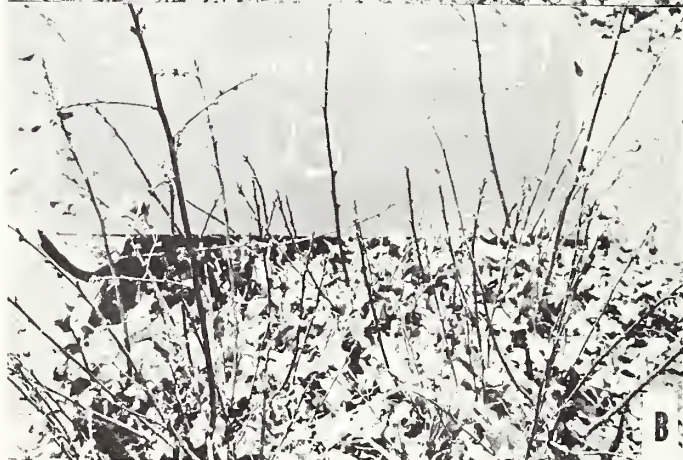
Figure 28. --

A, Untreated shrub
live oak plot.

B, Plot treated
with TBA amine
showing restricted
malformed growth.

the following January, but by June the plants had recovered to such an extent that only 15 percent killing was apparent. Apparent killing on TBA plots had dropped in that interval from 26 to 13 percent, but there was only a small amount of malformed growth (fig. 28). Growth on the 2, 4, 5-T plots was normal.

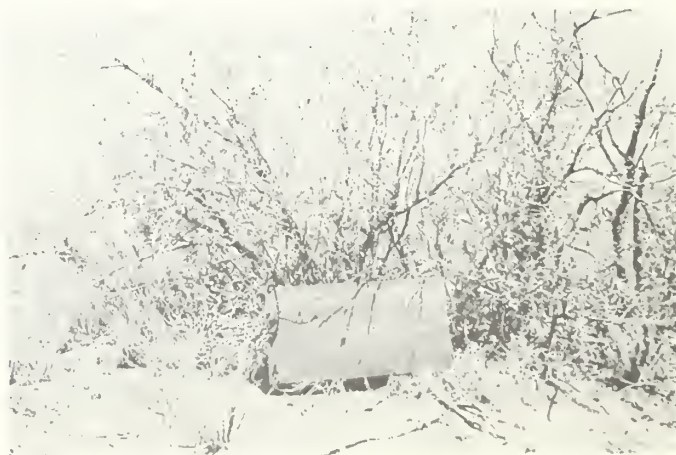
Figure 29. --

Plot treated
6 months
previously with
8 pounds per
acre of fenuron.
Leaves on bush
are nearly all
regrowth.

These granular and pelleted herbicides were applied in December 1958. Preliminary evaluations were made in June 1959. The chlorobenzoic acid herbicides and fenuron, monuron, and monuron-TCA had a considerable effect on the oak (table 18). Fenuron and to a lesser extent monuron succeeded in defoliating the plants almost 100 percent; however, the plants later refoliated and the leaves appeared normal. The chlorobenzoics (TBA), on the other hand, were not as effective in defoliating the plants, but the plants showed almost no growth and some smaller branches were dead (figs. 29 and 30). Simazine, 2,4-D, 2,4,5-T, and silvex have been ineffective up to this time.

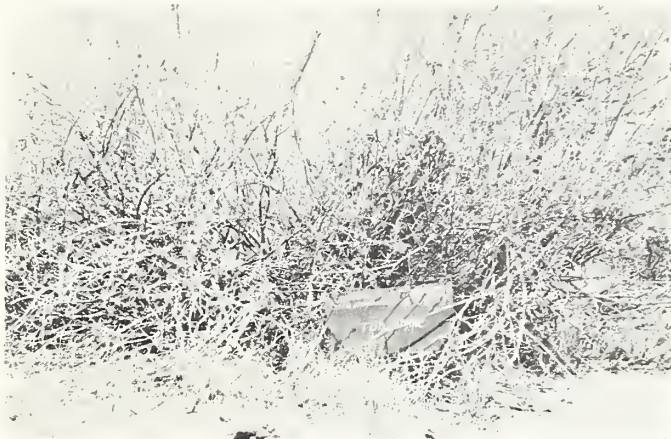
Figure 30. --
Plot treated
6 months
previously with
8 pounds per acre
of TBA amine.
Nearly all leaves
and some branches
are dead.

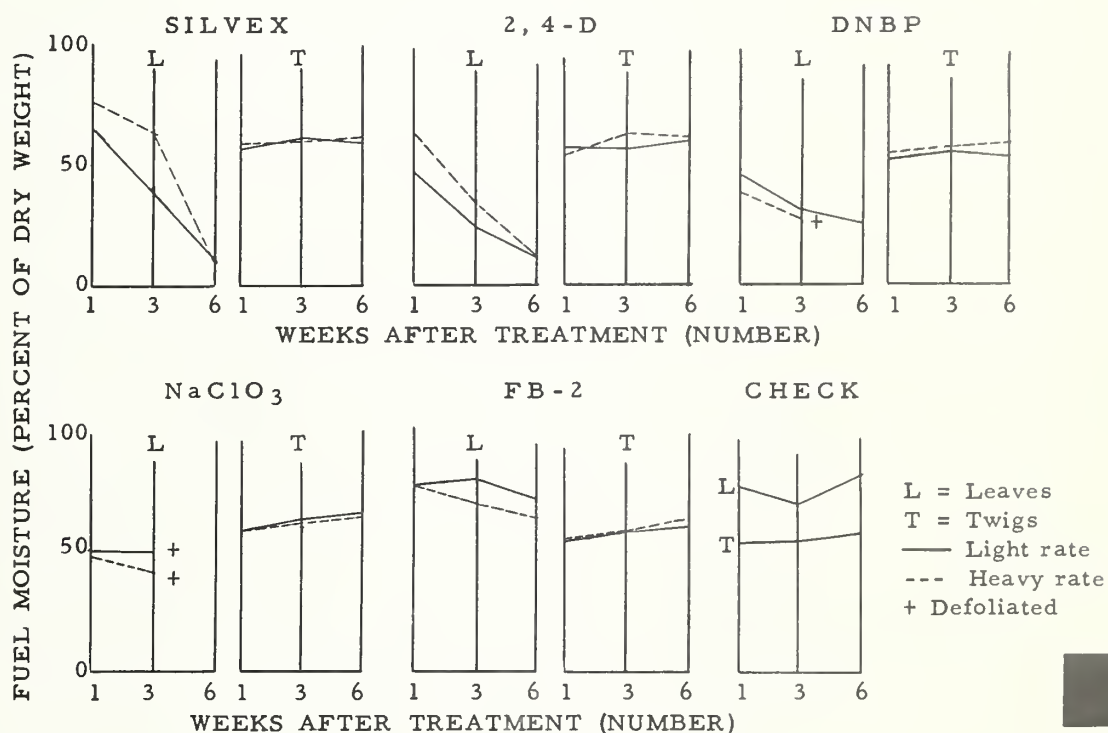
Figure 31. --Graphic results of desiccation study. Samples of leaves and small twigs taken 1, 3, and 6 weeks after treatment, oven-dried 24 hours at 105°C., and moisture loss presented as percentage of dry weight.

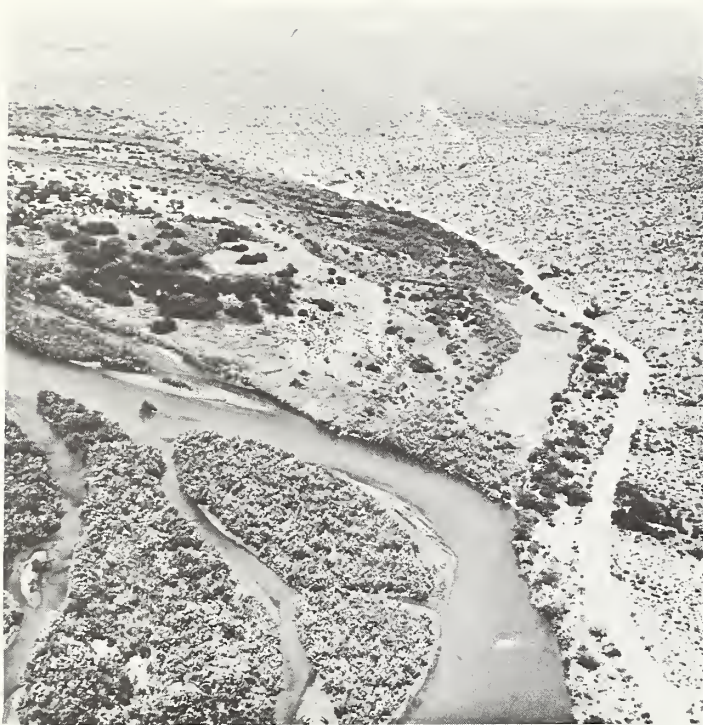
Figure 32. --Flood plain of the Salt River near Granite Reef Dam, Arizona. Tamarisk is growing along the river on the islands, and along the road in the background. The larger trees are mesquite and cottonwood. The lighter patches near the trees are arrowweed.

The most noteworthy association grows at relatively low altitudes (roughly below 6,000 feet) on the flood plains of the major rivers. Seepwillow *baccharis*, Fremont cottonwood, mesquite, and arrowweed are common species forming either dense thickets or open groves (fig. 32). In much of the area *fraxinifolia* tamarisk has completely replaced the native vegetation.

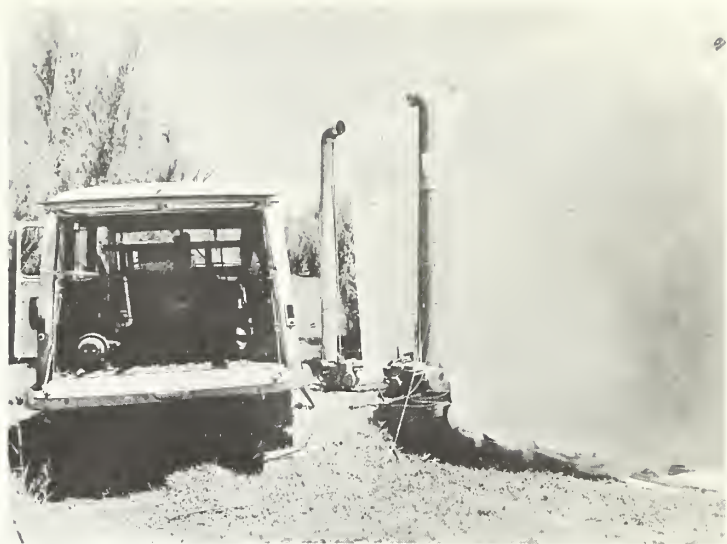
Figure 33. --In 1958 this apparatus was developed for measuring comparative evapo-transpiration of undisturbed naturally vegetated plots 10 feet in diameter and including shrubs up to 10 feet high. The apparatus consists of two transparent plastic tents with ventilating blowers, a sampling system, and an infrared-gas analyzer that acts as a highly sensitive hygrometer for measuring absolute humidity directly. All equipment and accessories fit into a 4-wheel-drive Willys station wagon for field operations beyond established roads.

Tents are erected over adjacent plots and are ventilated at known rates. Absolute humidity of air entering and leaving a tent is measured. Humidity difference multiplied by ventilation rate gives rate of vapor production within a tent. Evapo-transpiration rates measured with this equipment are shown in figure 34.

Another method measures directly the amount of water vapor produced by a plot. Decker and Wetzel (1957) used an adaptation of this method to show that transpiration of tamarisk seedlings increased with light intensity and temperature and decreased with absolute humidity. A mobile apparatus for use in the field was developed and is in current use (figs. 33, 34).

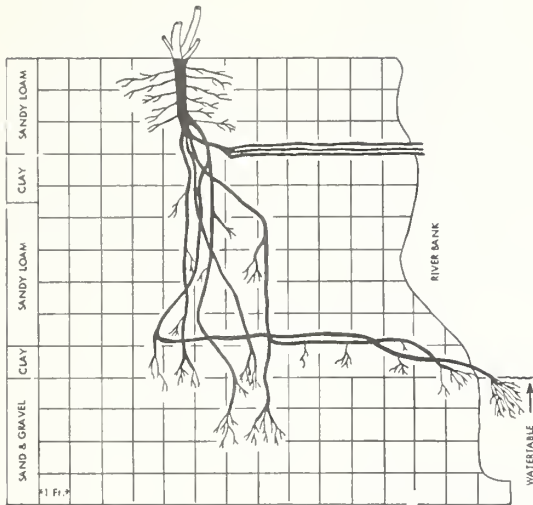
Figure 41. --Root system of large tamarisk shrub growing in deep soil, with the water table at 10 feet. Horizontal roots form on the surface of clay layers. There is a definite taproot, with most of the branch roots extending vertically to the water table.
