PNW-87

September 1968

AN OPERATIONAL TEST
 OF A NATURAL-SHAPED LOGGING BALLOON

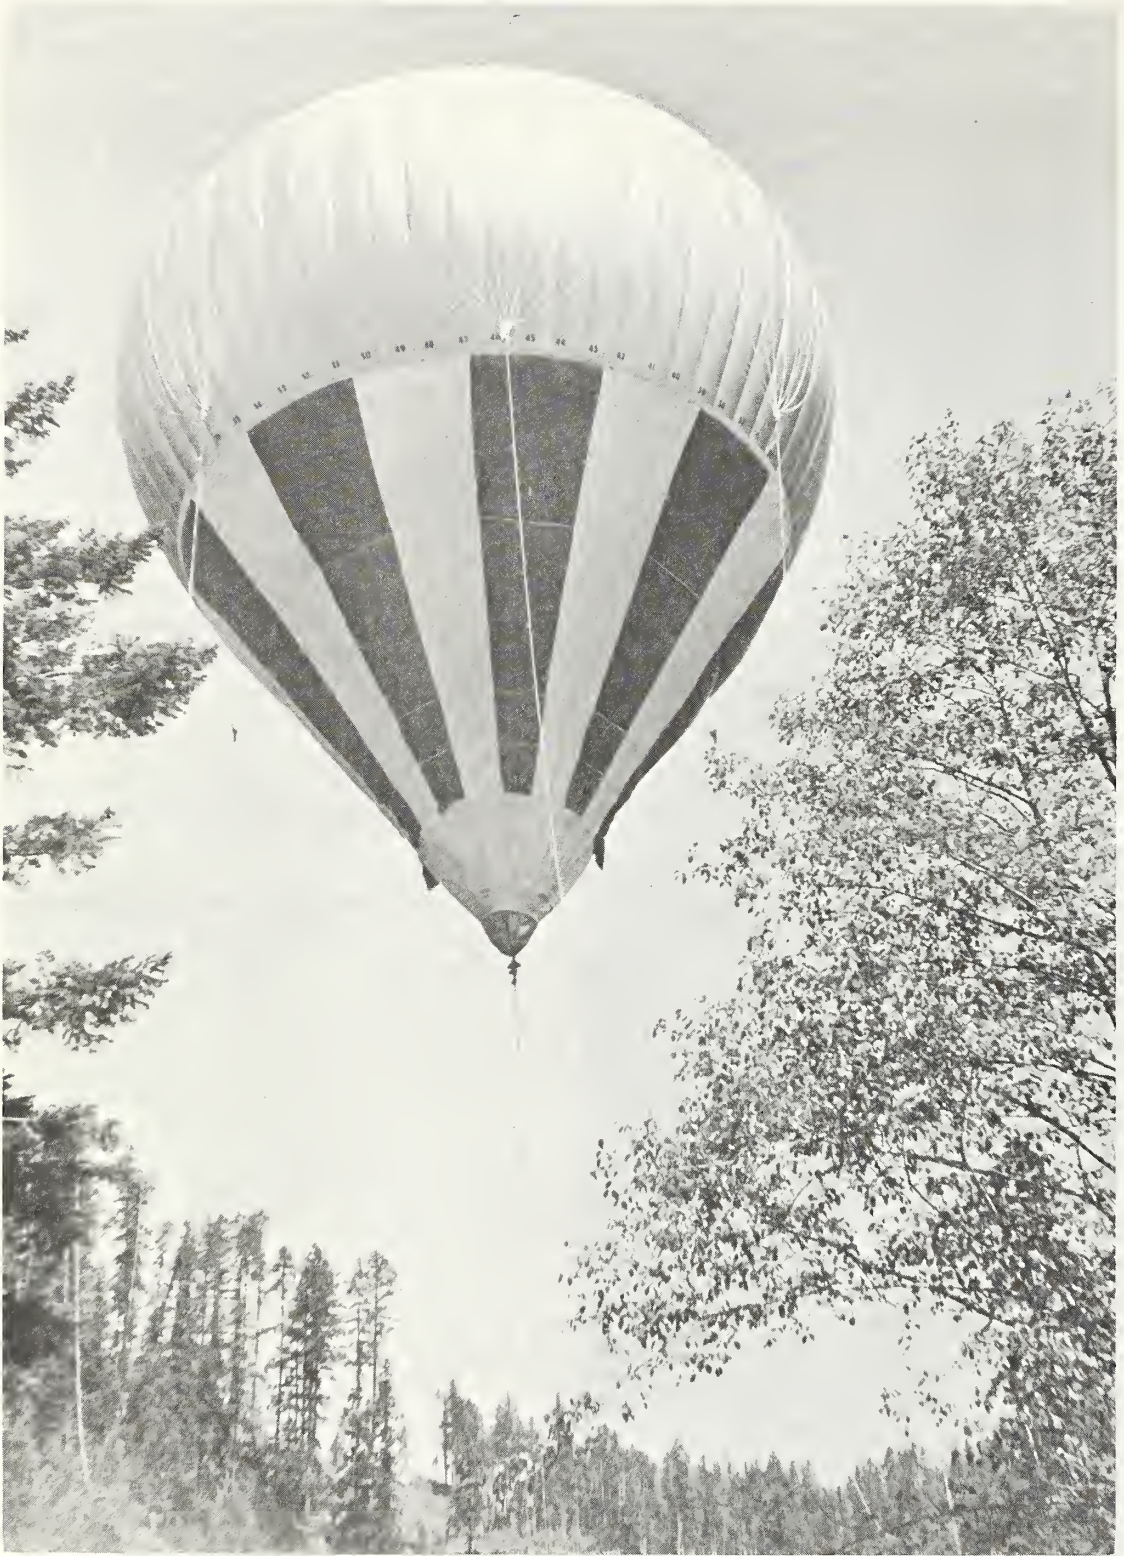
Figure 1.--Raven Industries, Inc., natural-shaped balloon.

The natural-shaped balloon (fig. 1) has several characteristics that distinguish it from other types. Its name is derived from the fact that a lifting gas naturally assumes this shape under the weight of the fabric containing it. The fabric of the fully inflated balloon is stressed uniformly,¹ which allows use of a material of uniform thickness in construction. This minimizes the weight of material required to contain a given amount of gas, and by this means, the design achieves the highest static lift efficiency of any balloon shape.

The natural-shaped balloon had a diameter of 82 feet and held 250,000 cubic feet of helium. It weighed 3,000 pounds and had a net static lift of approximately 11,500 pounds. The fabric was of a dacron base with elastomer coating on both sides. The load was suspended from the envelope with a modified tangent harness system. A light fabric was attached to the suspension system, which formed an external skirt-ballonet. It was pressurized by ram air acting through one-way valves around the lower circumference of the skirt.

A system of eight tie-down lines (these are visible in the photograph of figure 1) and the main load fitting bedded down the balloon, with approximately one-third of the total lift carried on the load fitting
