NIST Special Publication 901

The January 17, 1995 Hyogoken-Nanbu (Kobe) Earthquake

*Performance of Structures, Lifelines, and Fire
Protection Systems*

Riley Chung, Team Leader and Editor

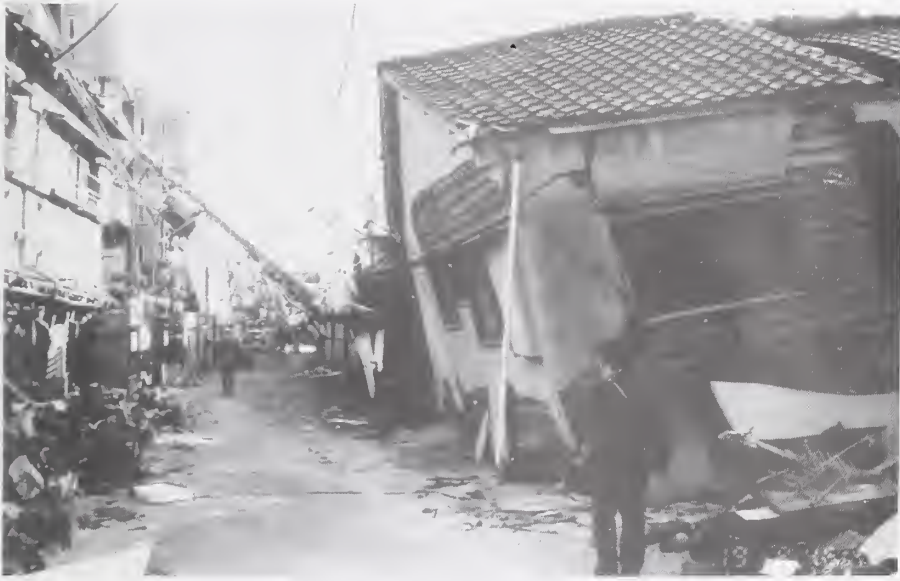
The number of collapsed houses constituted about 10 percent of the houses in the Kobe area. It was reported [3] that nearly 55000 houses collapsed and over 35000 houses were partially destroyed. These included both Shinkabe and Ohkabe houses. Typical damaged houses are shown in Figures 3.3.1 and 3.3.2.

Figure 3.3.1 A collapsed Ohkabe construction-type house.

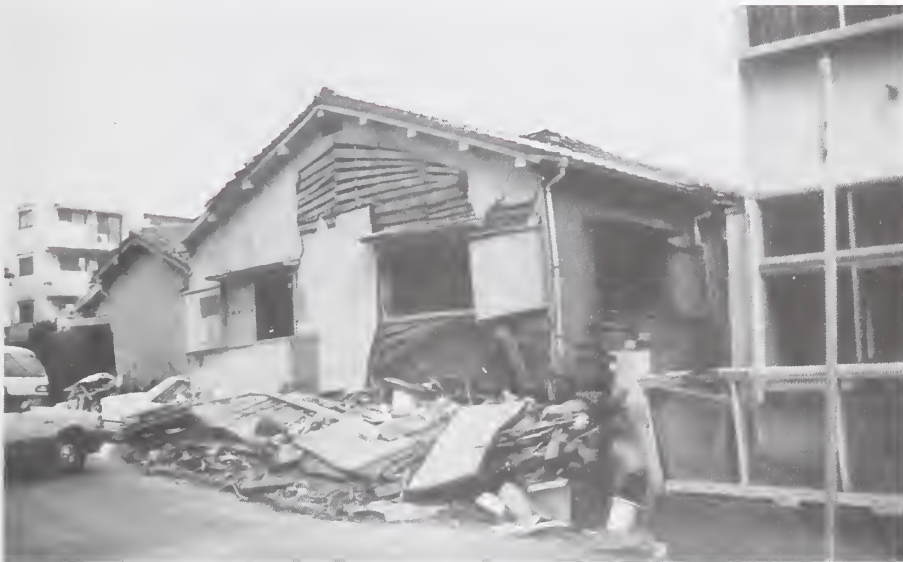
Figure 3.3.2 Same as Figure 3.3.1.

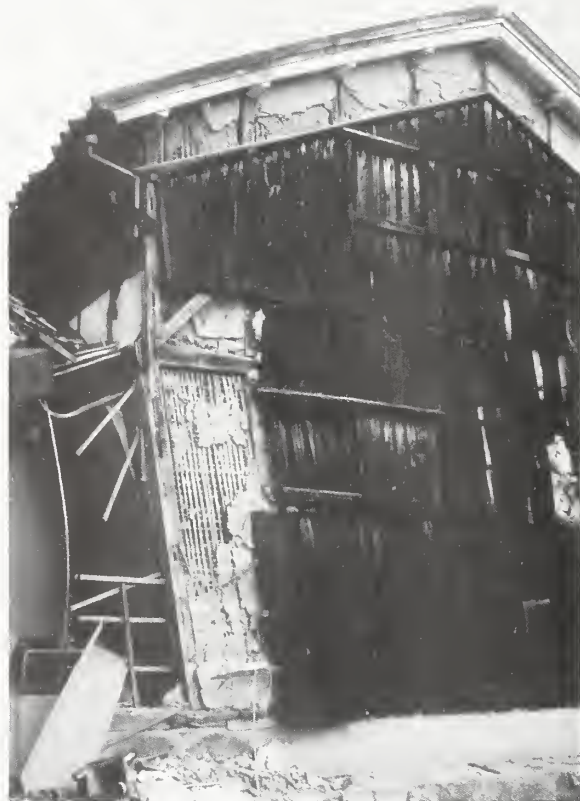
In general, more Shinkabe houses sustained complete collapse. The Shinkabe construction employed walls of bamboo thatch tied with rope and packed with mud. The outside facade consisted of stucco or some light coverings with no structural resistance. Figure 3.3.3 shows a damaged two-story Shinkabe construction and Figure 3.3.4 shows a completely collapsed Shinkabe house. In Ohkabe construction, the columns were joined by thin wooden slats (80 mm x 20 mm) placed horizontally (see Figure 3.3.5). Some parts of the Ohkabe houses were also reinforced by light wooden cross braces, and they performed better than the unbraced parts (see Figure 3.3.6). There were no indications of plywood or particle-board shearwalls being used in these constructions, as is a common practice in the United States. Only a few wood houses had some type of diagonal bracings, and a majority of the wood houses had essentially no significant lateral load carrying capacity to withstand earthquake loads.

Figure 3.3.3 A damaged two-story Sake factory with Shinkabe construction.

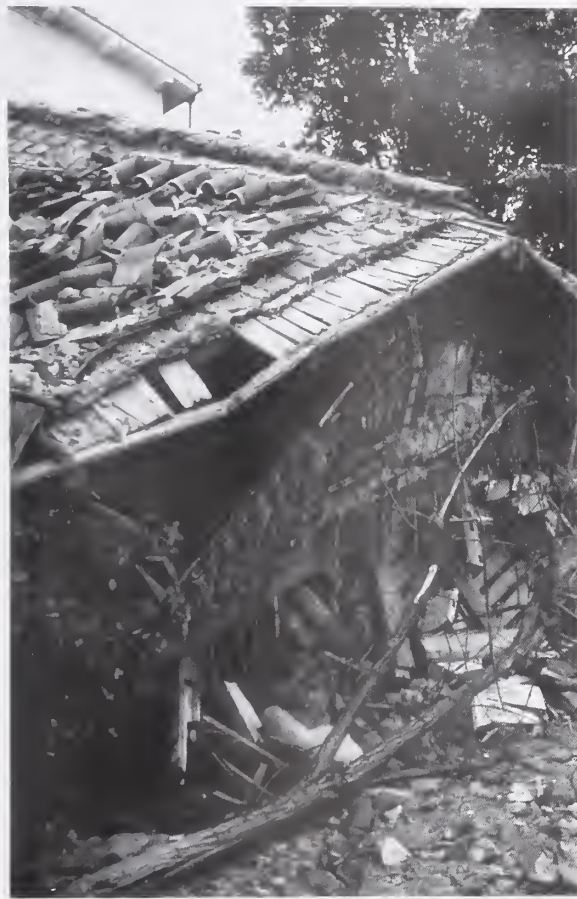
Figure 3.3.4 A completed collapsed Shinkabe construction-type house.

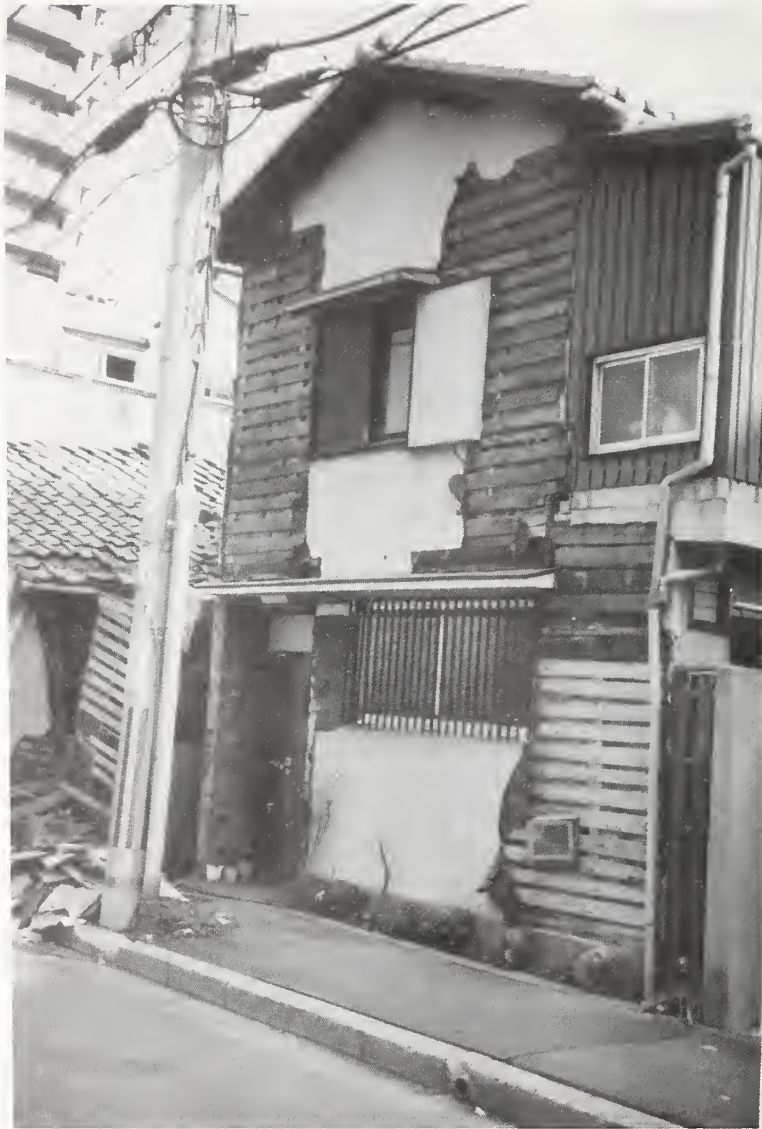
Figure 3.3.5 An Ohkabe house with only architectural design. Note a shadow of diagonal bracing on the left side of second story.

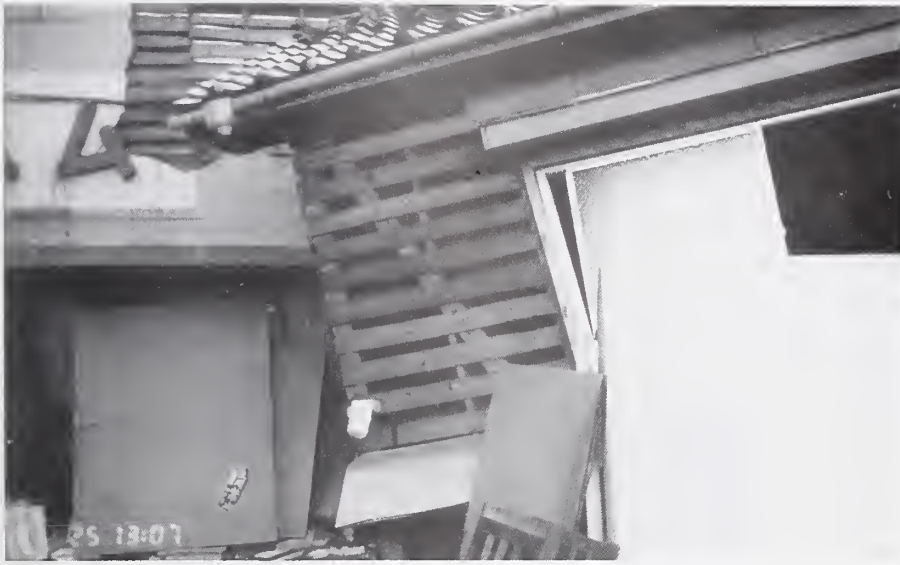
Figure 3.3.6 Intact upper story (braced) of a collapsed unit - Ohkabe construction.

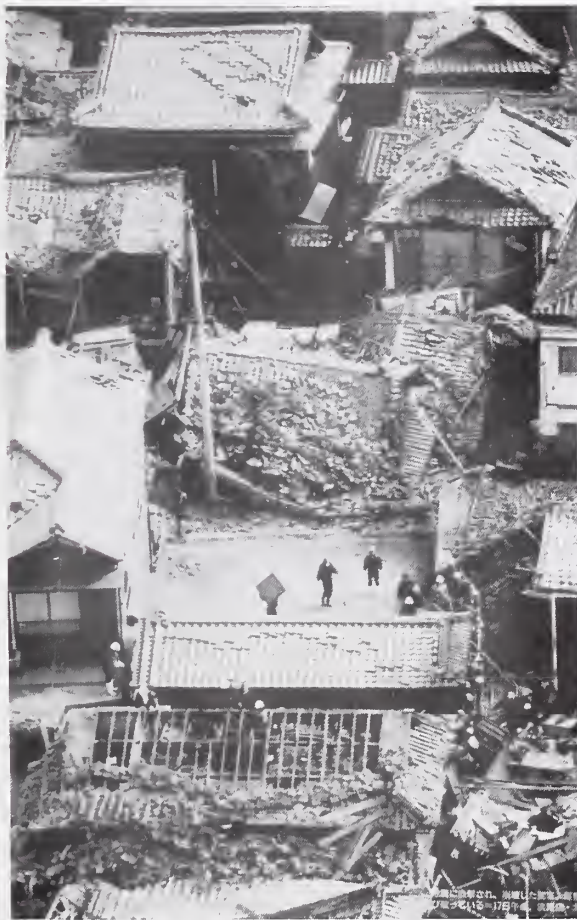
Many severely damaged houses had heavy ceramic roof tiles set on soil as bedding (see Figure 3.3.7). It is believed that heavy tiled roofs were preferred not only for the aesthetic and architectural reasons, but also because they could not be easily dislodged by gusty winds in a typhoon. The heavy roofs of these houses have contributed a great deal to their collapse. On the other hand, some of the older houses which used less elaborate and less expensive synthetic roofing made of light material performed well in this earthquake.

Figure 3.3.7 Collapse of some heavy tiled roof houses - Shinkabe construction.

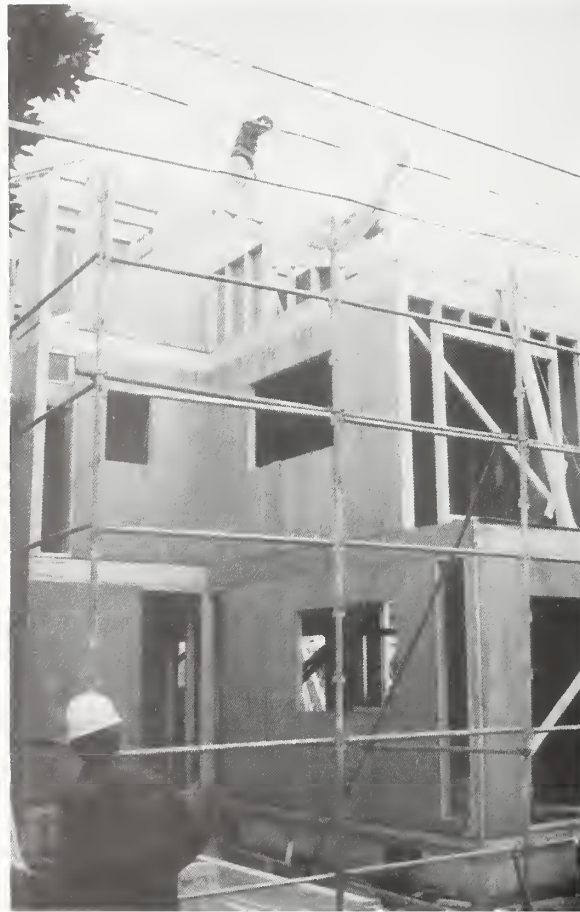
construction and the residential houses which followed the 1971 and later code regulations performed rather well in this earthquake. Figure 3.3.8 shows a frame house under construction using 2x4's which survived the earthquake.

Figure 3.3.8 A new "two-by-four" construction replacing a destroyed residential unit.

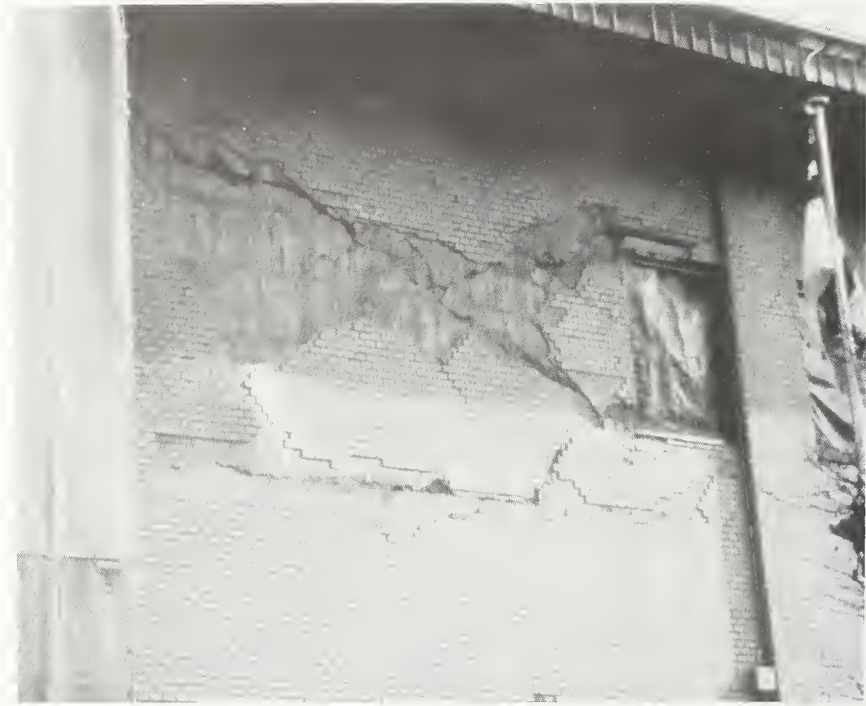
Figure 3.4.2 Damage to shear walls - Kobe Central Post Office.

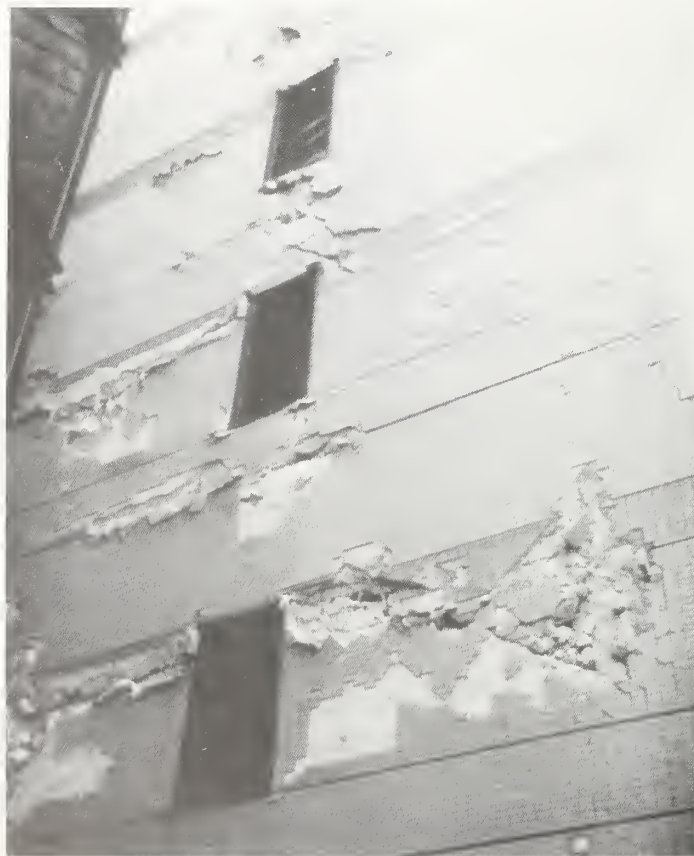
Figure 3.4.3 Damage to shear walls - office building in downtown Kobe.

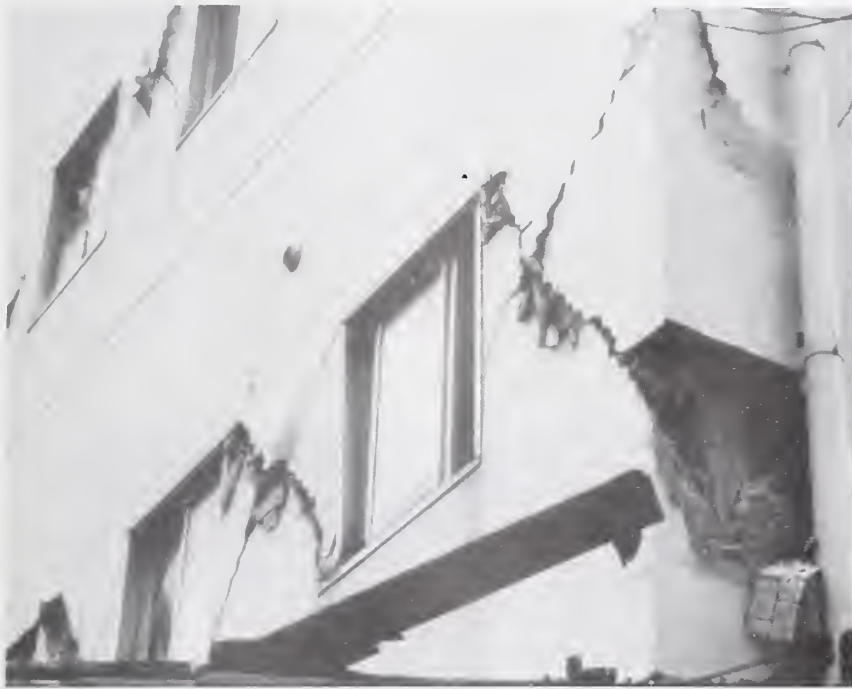
Figure 3.4.4 Diagonal tension cracks - apartment building in Nishinomiya area.

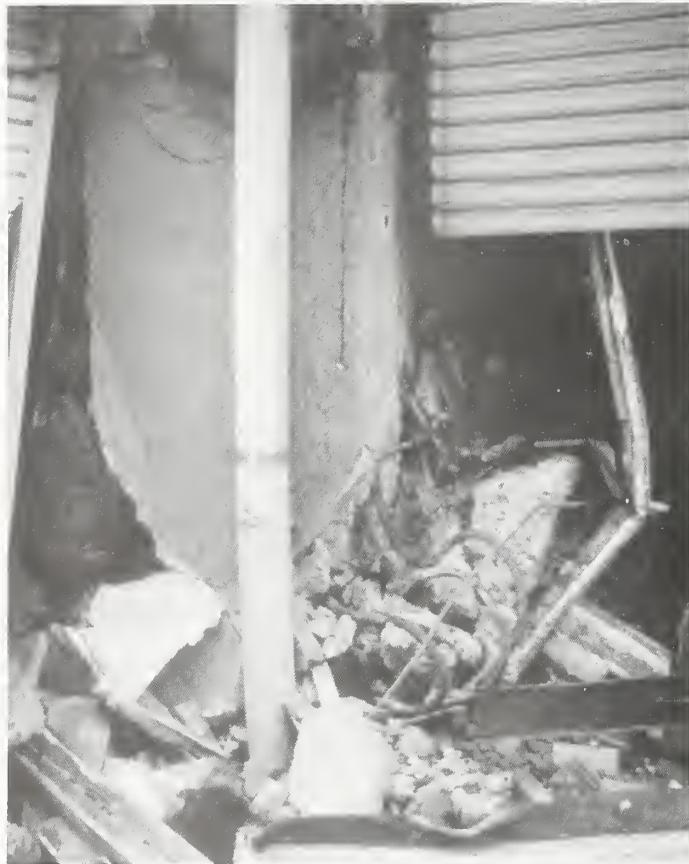
Figure 3.4.6 Failure of older column - local bar buckling.

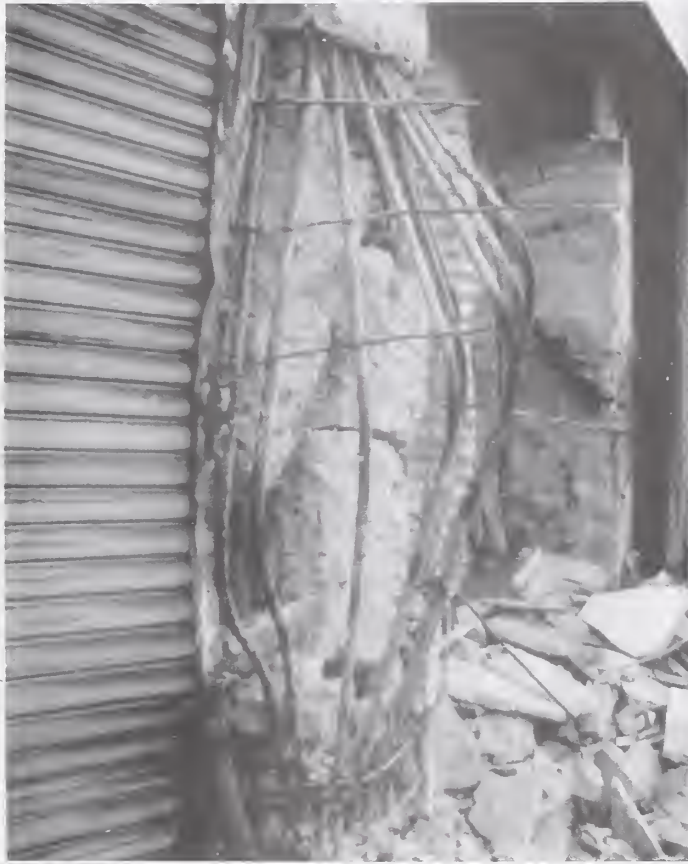
Figure 3.4.7 Failure of older column - general bar buckling.

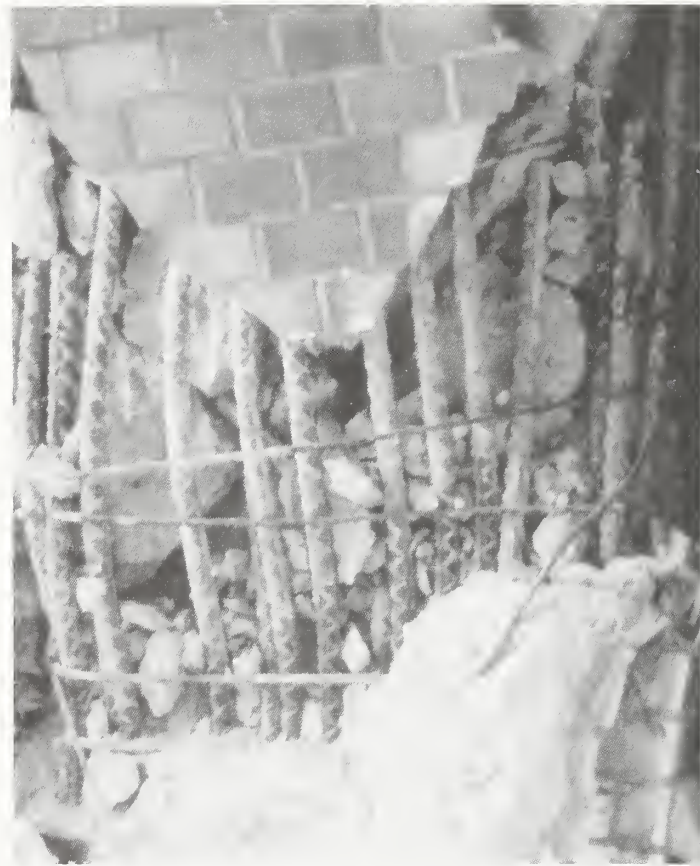
Figure 3.4.8 Failed column in commercial structure.

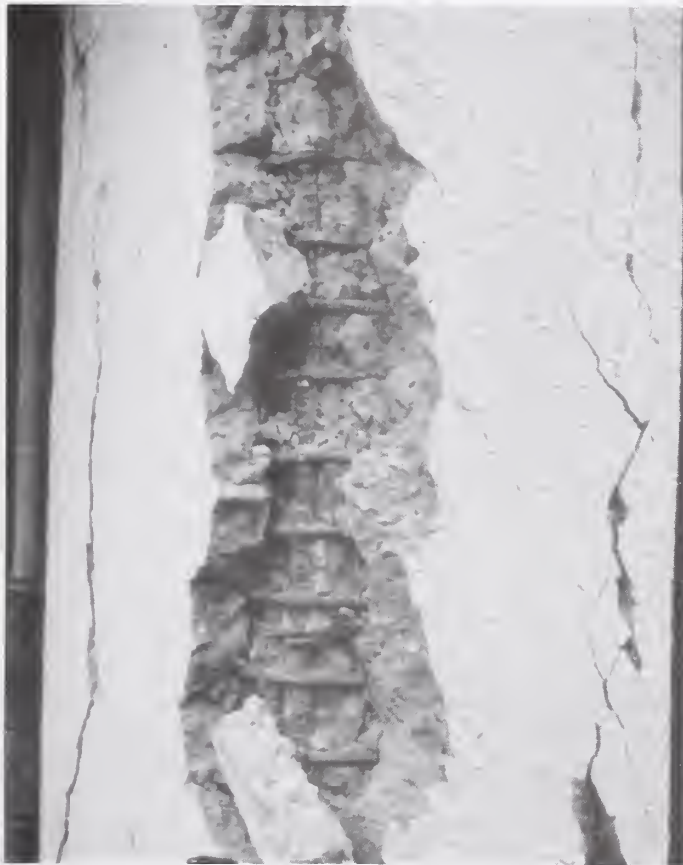
Figure 3.4.9 Damaged column in commercial structure.

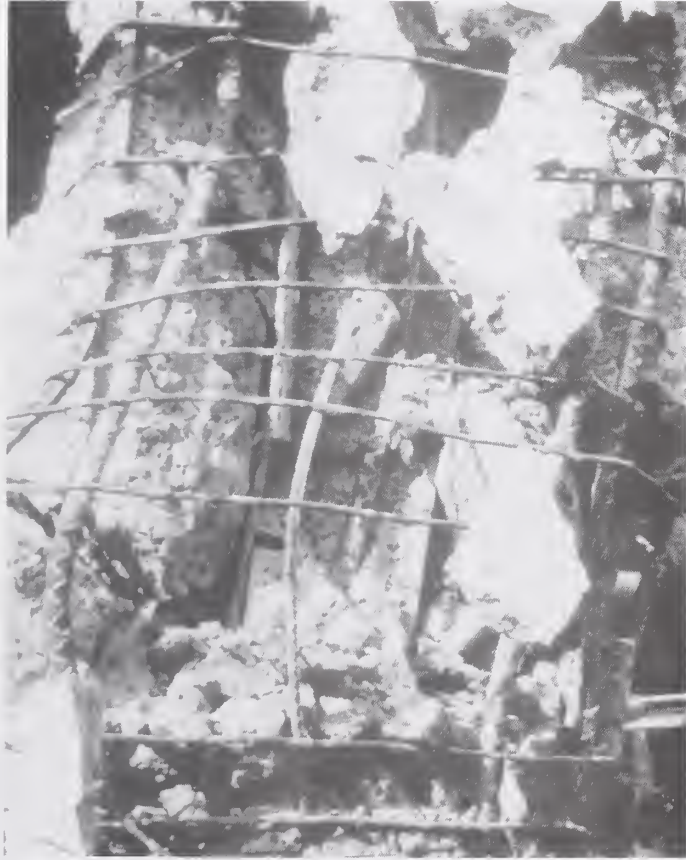
Figure 3.4.12 SRC column - Fukae Mitsuku Housing Project.

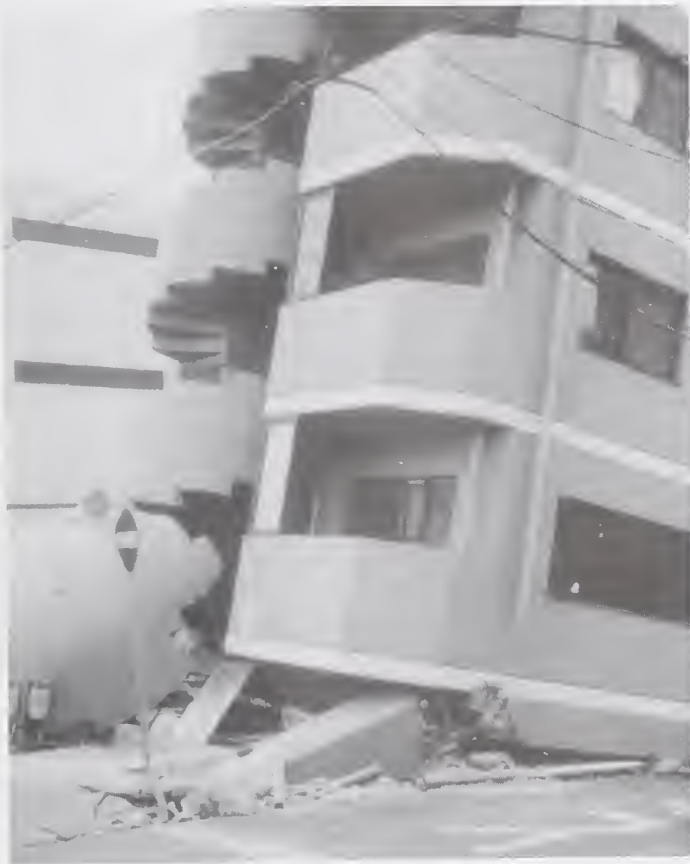
Figure 3.4.15 Collapsed first story.

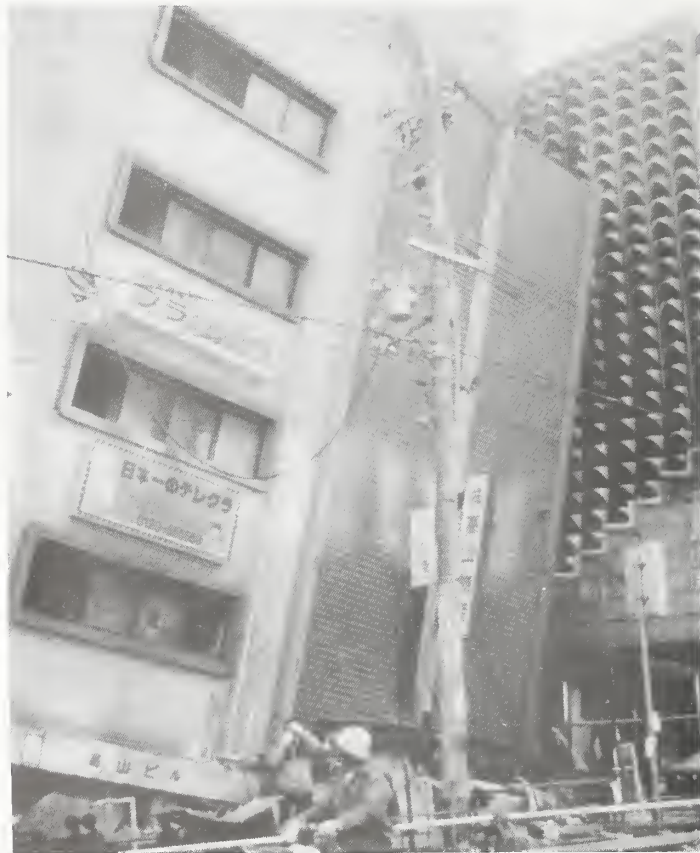
Figure 3.4.16 Collapsed first story - downtown Kobe.

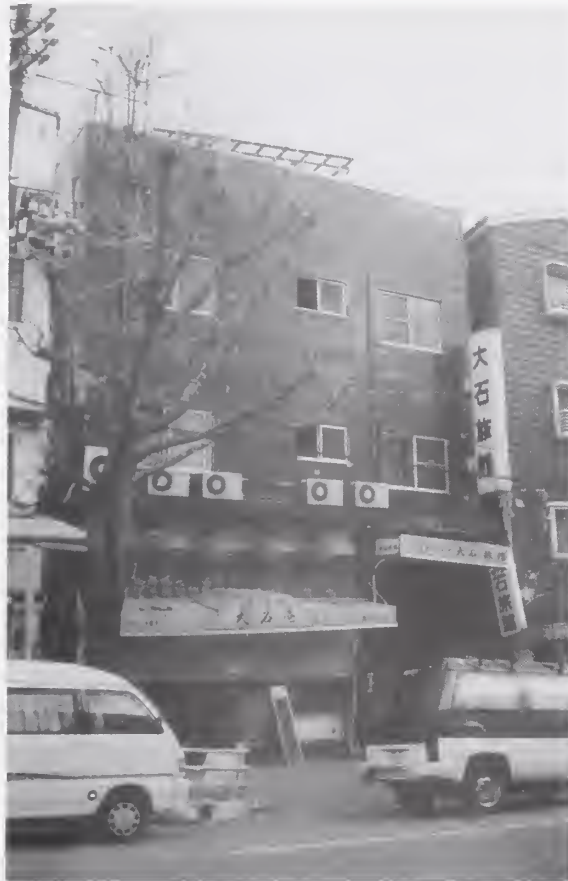
Figure 3.5.6 Three-story brick-faced light gage steel apartment. Has roll up door. Closeups (Fig 3.5.7) show that there is a great deal of rust at the connections at the second floor which connect 8 inch light gage wide flange columns. Rust clearly was at fault in the failure, not the steel frame itself... this is a common type of failure that seems peculiar to this form of light gage steel frame construction... perhaps it is the salt atmosphere of a port city that leads to such extensive corrosion.

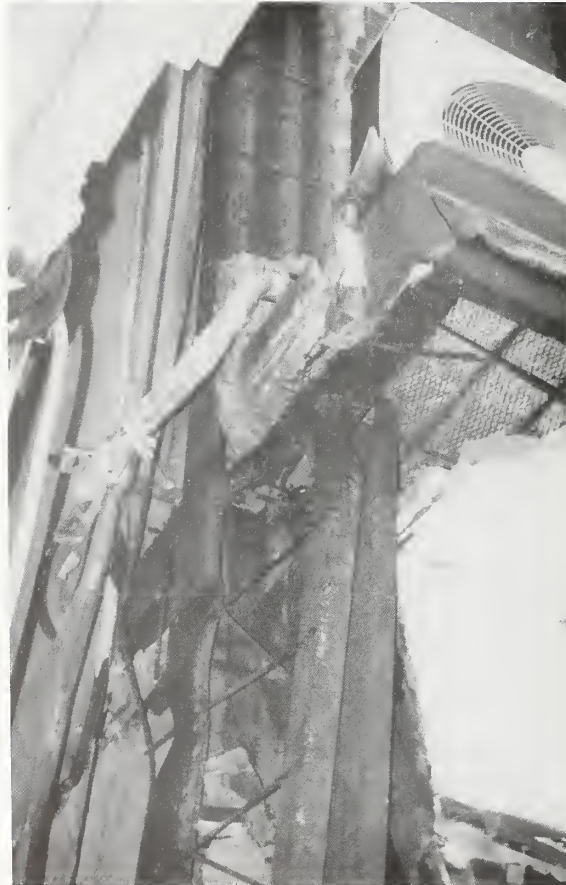
Figure 3.5.7 See caption for Figure 3.5.6: a closeup showing the rusted joint.

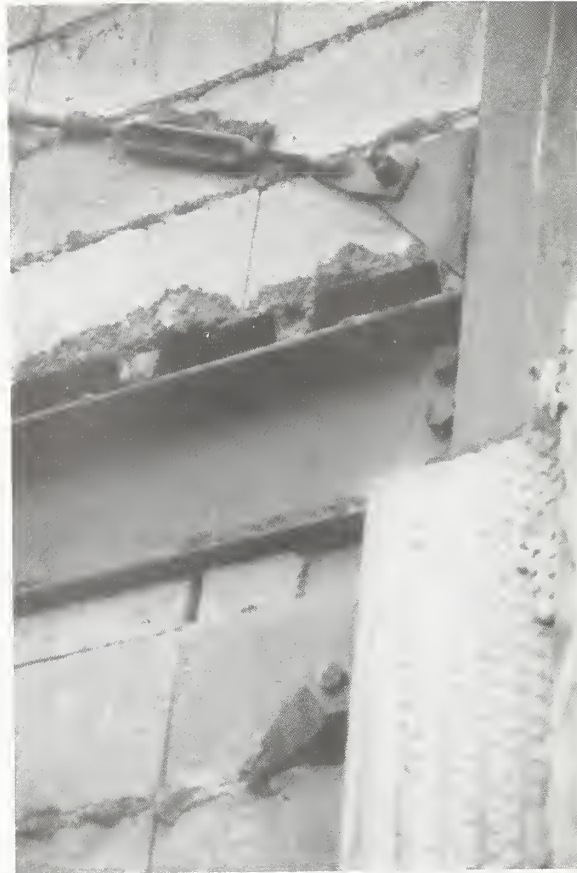
Figure 3.5.9 Many braced frame structures had failures of the diagonal braces at the welded connections. This photo shows a weld fracture between the turnbuckle rod and the gusset plate.

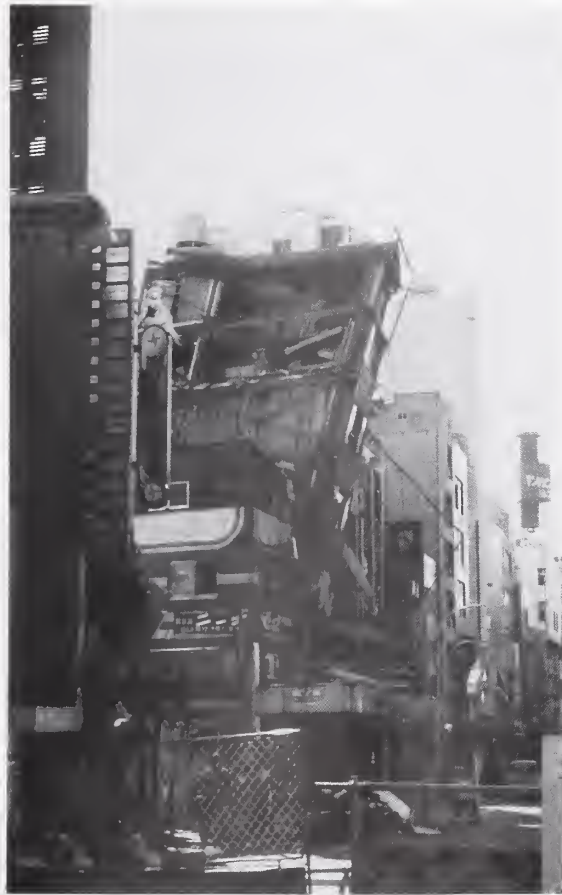
Those braced frame structures which did not have infilled walls were more flexible. One of the more striking failures in downtown Kobe was a seven-story braced frame system (Figure 3.5.10) with autoclaved lightweight concrete panels for cladding (Figure 3.5.11). This building had a very narrow platform with one bay in the east-west direction and two bays in the north-south direction. However, the building drifted severely toward north (stiffer direction) due to fracture of numerous braces (each approximately 6 mm x 75 mm in cross section) at bolted connections to gusset plates which are welded to the columns. In the upper floors, it can be seen that the braces in tension, which attempted to prevent displacement of the building toward the north, fractured through the bolt hole. The building remained standing only due to the presence of bolted shear connections for the beams, which managed to resist some lateral load.

Figure 3.5.10 Partial failure of a 7-story steel braced frame structure. Braces failed in tension at the bolted connections. Significant rust is evident in most closeups (see next four slides) around the vicinity of these bolt holes which may have permitted widespread fracture of the brace plates (approximately 6mm x 75mm plate).

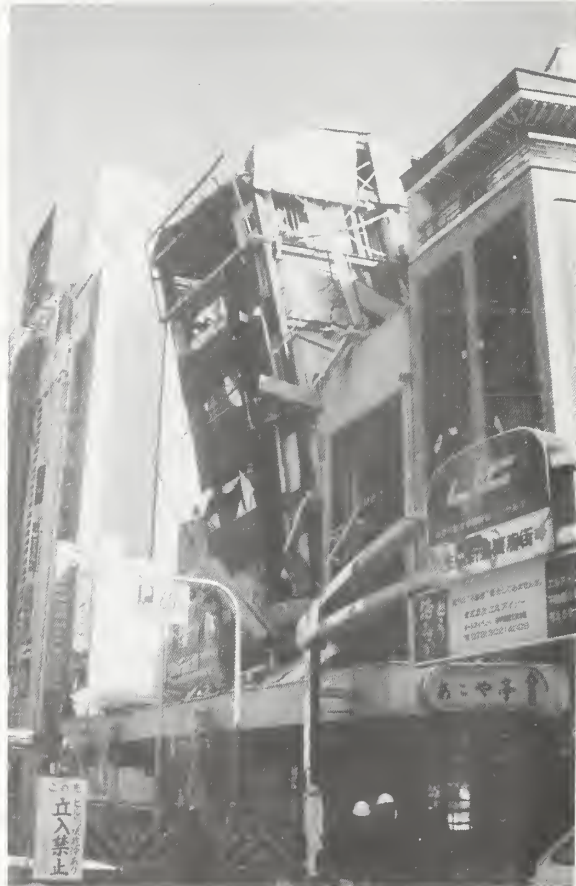
Figure 3.5.11 West side of the building shown in Figure 3.5.10.

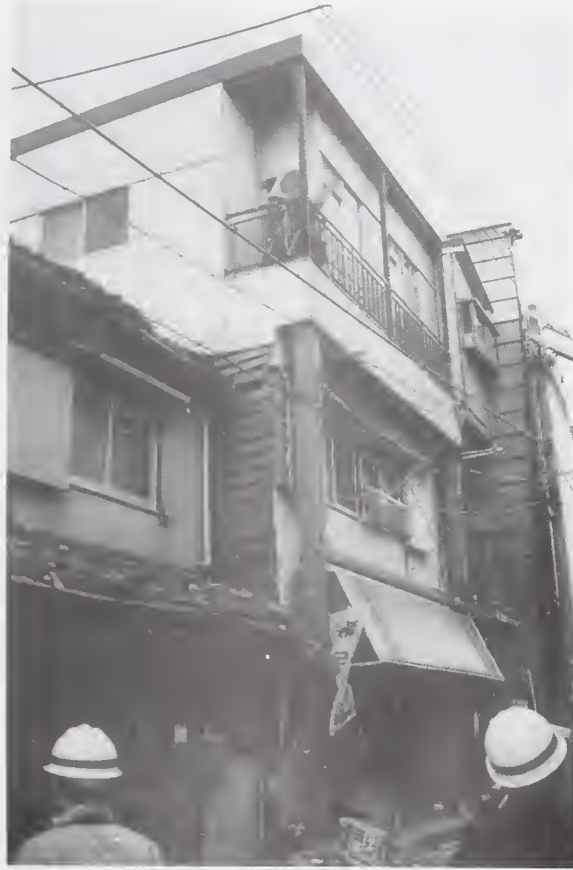
Figures 3.5.12 and 3.5.13 are of a rather unique braced frame failure in Higashi Nada ward. This was originally a two story Ohkabe type traditional dwelling, as evidenced by the exposed slat timber wall construction beneath the stucco in Figure 3.5.12. At some time a third story was added. To do this, an exterior steel braced frame was used. During the earthquake the cross braces (18 mm round bars) failed. These were attached to the steel frames apparently by means of field welded clip angles (Figure 3.5.14). The clip angle welds failed and the third floor shifted westward by approximately 300 mm.

Figure 3.5.12 Two-story traditional Ohkabe construction house with a third story add-on supported by a steel braced frame near the Mikage metro station, Nada ku.

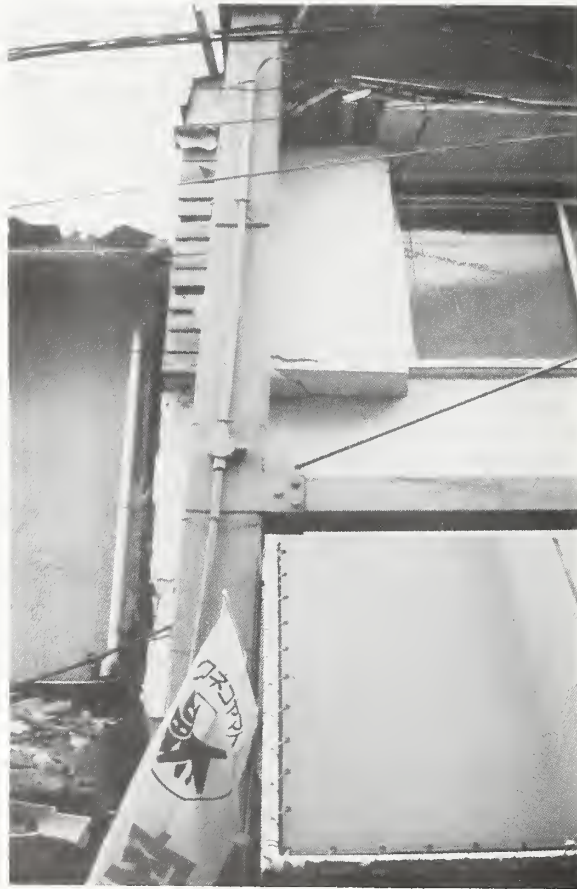
Figure 3.5.13 Detail showing drift in the building shown in Fig. 3.4.16 when diagonal braces failed.

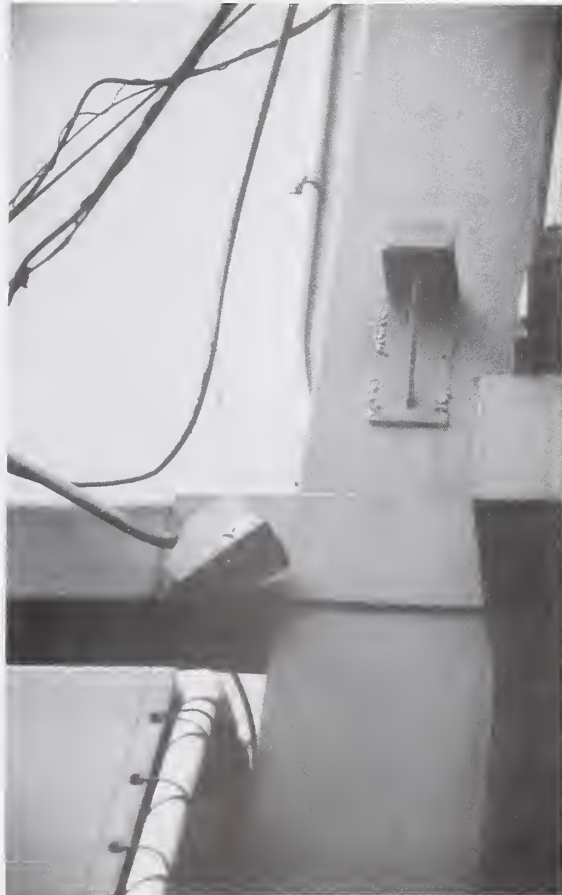
Figure 3.5.14 Detail of brace failure: angle plate weld to the steel frame failed (not the tension diagonal rod).

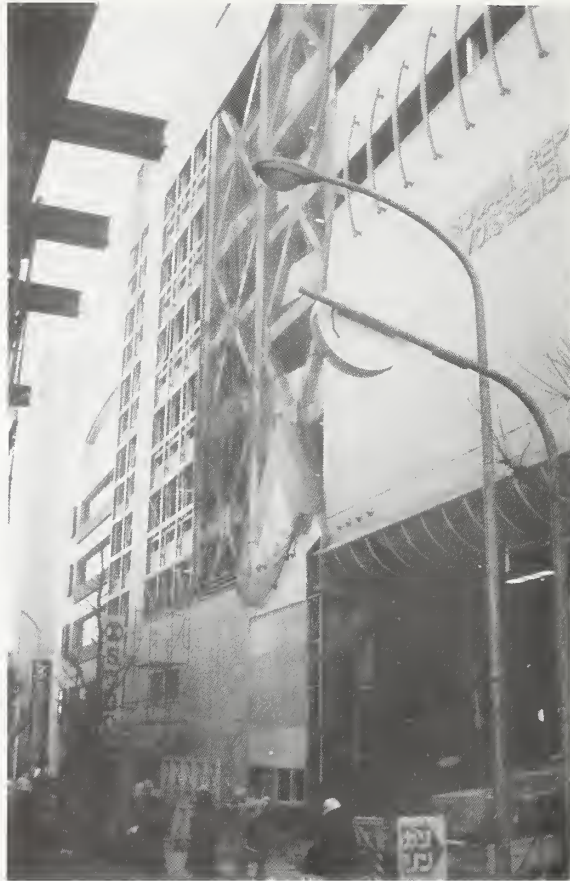
Column buckling in steel structures was a relatively rare event, with the notable exception of some unusual failures in transportation infrastructure. An example of column buckling in an 8-story building was a parking garage in downtown Kobe (Figure 3.5.15). This structure (NO.2 South Parking Building) is comprised of tubular columns (16 mm wall thickness) and wide-flange beams with diagonal braces. The first two floors of the northeast corner of the structure has a large unobstructed open space for the gas station. It was the northeast steel column that buckled (Figure 3.5.16). An unusual architecture (large eccentric open space on the first floor) contributed to the excessive loads experienced by column.

Figure 3.5.15 Northeast corner of a Mitsubishi/Sogo garage/gas station located just one block east of Kobe City Hall. Main steel tubular column at the northeast edge of the first floor opening buckled.

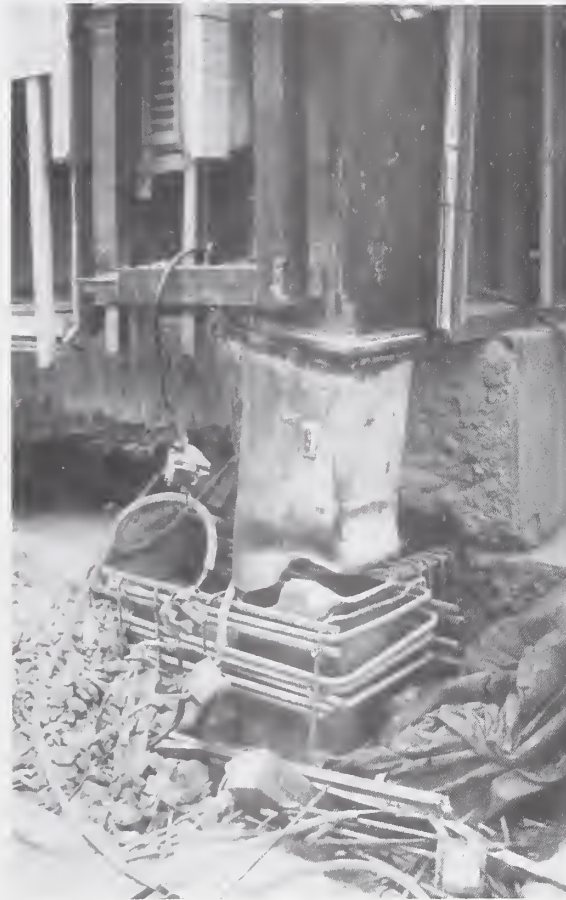
Figure 3.5.16 Closeup of the buckled tubular column in Figure 3.5.15.

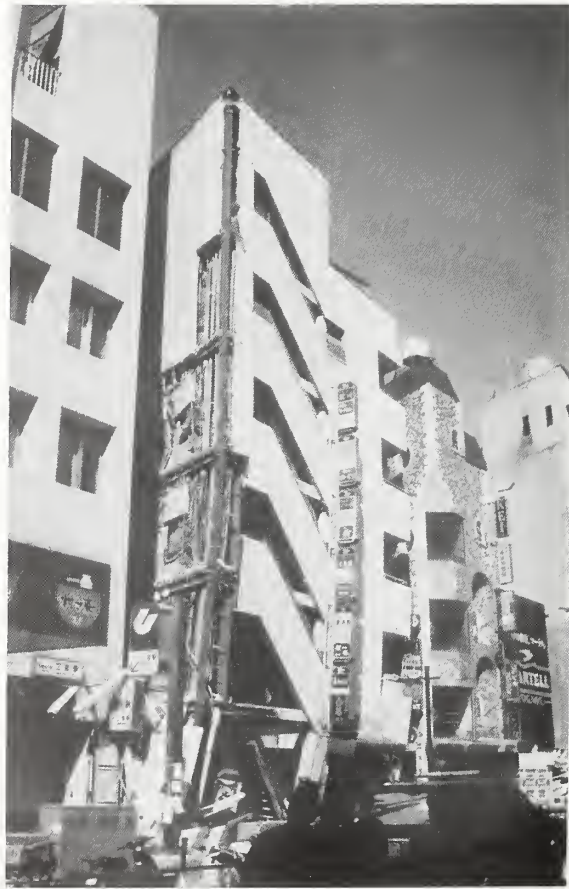
One example of moment frame structures which did suffer severe damage was a seven-story Nari Hiro Building in downtown Kobe (Figure 3.5.17). Figure 3.5.18 shows a closeup view of the southwest column, second story junction showing lateral buckling of the first story column. This, however, was a result of more dramatic weld failures on the east face of the building.

Figure 3.5.17 "Nairo Hiro" Building, a seven-story steel moment frame structure in downtown Kobe.

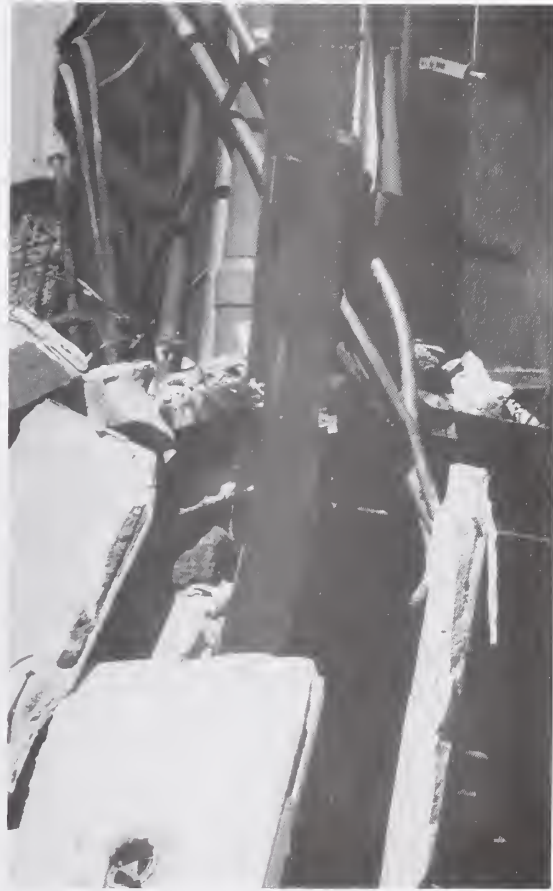
Figure 3.5.18 Closeup photo of the southwest column, second story junction in the Nairo Hiro building showing lateral buckling of the column.

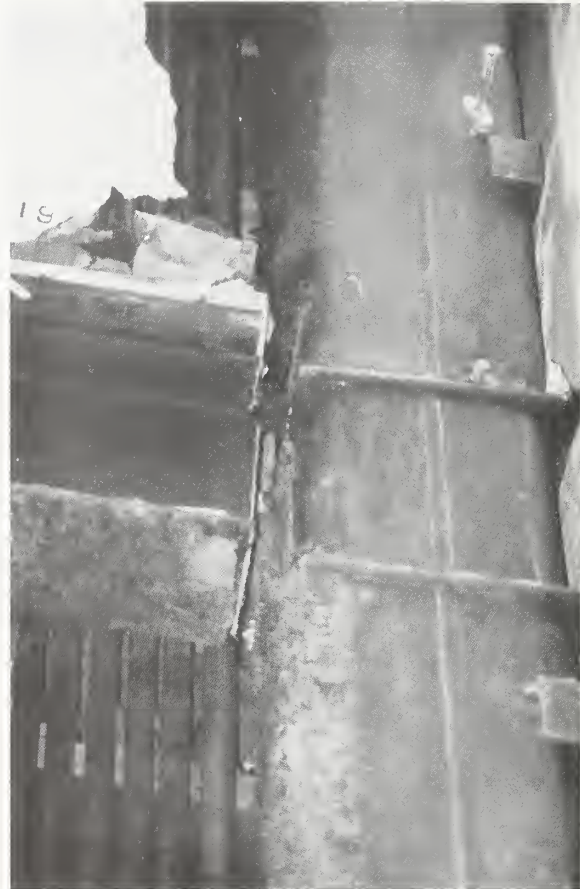
Figures 3.5.19 show details of a beam stub-to-column connection failure on the east face of the same building. Figures 3.5.20 and 3.5.21 show first floor column to second story column joint fillet weld failure.

Figure 3.5.19 Beam Stub-to-Column weld failure on the east face of the Nairo Hiro building.

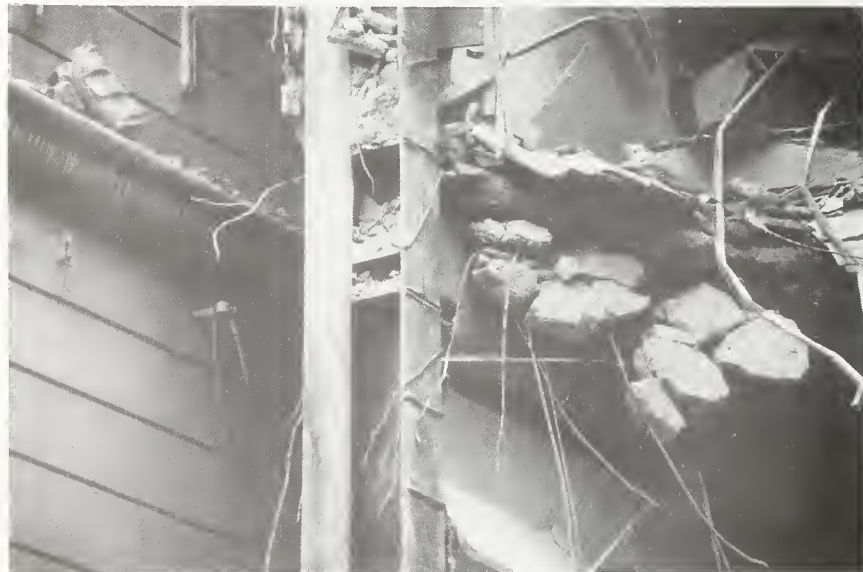
Figure 3.5.23 Close up of welded beam-column connection of Tanigawa building.

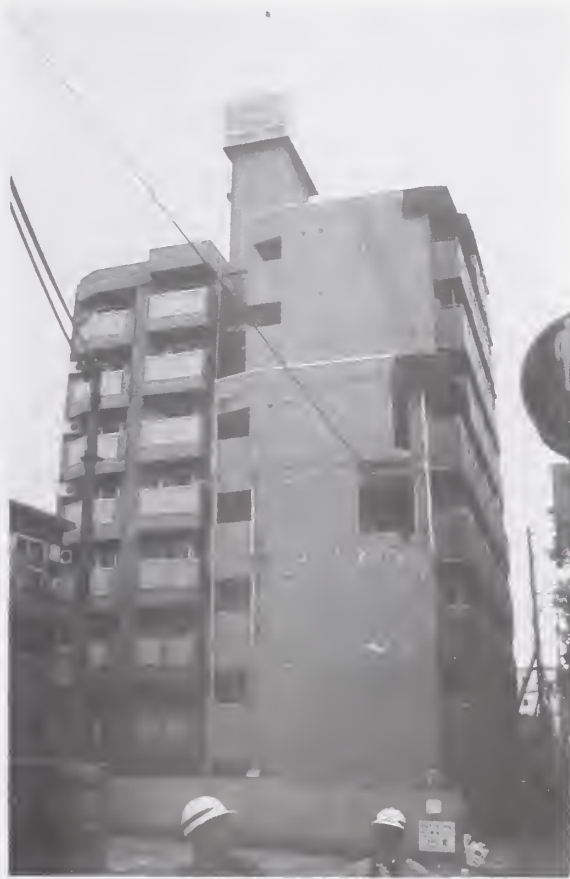
Figure 3.5.24 West face of the Liberty apartment complex in Higashi Nada-ku. This eight-story steel moment frame was typical of the performance of mid-rise steel structures designed according to post-1981 procedures.

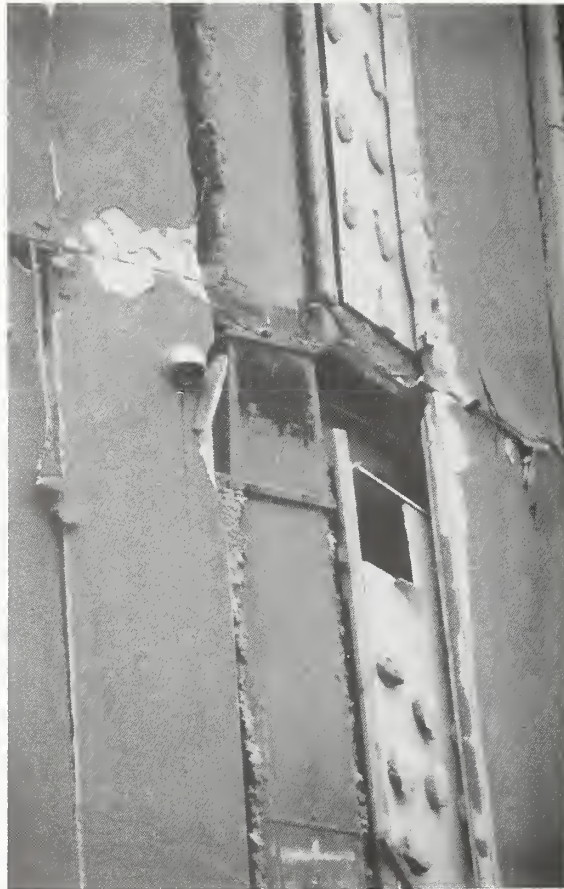
Figure 3.5.27 Closeup photo showing locally yielded third floor column joint in the Liberty apartment complex.

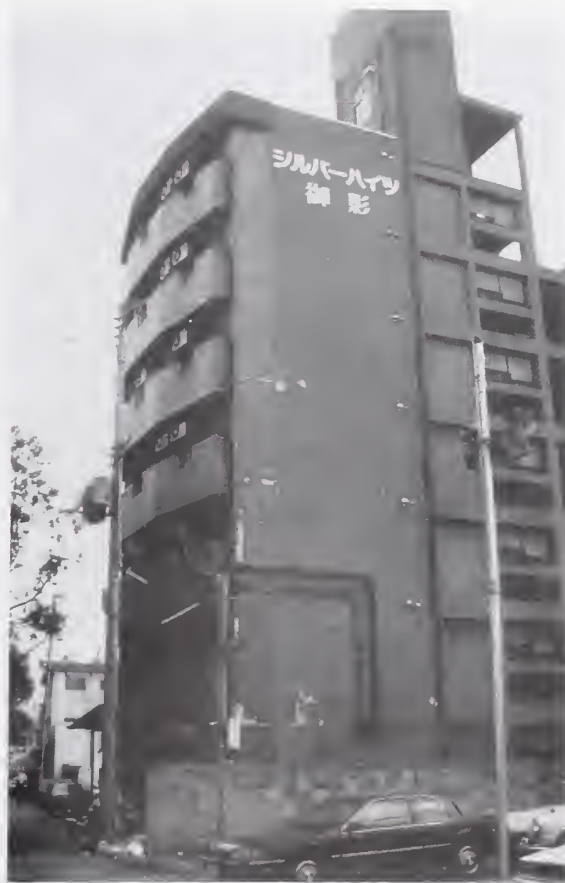
Figure 3.5.28 Seven-story Silver Heights Hotel in Higashi Nada-ku. This was another steel moment frame mid-rise building with cracking in the precast lightweight cladding.

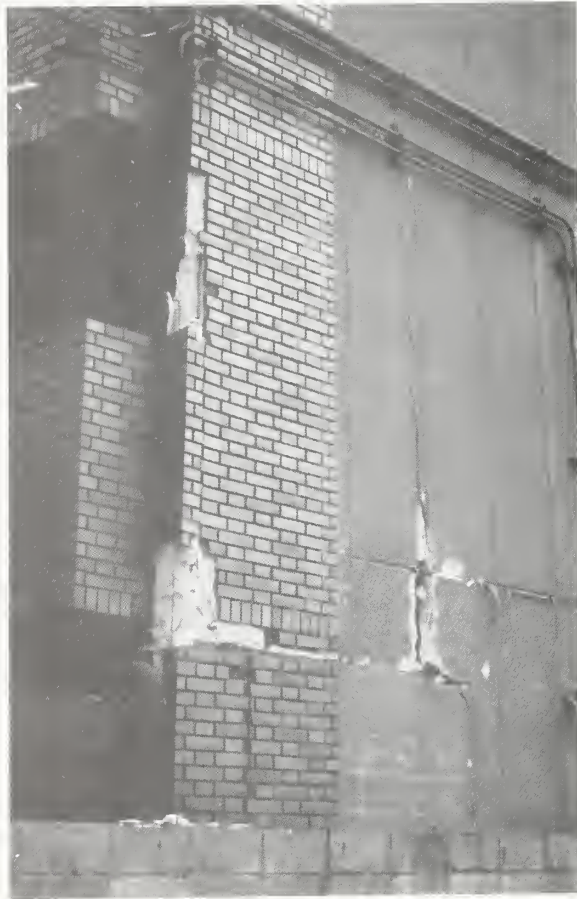
Figure 3.5.29 Closeup of cladding cracking at the Silver Heights Hotel.

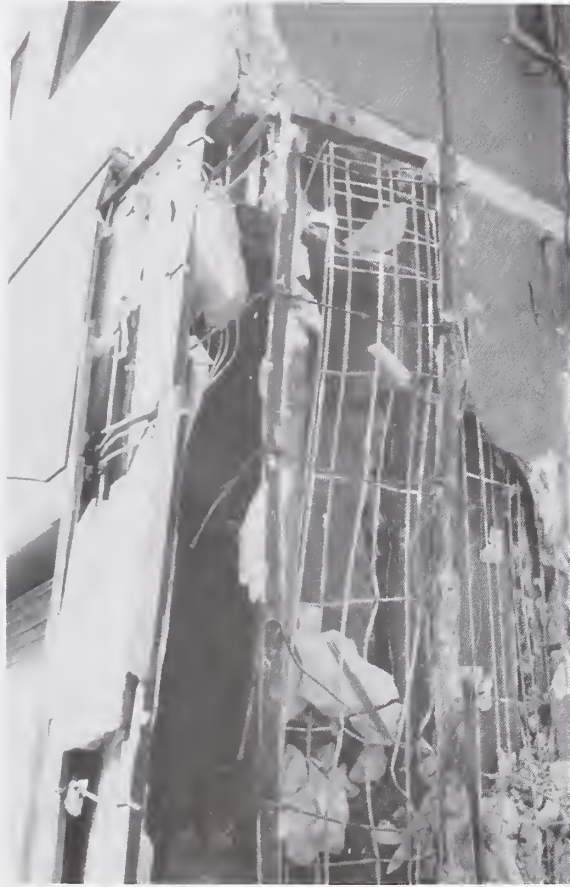
Figure 3.5.32 Closeup photo revealing steel moment frame beneath failed cladding of the Pacific Power Corporation building.

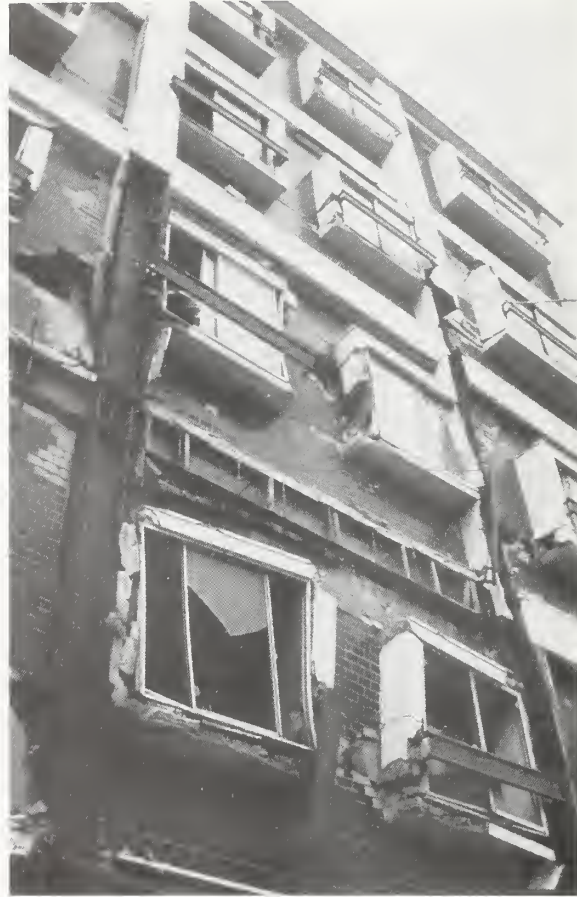
Figure 3.5.33 Older 5-story steel moment frame building showing extensive cladding damage to brittle cladding in Nada-ku near the Mikage metro station.
