NIST Special Publication 901

The January 17, 1995 Hyogoken-Nanbu (Kobe) Earthquake

*Performance of Structures, Lifelines, and Fire
Protection Systems*

Riley Chung, Team Leader and Editor

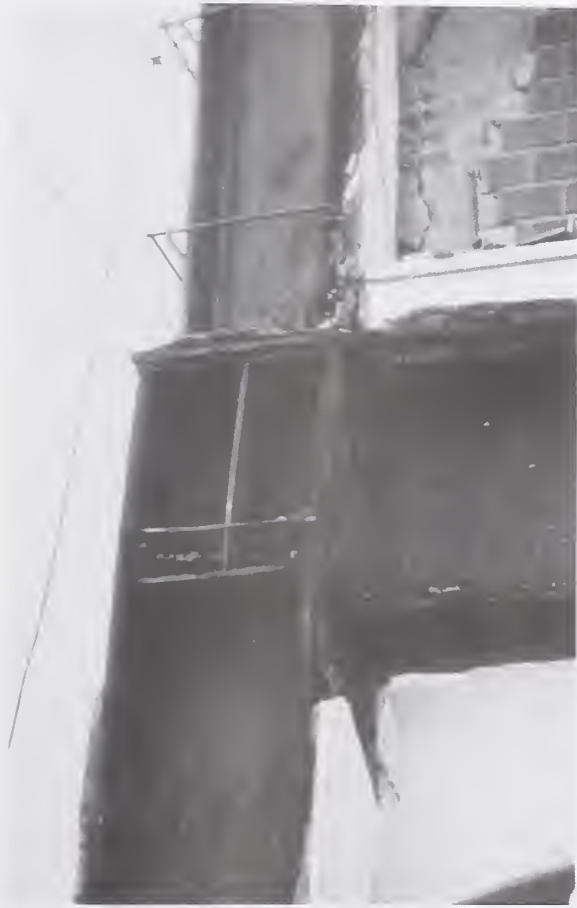
Figure 3.5.34 Closeup of rusted, older steel moment frame.

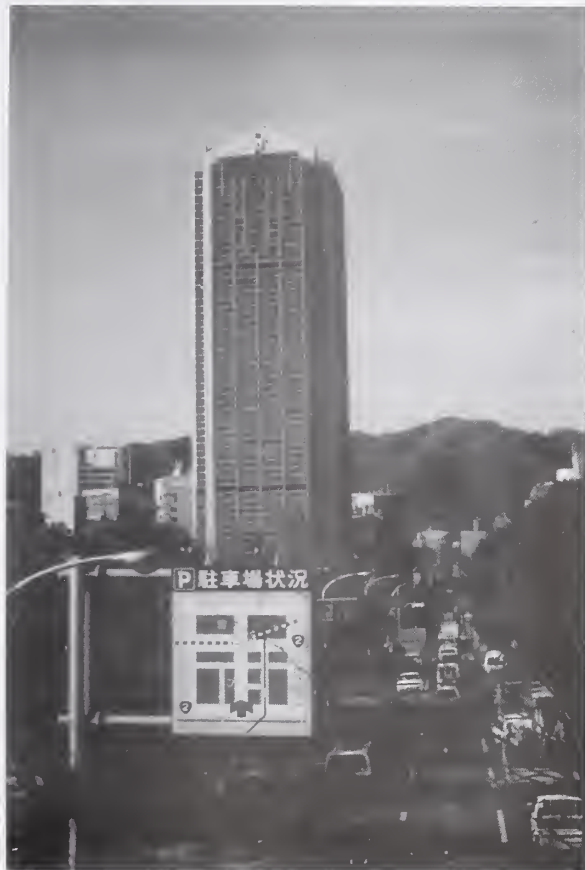
Figure 3.5.37 New Kobe City Office building. A 30-story steel frame structure without reported damage. The adjacent old Kobe City Office building sustained severe damage.

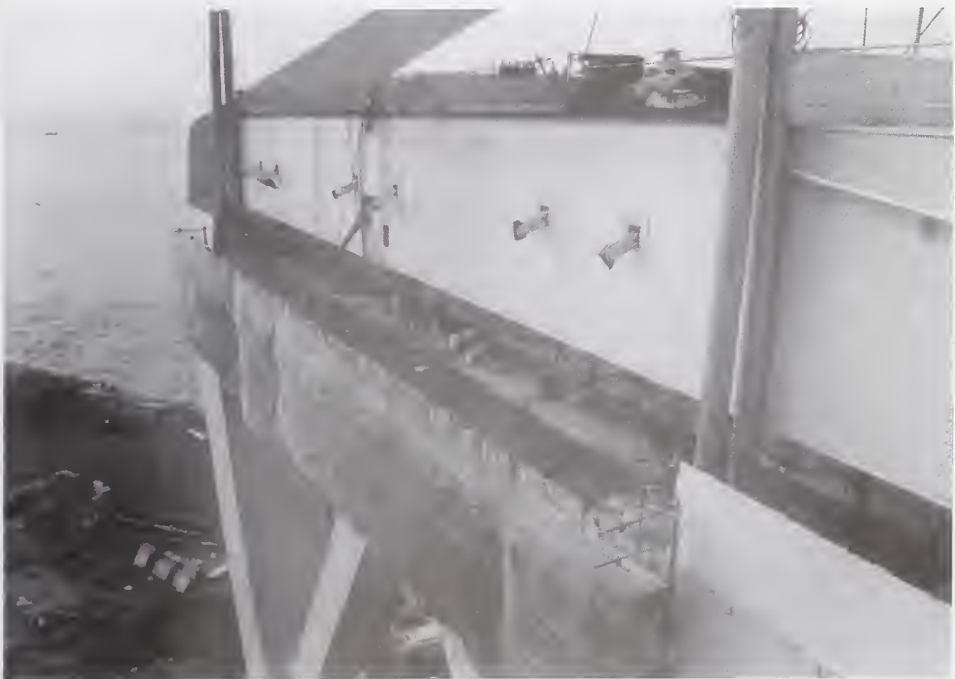
Figure 4.2.4

Cap beam of Pier 111, Nishinomiya-ko Bridge, showing cross-girder of arch and failed restrainers.

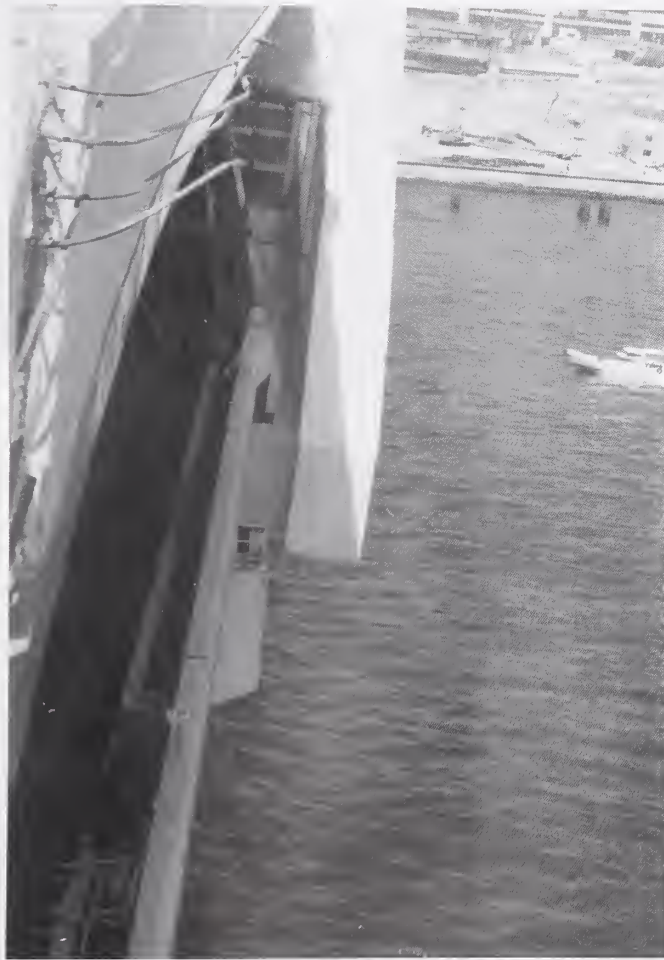
Figure 4.2.7 Lateral offset at east face of South Pier, Rokko Island Bridge.

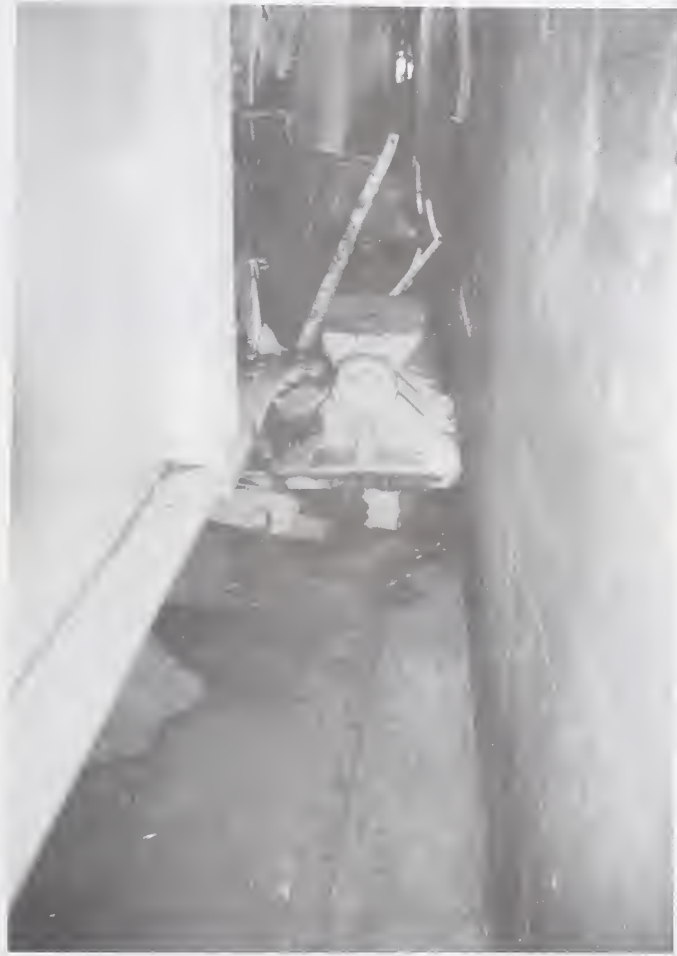
Figure 4.2.10

Bearing and restrainer damage at abutment A1, Mukogawa Bridge, showing distorted guide rails and uncoupled restrainer from abutment backwall.

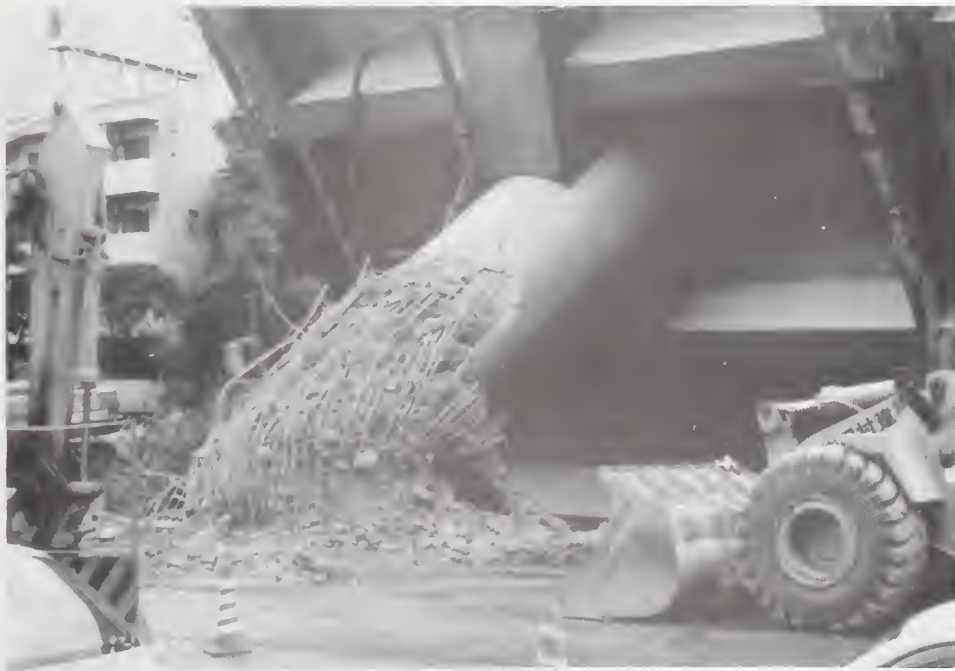
Figure 4.2.18

Pier 240 of Hanshin Expressway showing temporary repair to this single column bent.

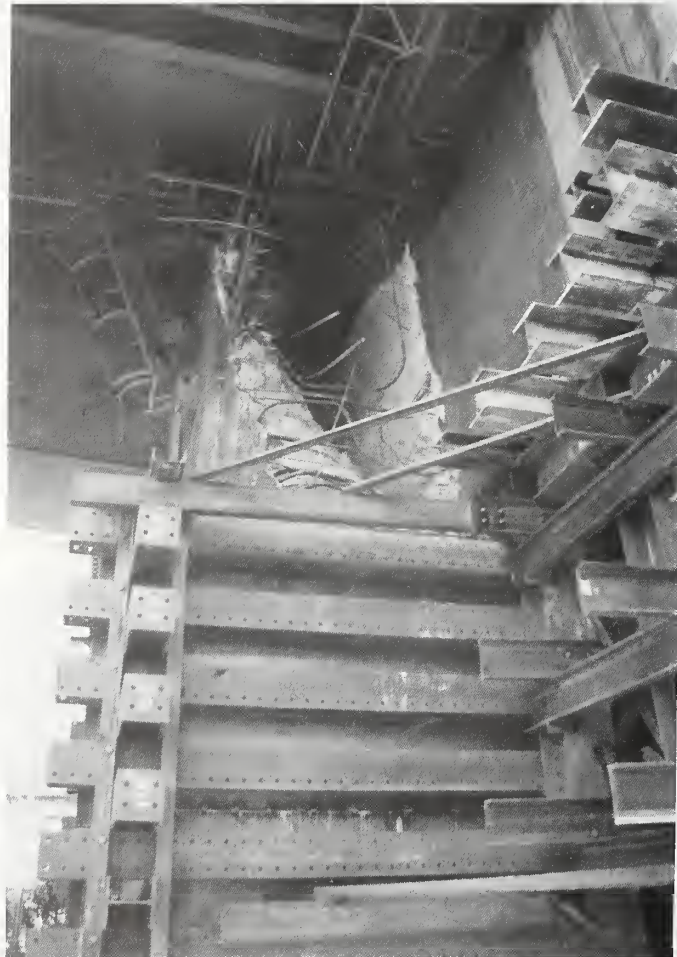
Figure 4.2.19

Shear failure in Pier 240 of Hanshin Expressway showing temporary repair to column to prevent total collapse.

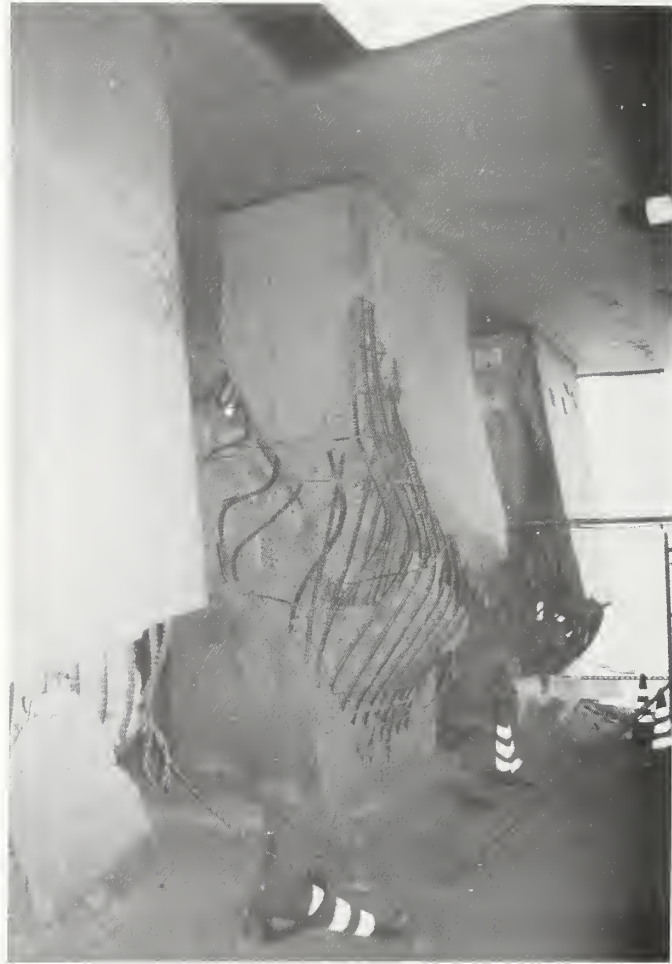
Figure 4.2.22 Shear failures in 3-column bent at Pier 3, Takarazuka Viaduct.

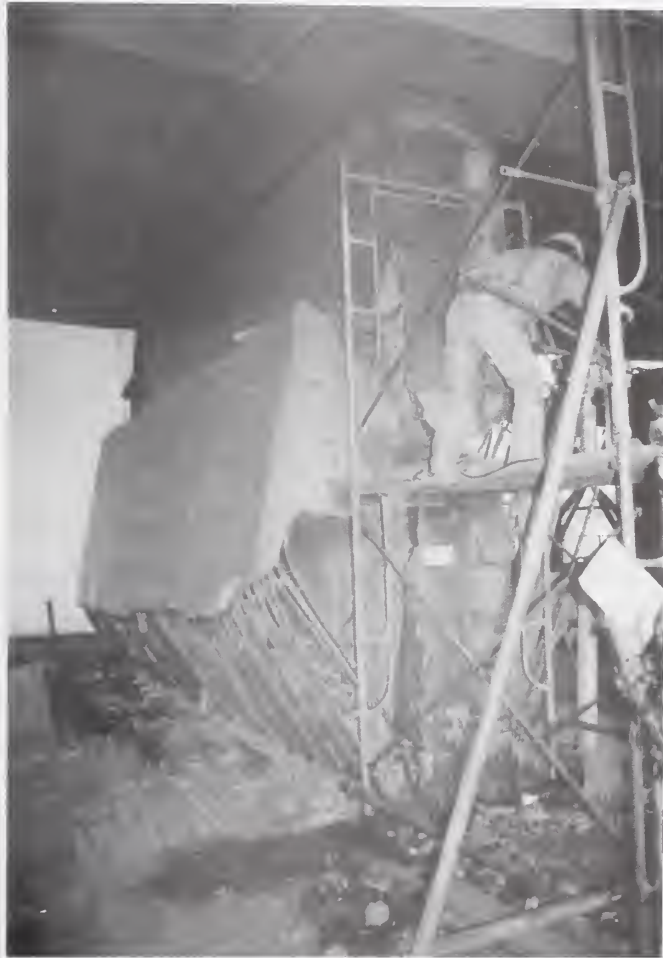
Figure 4.2.23 Shear failure in wall pier (west face), Moribe Viaduct.

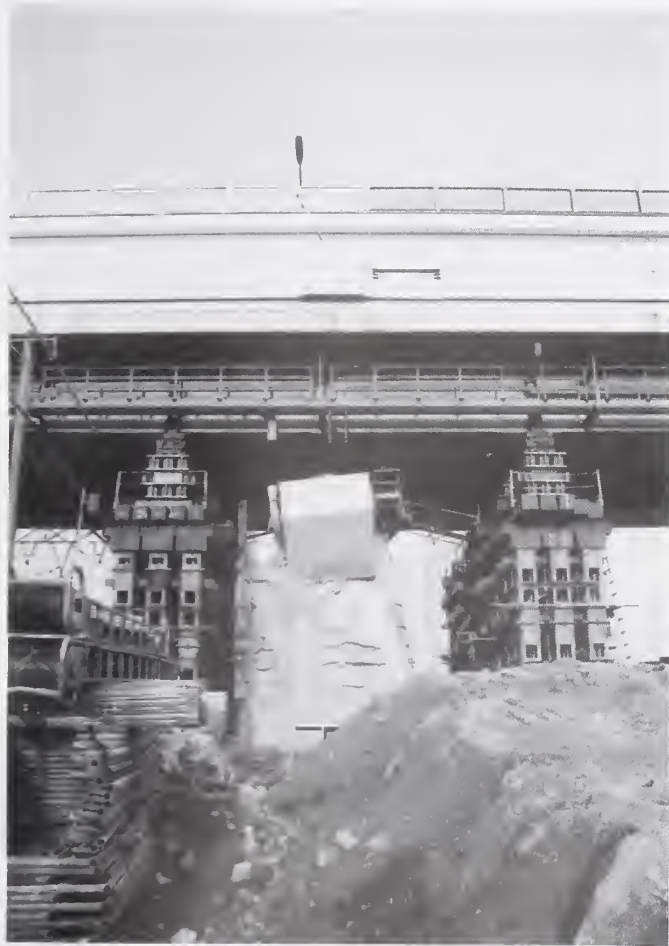
Figure 4.2.32 Side view of shear failure in Pier 688 of Route 3 near JR Sanyo Line.

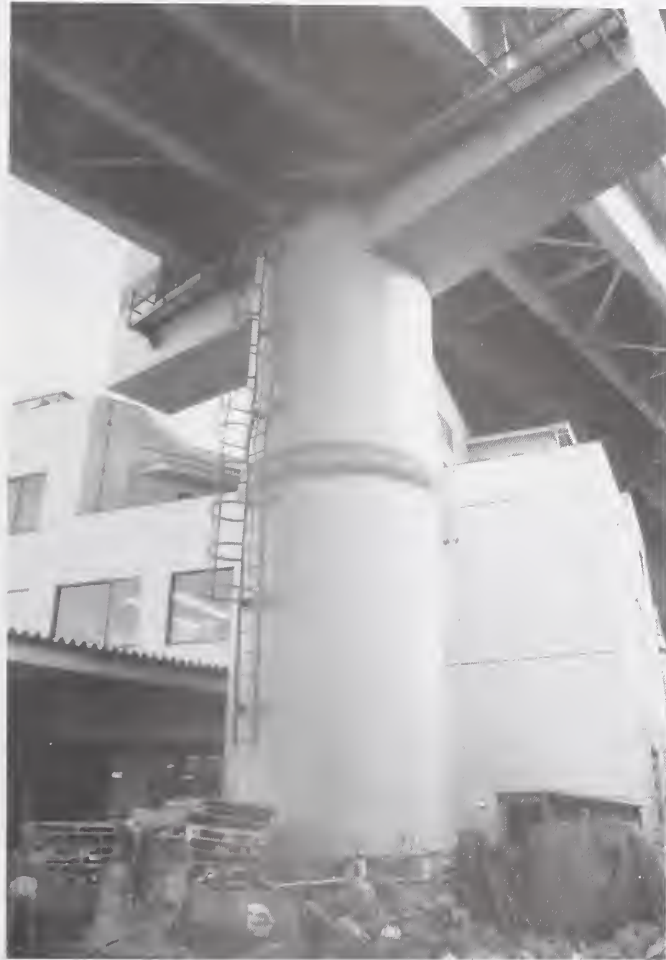
Figure 4.2.40 Buckling in steel columns at Pier 49 of the Hamate By-Pass Viaduct.

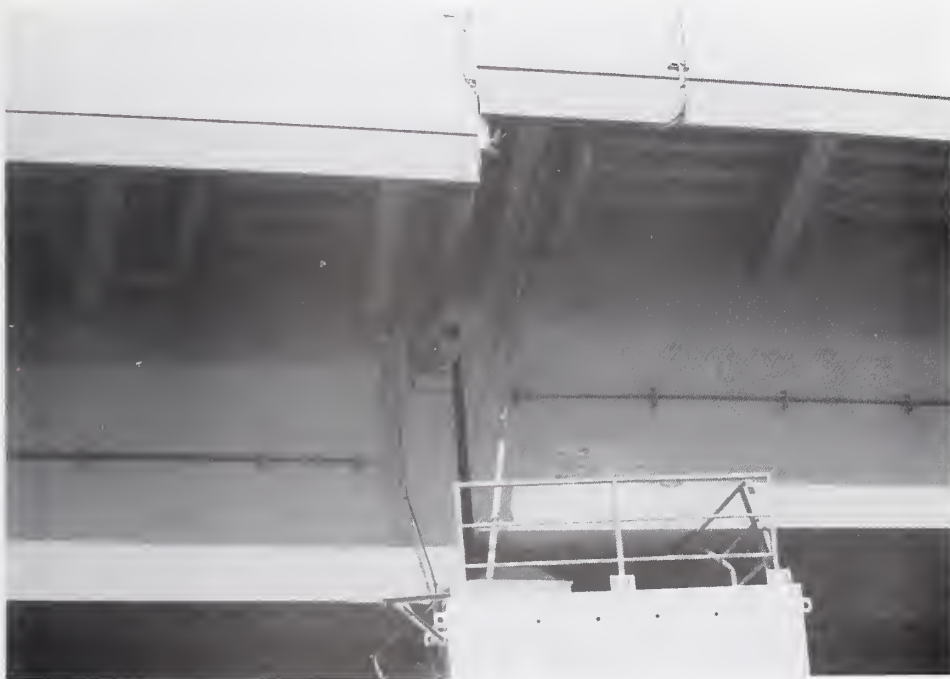
Figure 4.2.44 Approach span at edge of seat at Pier 134 of Shukugawa Bridge due to lateral movement of the pier by about 1 m towards the center of the channel.

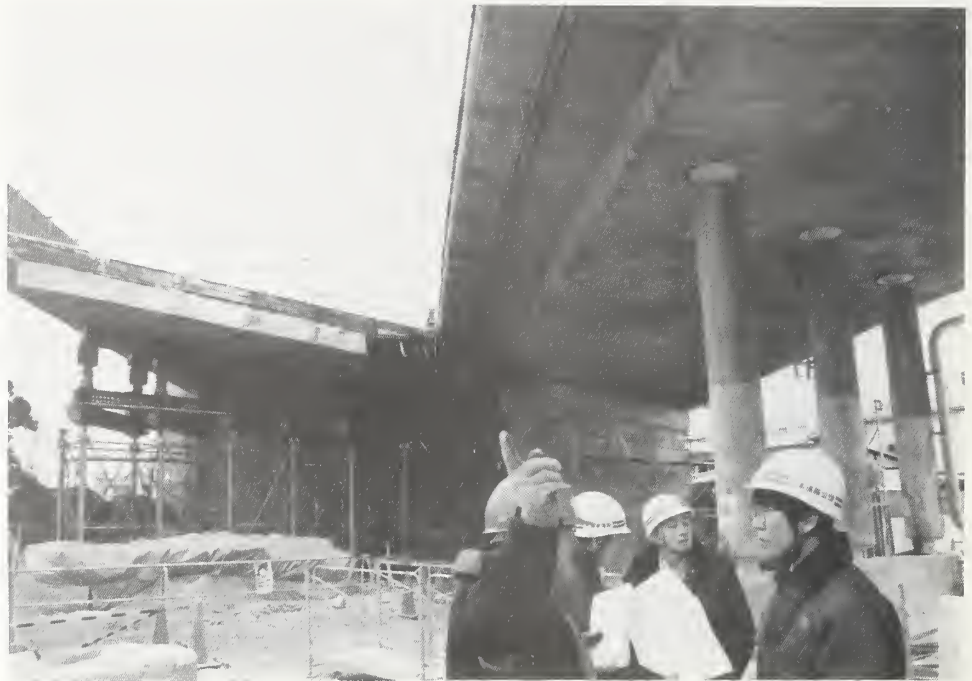
Figure 4.2.45

General view of Kawaraginishi Bridge after removal of collapsed eastbound bridge showing skew and pin-ended columns under westbound bridge.

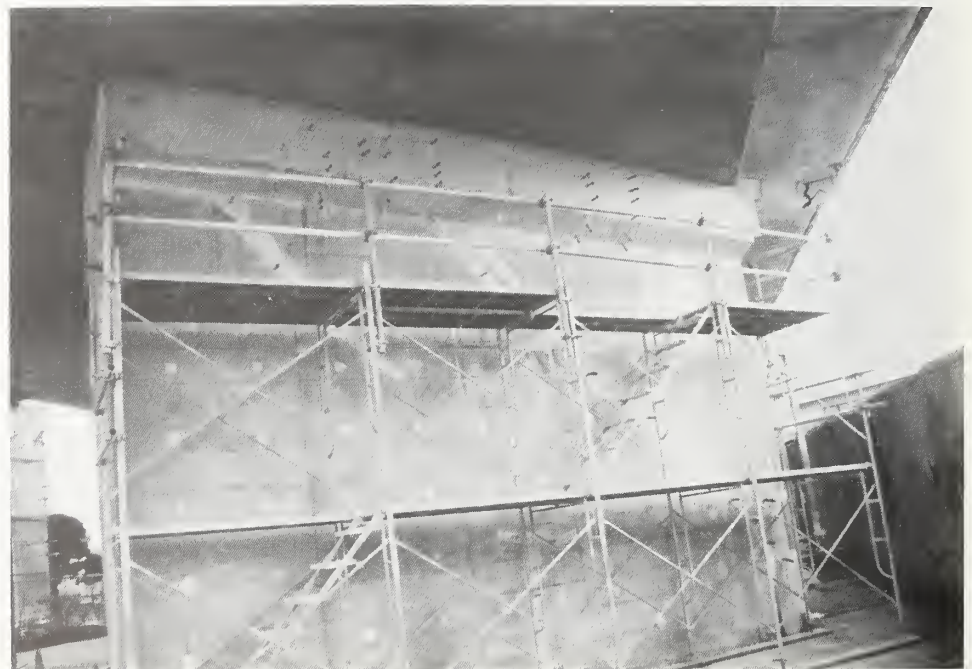
Figure 4.2.46

Pier 27 of the westbound Kawaraginishi Bridge showing shear cracking and repair by injection grouting.

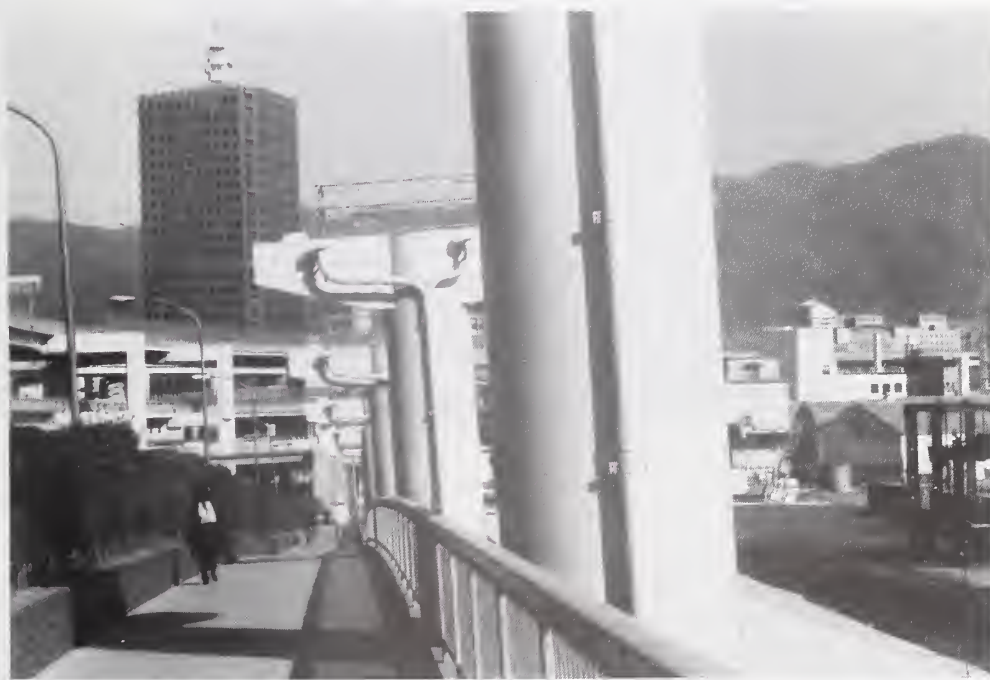
Figure 4.3.12 Tilted pier - Port Liner.

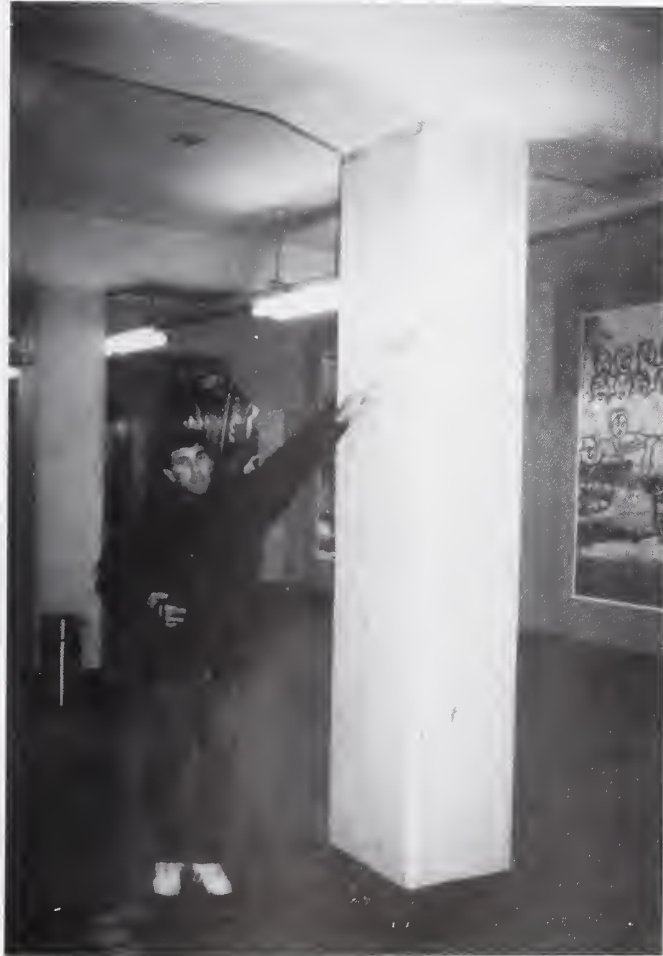
Figure 4.3.14 Cracked reinforced concrete column at underground shopping mall near Shin Kaichi Station.

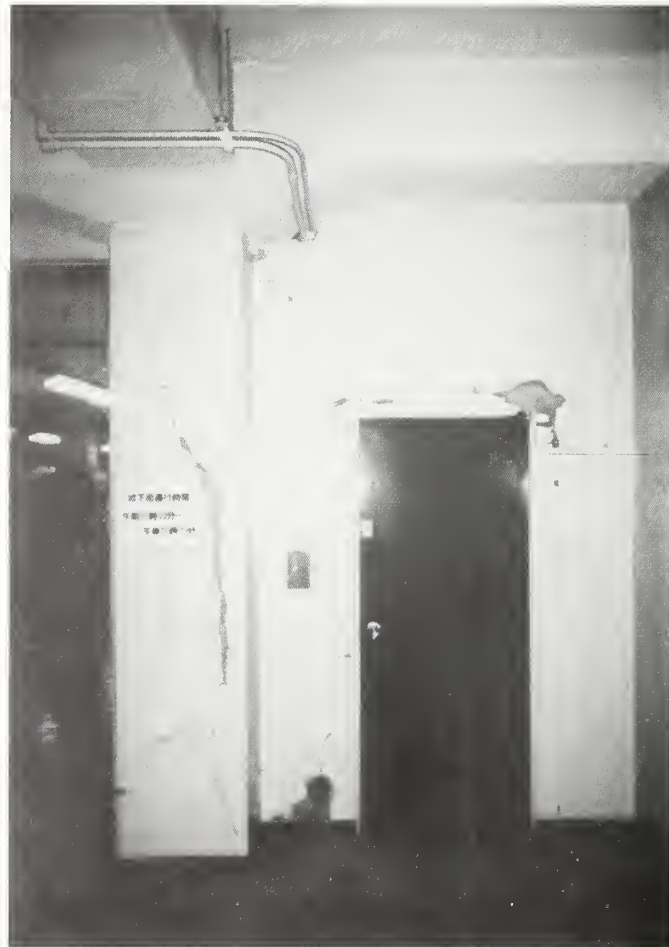
Figure 4.3.15 Cracked reinforced concrete column and concrete panel wall at underground shopping mall near Shin Kaichi Station.

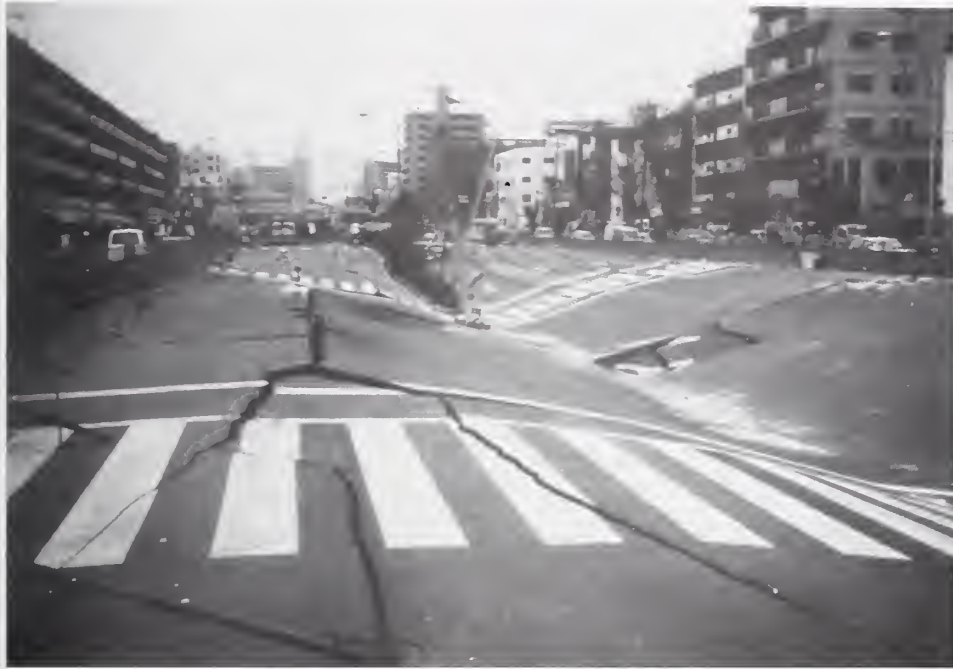
Figure 4.3.21 Subsidence of street surface over the collapsed Daikai Station.

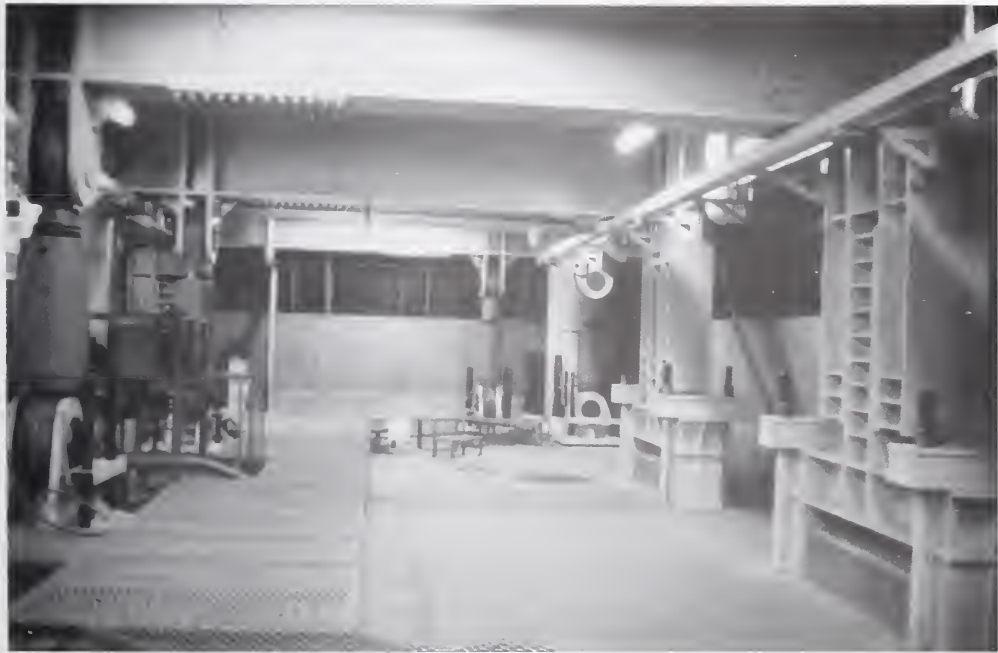
columns is not known, but there are two shear keys on each side of the tower (Figure 4.4.9). These shear keys are detailed to carry lateral load parallel to the foundation wall, including torsion of the building, but no vertical axial load (Figure 4.4.10). The lower end of each ram is supported by the foundation pad and the upper end is connected to a stiff diaphragm, consisting of the deep beams shown in Figure 4.4.11. The shear keys are configured so that they stay engaged when the rams are used to relevel the structure. It is not known if the leveling mechanism is used to compensate for differential settlement of the tower to prevent leaning, or if it is also used to maintain the level between the structure and the surrounding ground. This may be needed to prevent damage to utility lines that enter the building.

The leveling system provided in the basement of the Kansai Airport Control Tower appears to be an innovative approach to provide for the possible uneven ground settlement that may be caused by liquefaction or consolidation.

Figure 4.4.9 Basement of the tower showing system for leveling the building and shear keys.

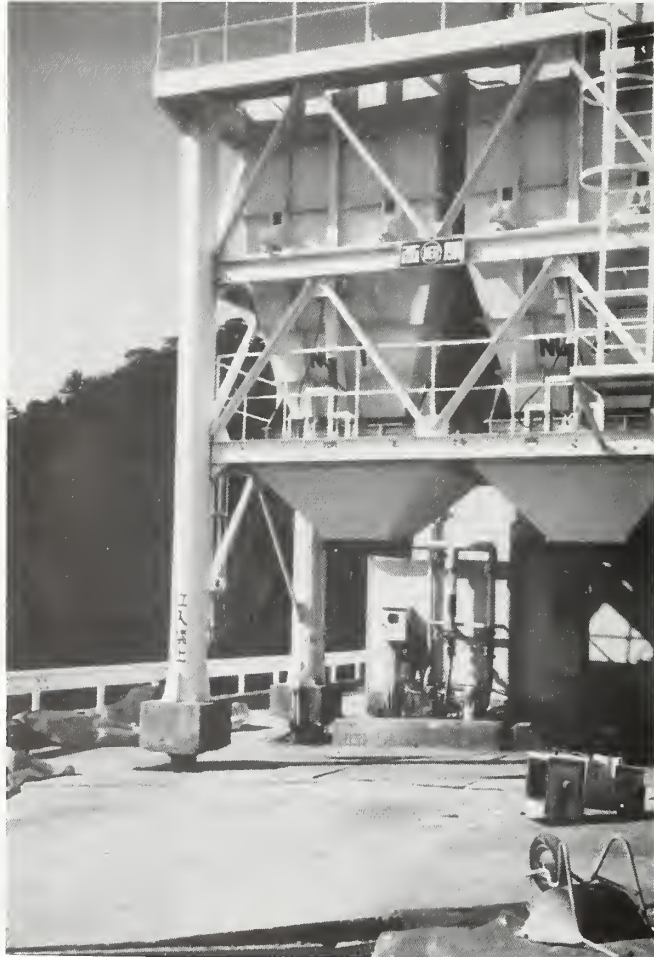
Photo 10 Repair of one of the three 1.2 m treated water lines leaving the Uegahara/Hanshin Plants site.

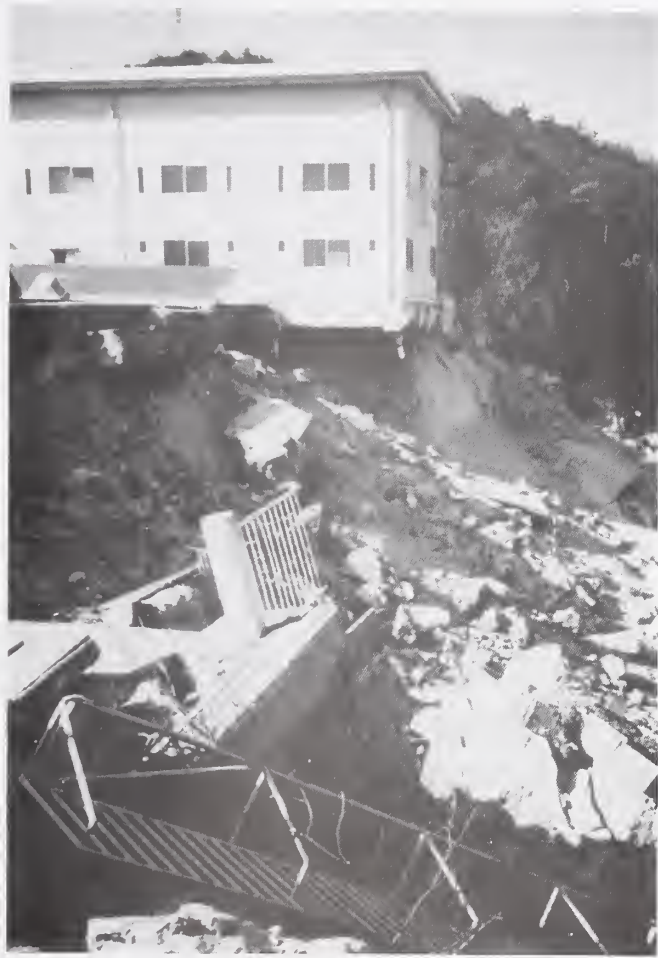
Photo 11 Subsidence (approximately 30 cm) around pile-supported sludge hoppers at Uegahara Plant.

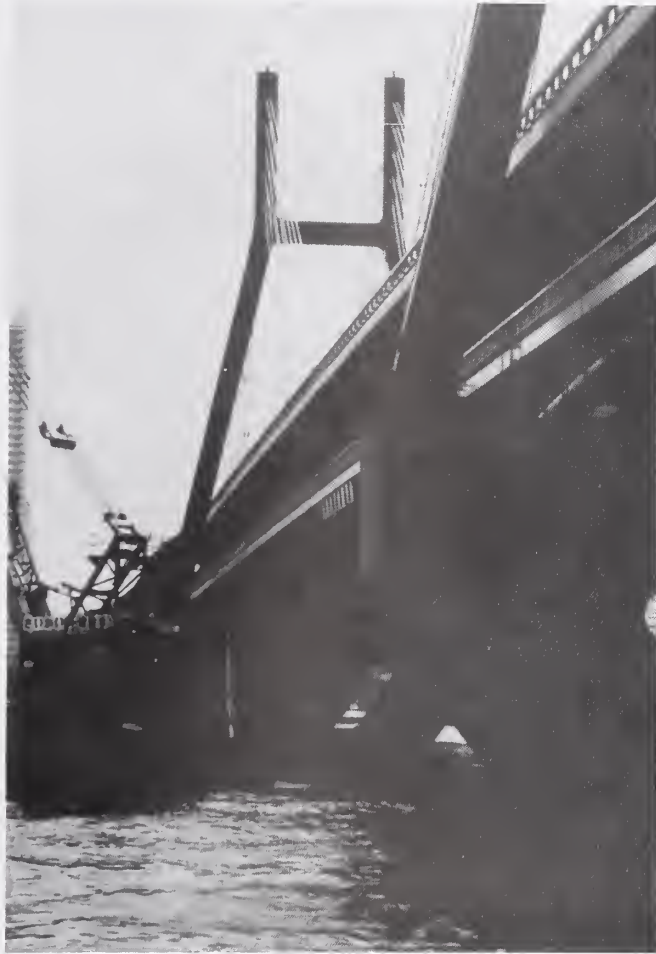
Photo 14 The retaining wall on the left cracked damaging the overflow line from the Motoyama Plant's intake box .

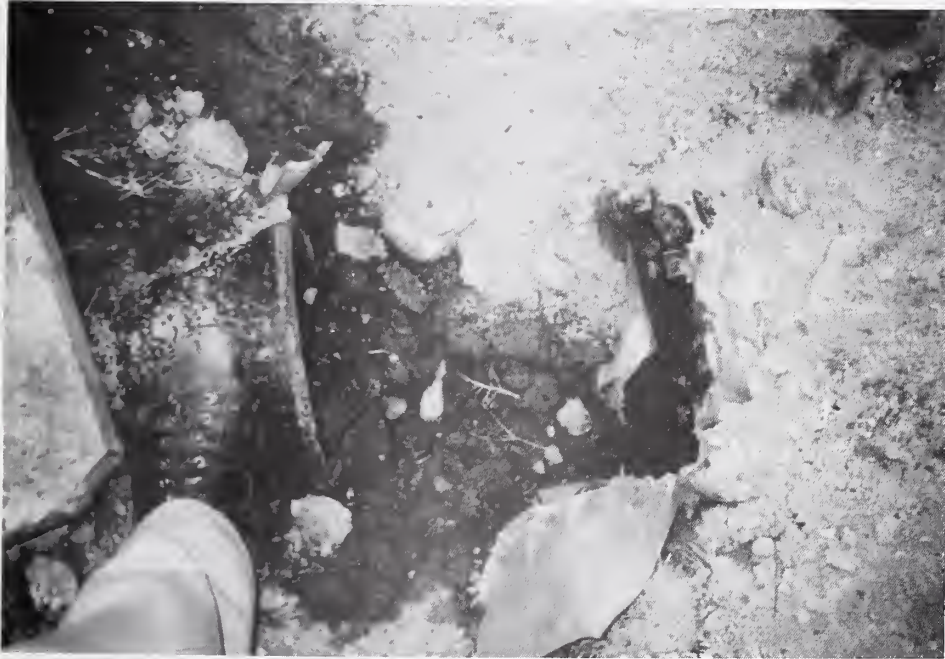
Photo 17 Ground cracking from lateral spread in fill area along a water way. Immediately behind the crack, a pipeline emerges out of the ground to be supported on the bridge.

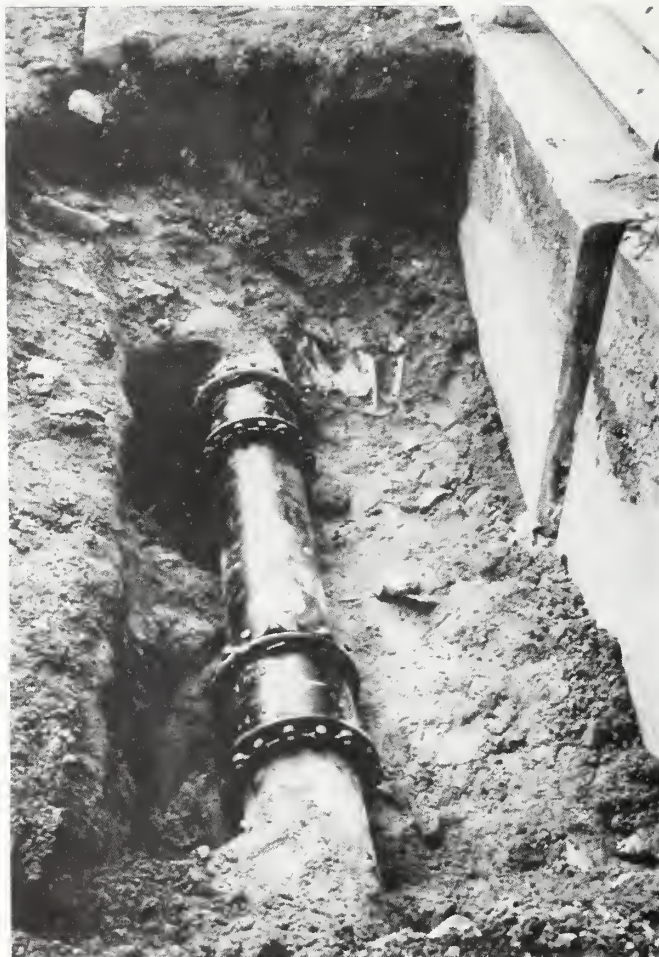
Photo 18 Shows a 300 mm diameter pipe joint in the bottom of the crack (Photo 17), where the bell (to the right) was separated from the spigot (under foot).

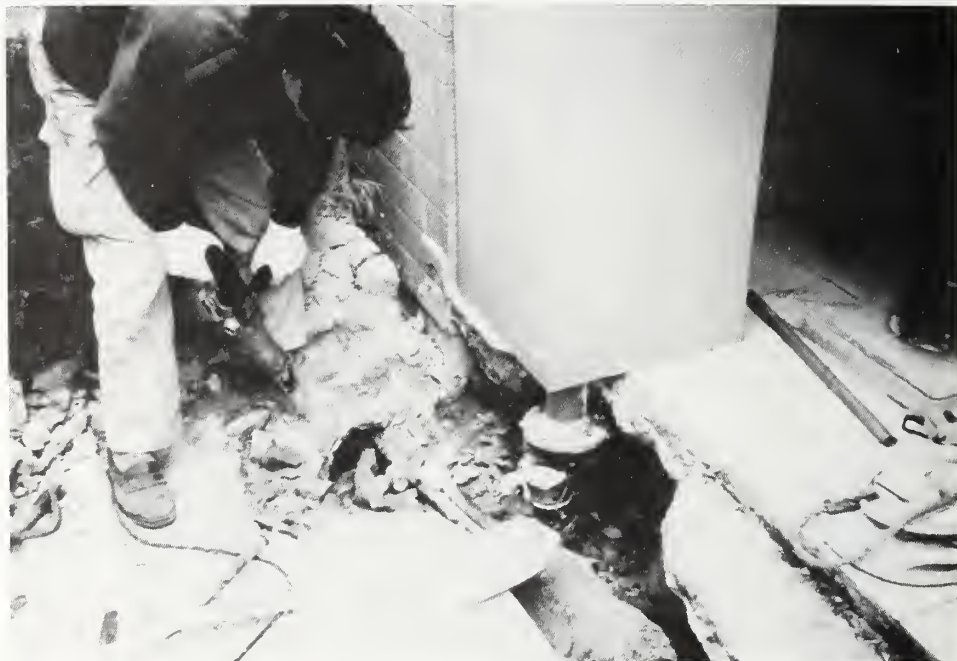
Photo 21

Differential settlement at building in mid-Rokko Island. Most modern buildings on the island were pile supported and were not damaged. Differential settlement required repair of utility connections as shown in Photo 22.

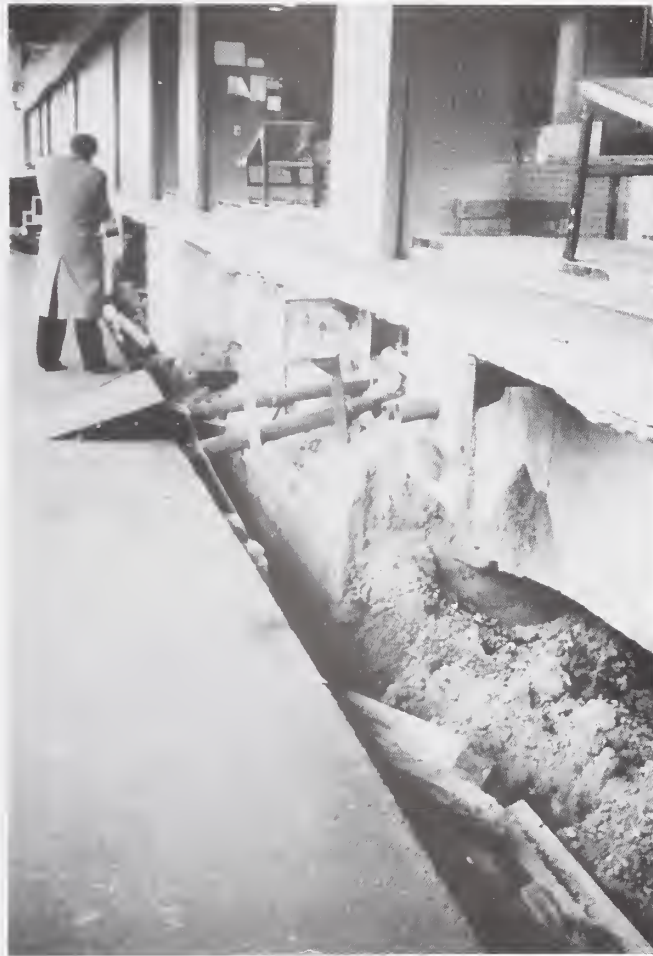
Photo 22 Repair of utility connections in mid-Rokko Island.

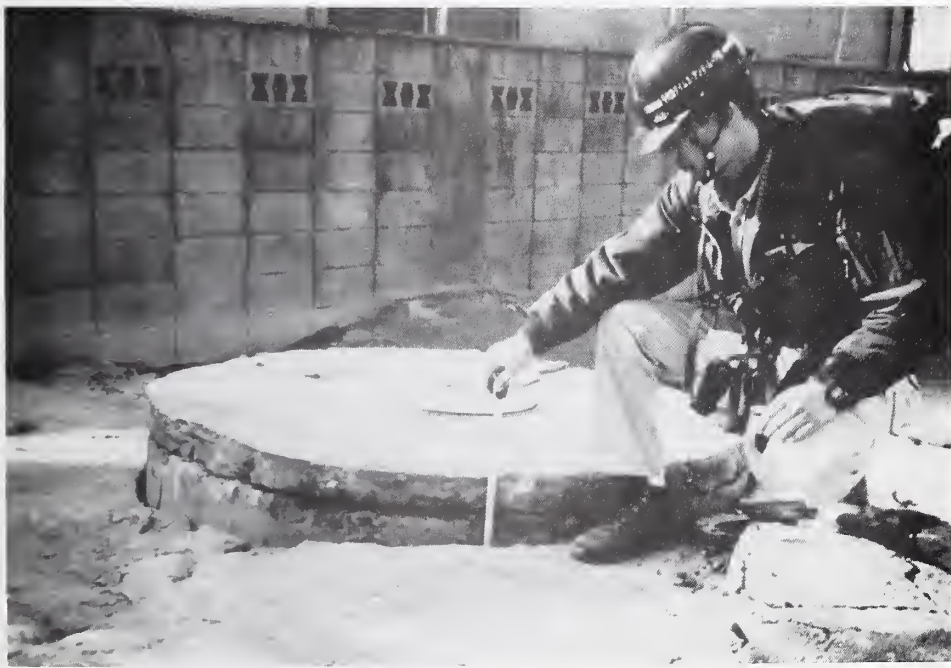
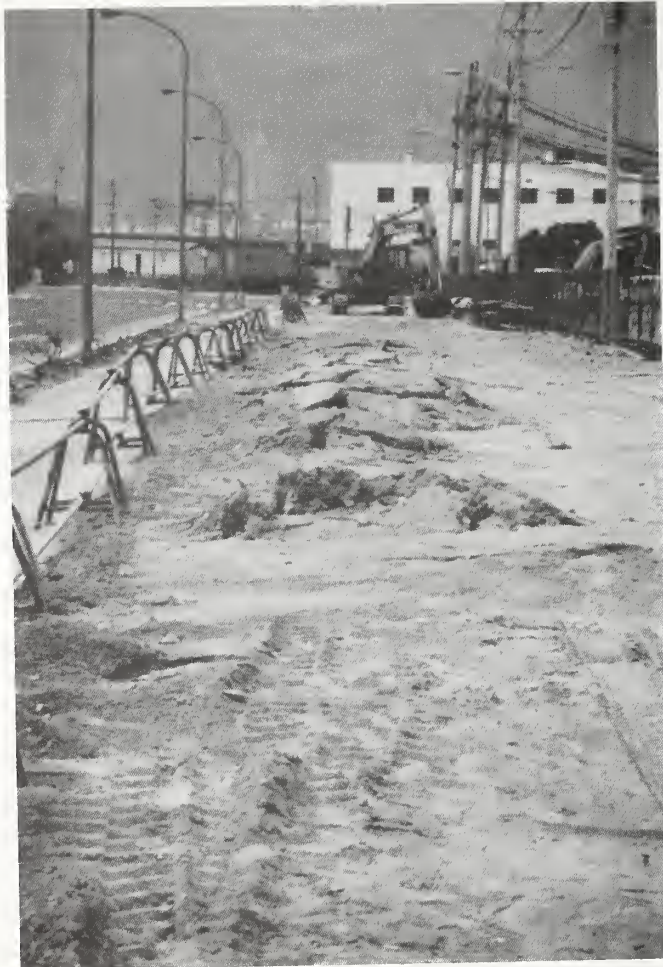
Photo 25 Manhole floated as a result of liquefaction near the wastewater treatment plant.

Photo 26 Same as Photo 25.

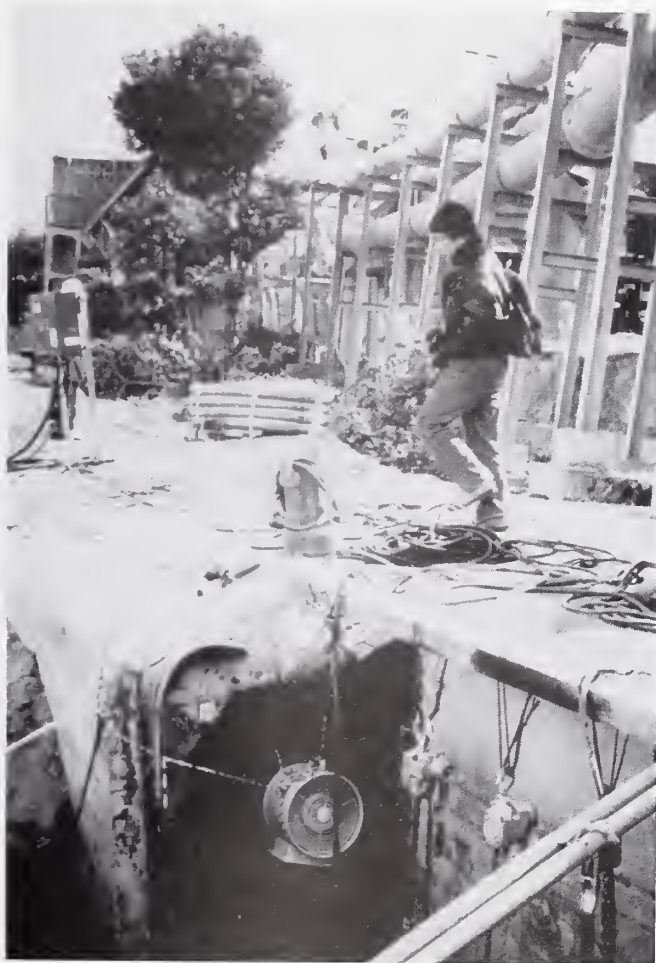
The facility was heavily damaged when the seawall along the north side of the plant adjacent to the channel moved as much as 3 m towards the water as a result of liquefaction (Photos 29, 30). As a result, the entire site settled an average of one meter. Liquefaction-induced lateral spread and settlement were most severe within a distance of 100 m south of the seawall along the southern margin of the channel. Horizontal displacements of 3 m and settlements as large as 2 m were observed within the plant site. Figure 5.2.19 shows the plant layout and notes damage locations.

Photo 30 Ground cracking behind the retaining wall (which is off to the left).

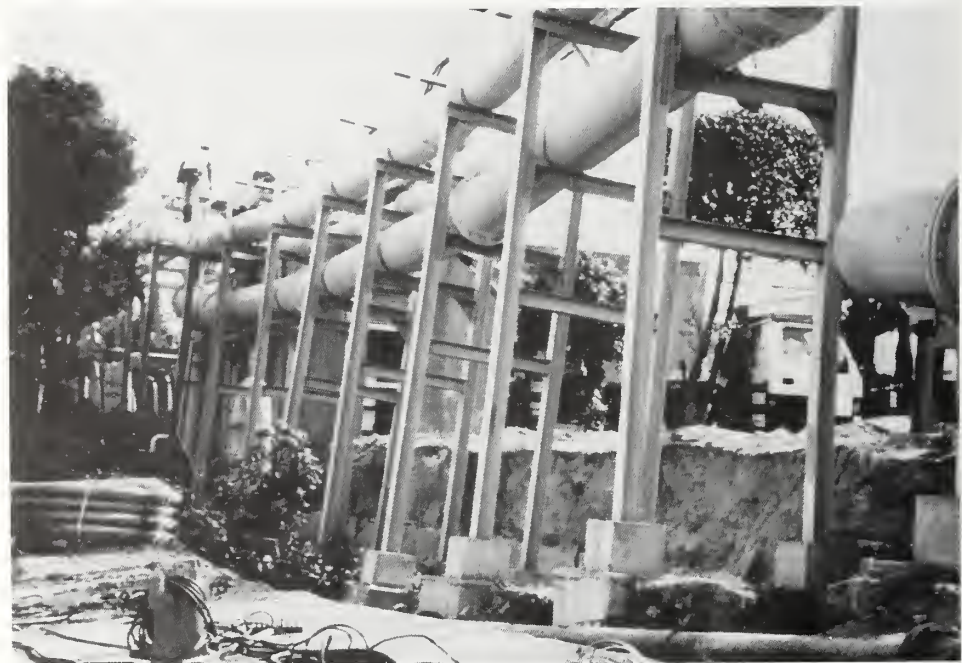
Lateral deformation caused severe damage to underground structures and facilities founded on spread footings. The effluent channel separated in 4 places (Photo 31). The pipe rack distorted from foundation settlement (Photo 32).

Photo 31 Effluent channel, approximately 2 m², offset nearly one meter from lateral spreading.

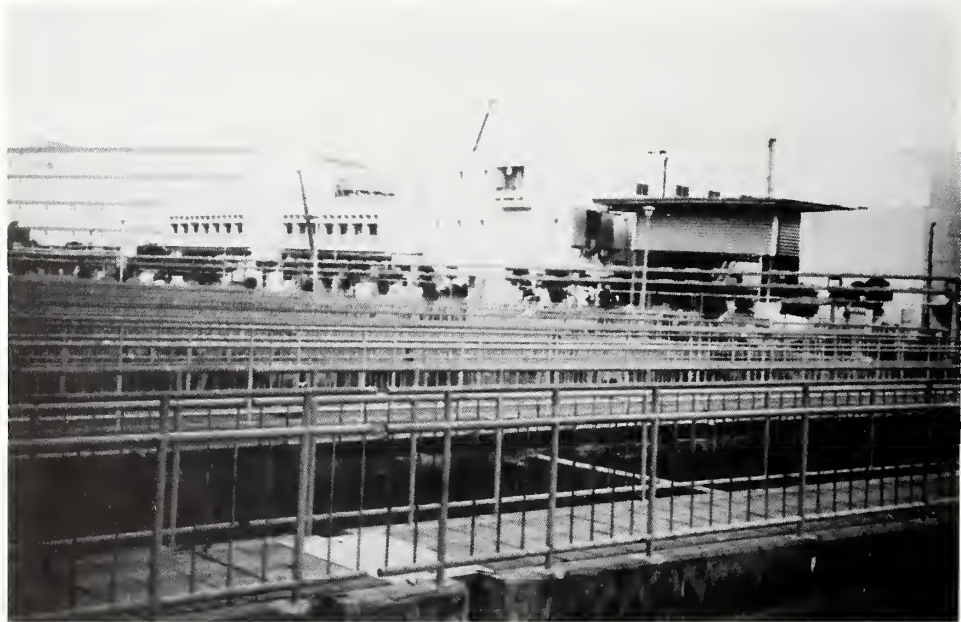
Differential settlement and lateral spreading of approximately 600 mm occurred at the filter building, as shown in Photos 38 and 39 resulting in some pile damage. The control building and the sludge thickener room moved north 60 cm (Photos 40, 41). The

Photo 39 Piping distorted as a result of the building movement.

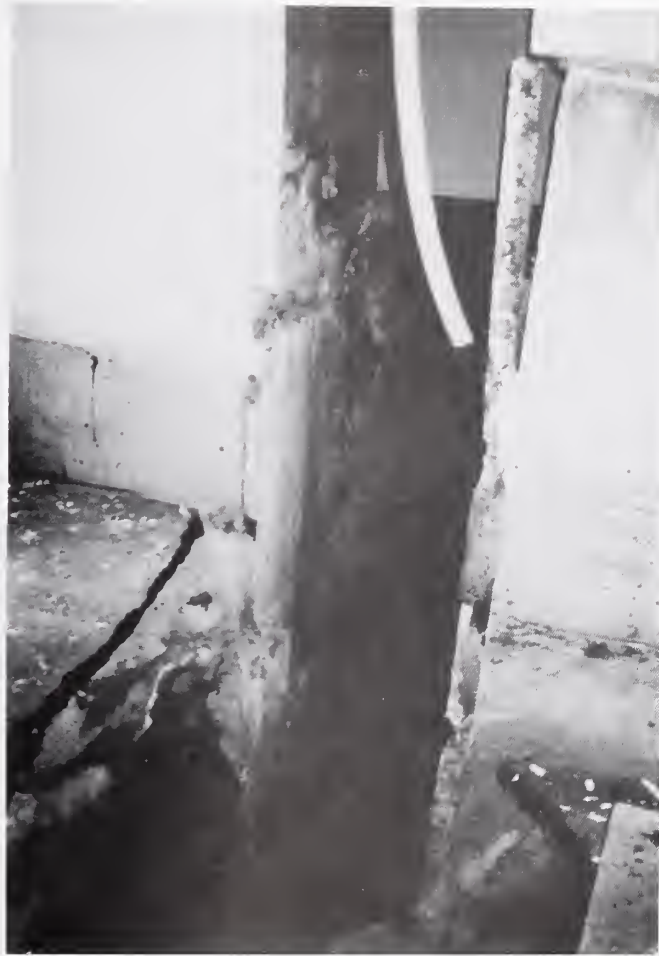
Photo 40

Control building (upper right), which is pile supported, moved towards inlet approximately 30 cm, moving away from adjacent building which had a basement.

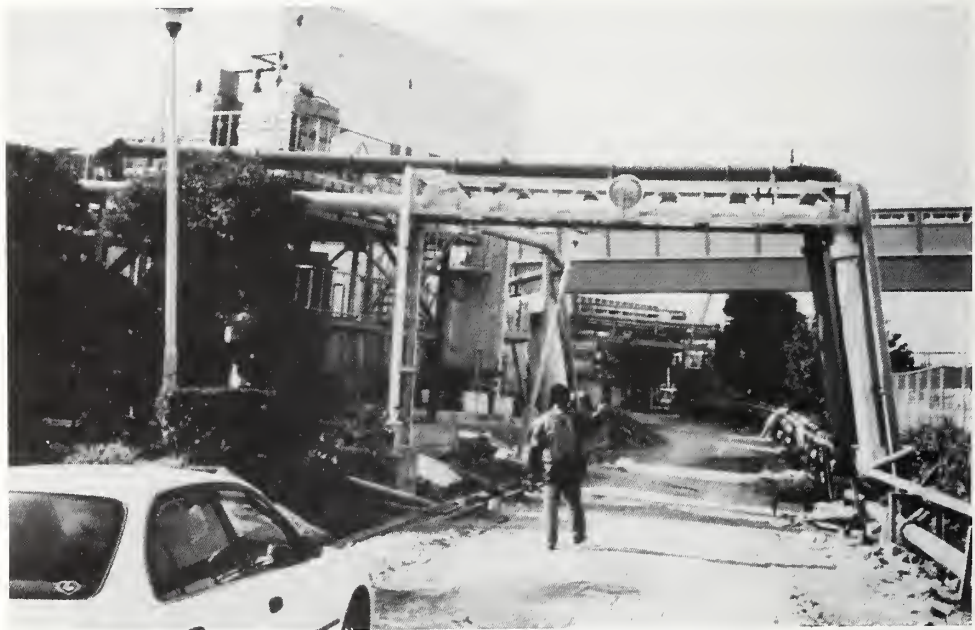
Photo 41 Shows the gap between the two buildings in Photo 40.

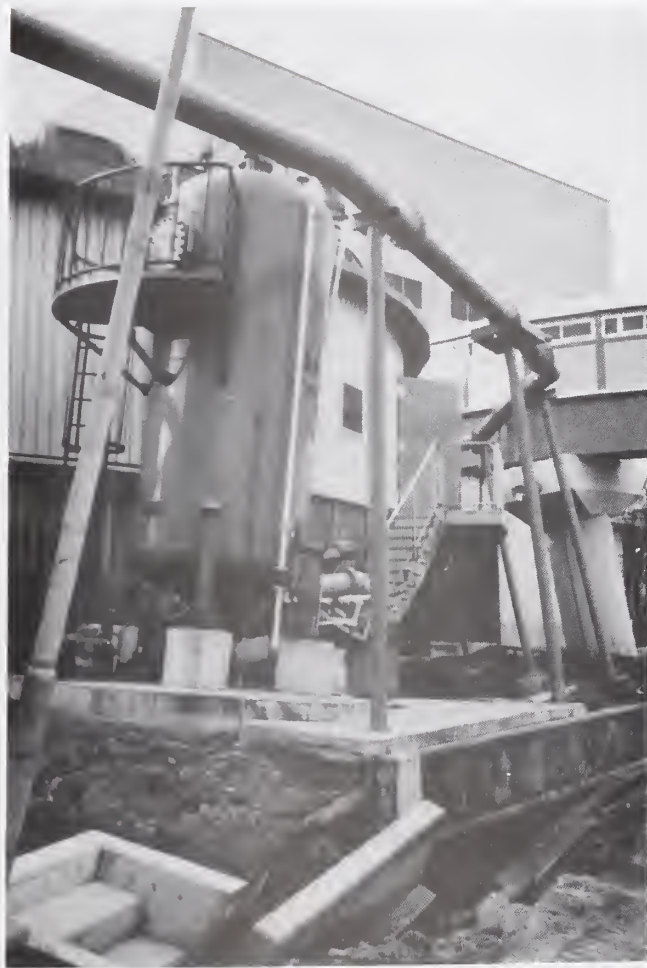
Photo 42 Piping distorted as a result of the movement.
