NIST Special Publication 901

The January 17, 1995 Hyogoken-Nanbu (Kobe) Earthquake

*Performance of Structures, Lifelines, and Fire
Protection Systems*

Riley Chung, Team Leader and Editor

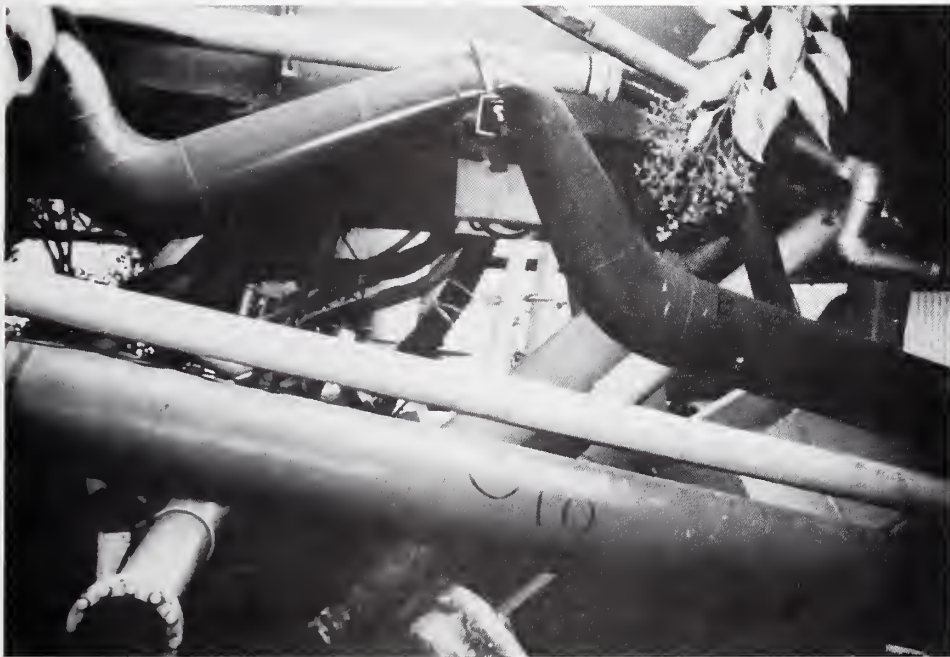
Photo 43 Piping and equipment distorted as a result of subsidence of the structures' foundation.

Photo 44 Same as Photo 43.

Photo 45 Same as Photo 43.

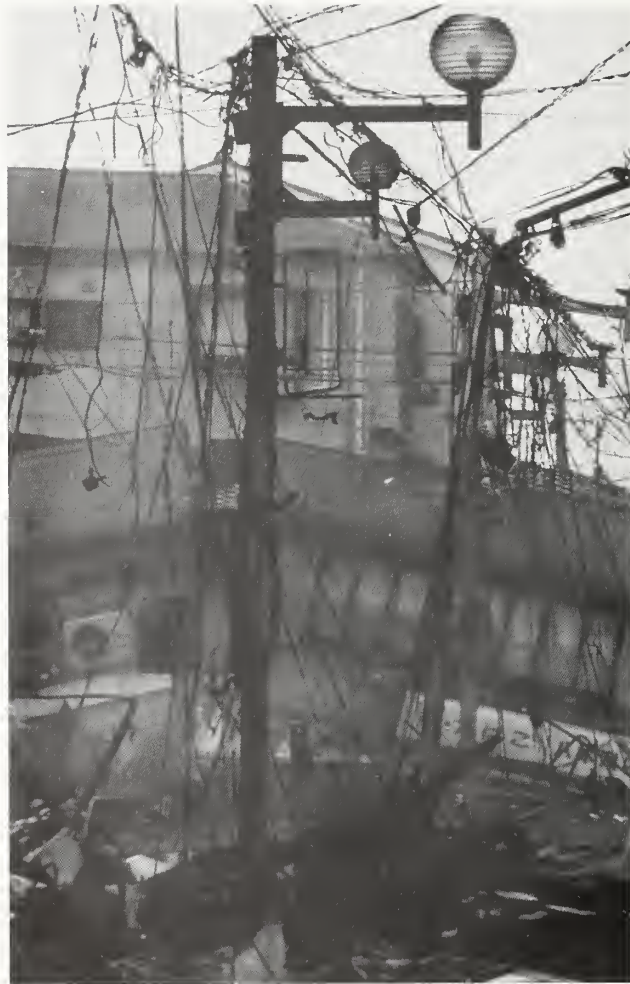
Figure 5.4.18

Damage to the distribution system was massive, but a traffic light in the background is the result of special restoration of the traffic control system.

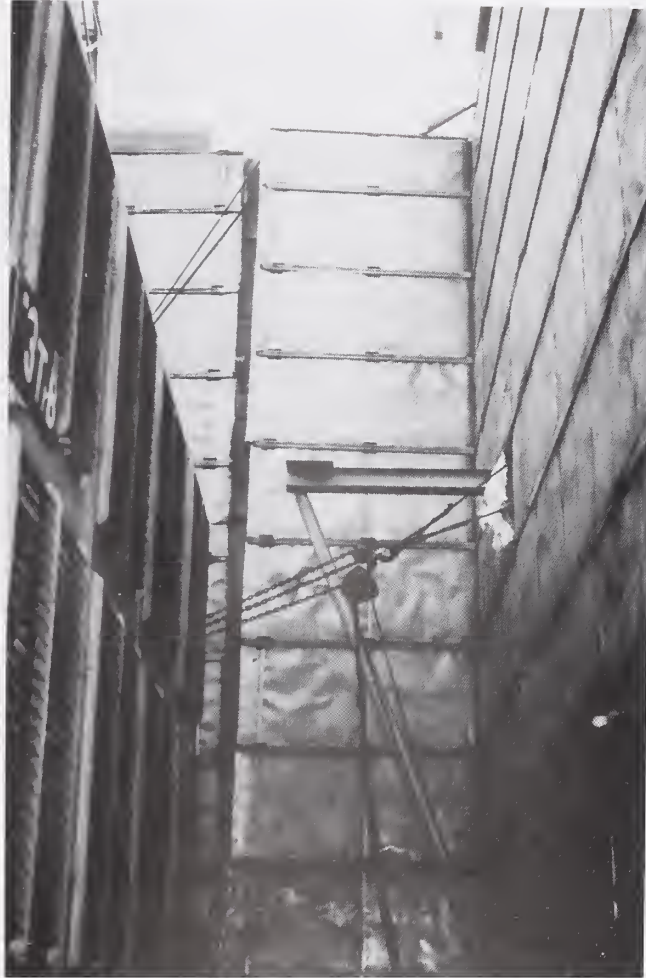
Figure 5.4.37

Transformer acoustical enclosure support was damaged and the enclosure shifted.

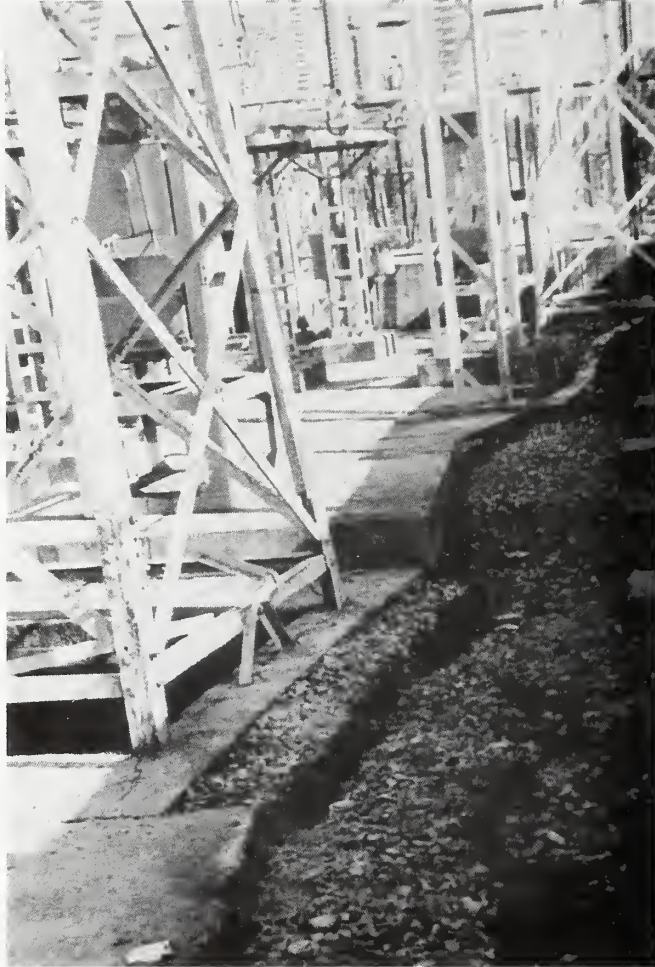
Figure 5.4.44

Cable trenches were deformed with the ground fracturing an air line
be leaving control cables undamaged.

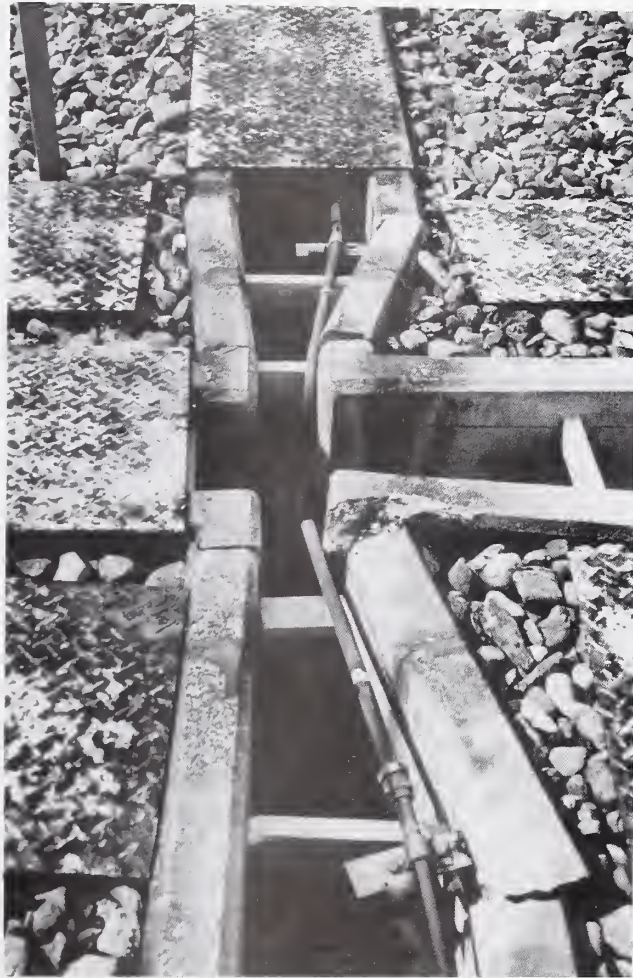
Figure 5.4.45

Large soil deformations at equipment and pedestal foundations did not damage control cables.

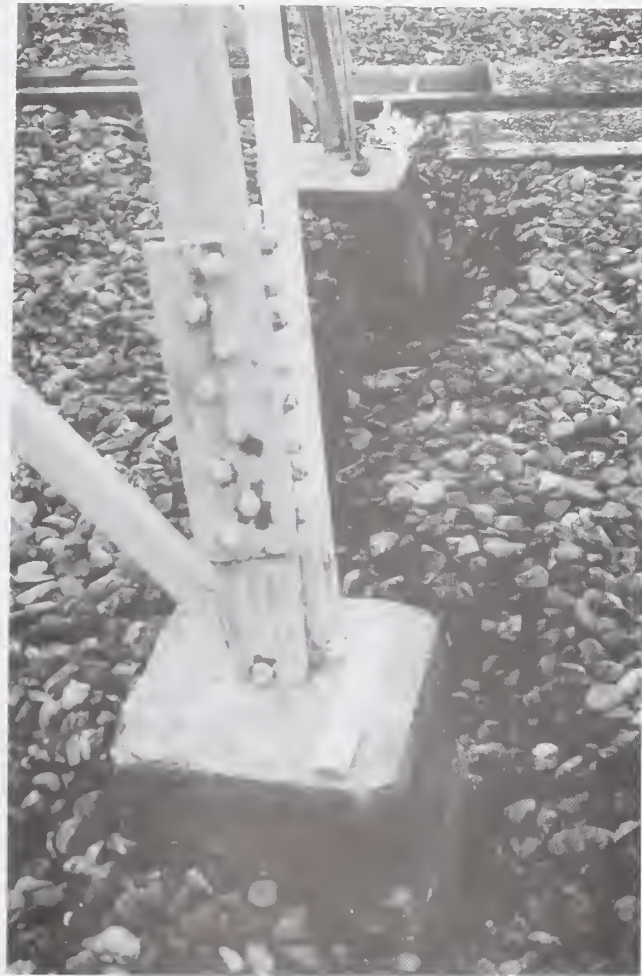
Figure 5.4.47

A lightning arrester support structure tipped about 2-1/2 degrees and probably contributed to the failure of the lightning arrester.

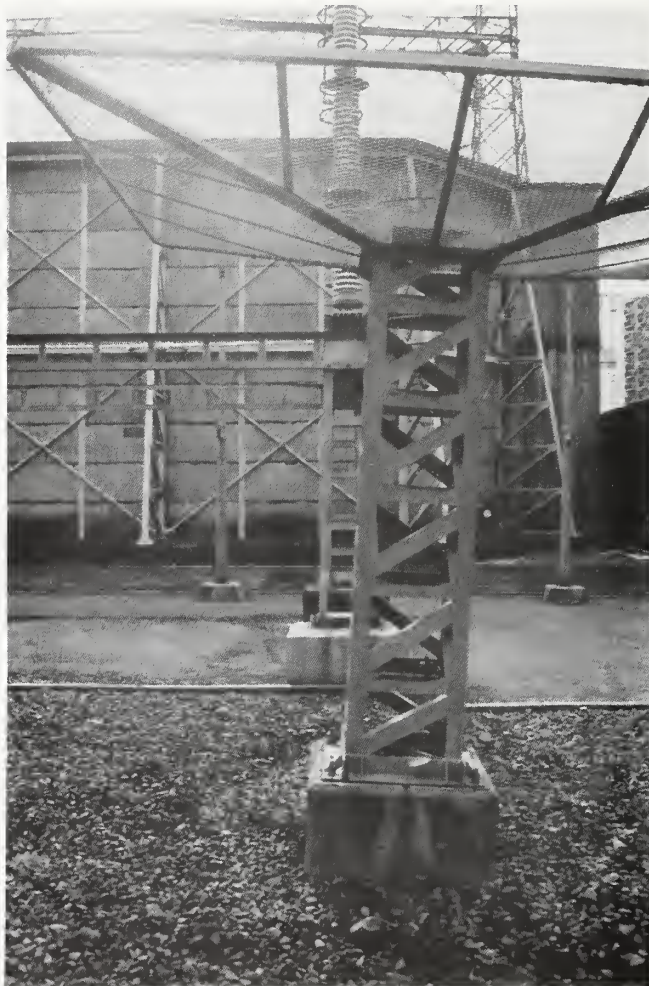
Figure 5.4.48

A new monolithic disconnect switch pad replaced individual footings that were disturbed by a surface crack in the soil.

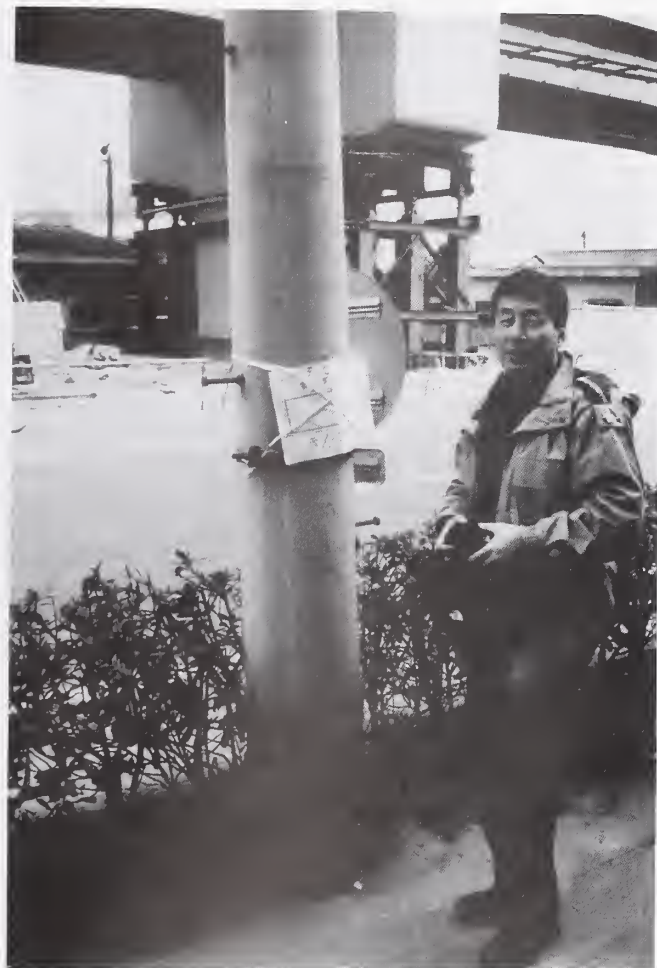
Figure 5.4.71 This pole settled about 1-1/2 m due to liquefaction at the site.

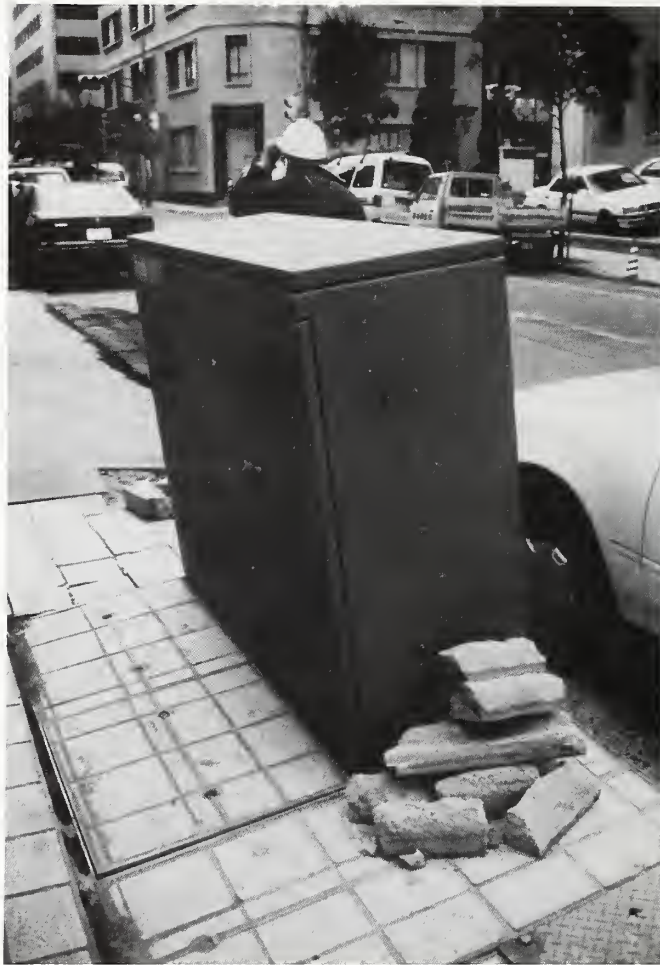
Figure 5.4.72

The conduit and the foundation pad under this transformer pad was disrupted in down town Kobe due to soil liquefaction.

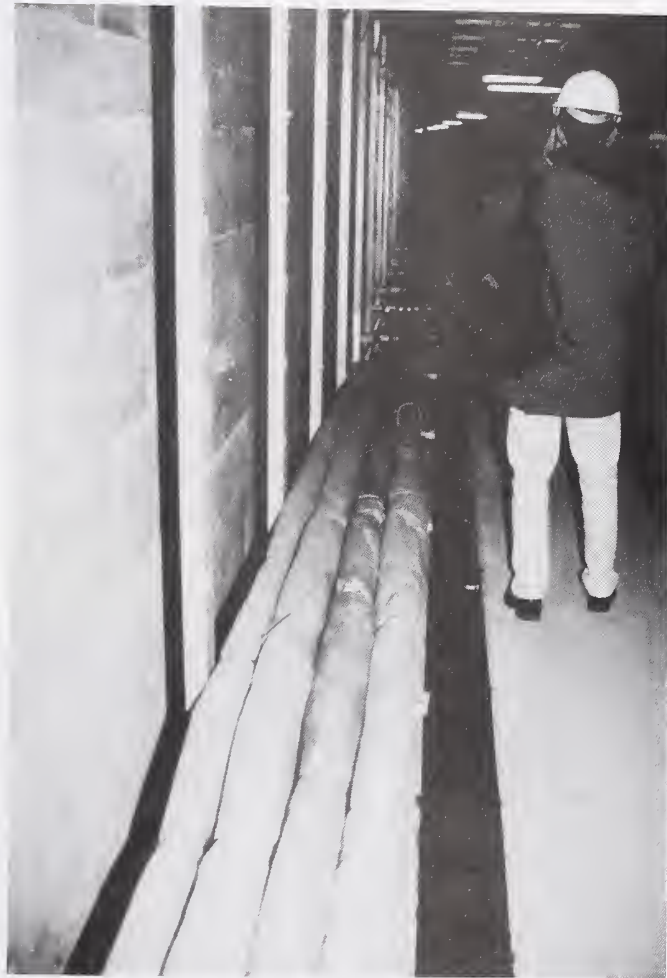
Figure 5.5.5

At many manholes, the conduits were pushed into the manhole boxes by up to 30 cm. This can exceed the available cable slack and cause a cable failure (Figure 5.5.5). The relative motion also can damage the manhole-conduit seal, and water seepage can also damage the cables. In older conduits, cable slack was 2 cm at the manholes, and some of these broke. At new conduits, cable slack was up to 15 cm, and these did not break. It appears that there can be large variations in slack provided to cables at manholes. In an earlier visit to Tsukuba City, an NTT Outside Plant research group proposed service loops of about 8 cm diameter before each splice joint. However, a tie-wrap to secure the loop to a tray or shelf was also recommended, so that the deployment of the slack may be impeded. Liquefaction and soil movement also moved junction boxes (Figure 5.5.6). Figure 5.5.7 shows a schematic diagram of a 4 cm offset of plates used to form the manhole entry. Subsidence of soil around manholes also caused conduit failures (Figure 5.5.8). Conduit carried on bridges were also damaged due to motion of the bridge deck (Figure 5.5.9). Subsidence in roadways caused extensive damage (Figures 5.5.10 and 5.5.11). Telephone booths were also severely damaged by soil

Cables were pushed into manhole boxes breaking water seals and in some cases damaging cables.

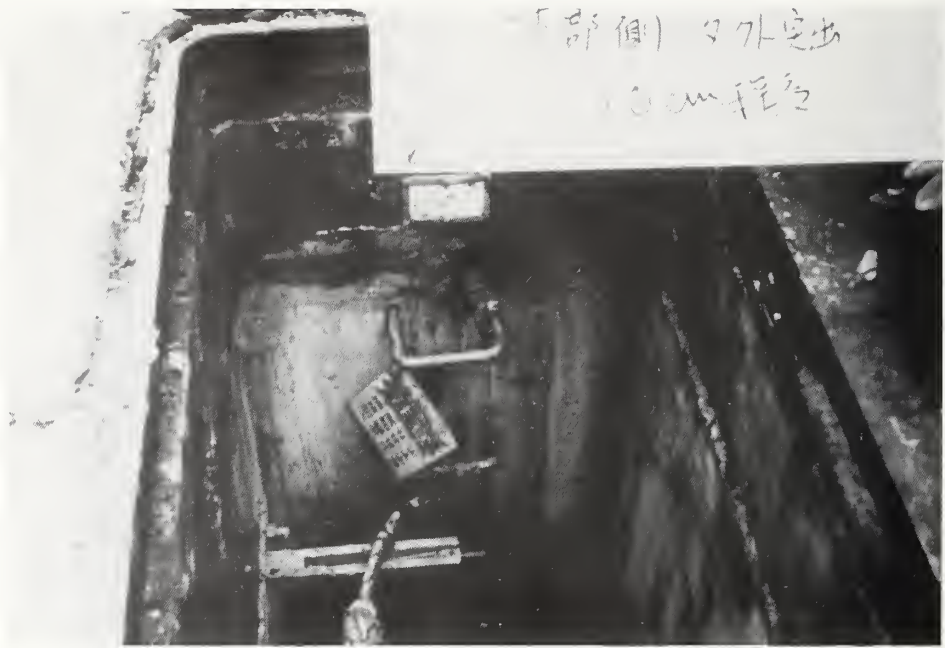
Figure 5.5.6

Movement of manhole box can damage conduits and trunk lines.

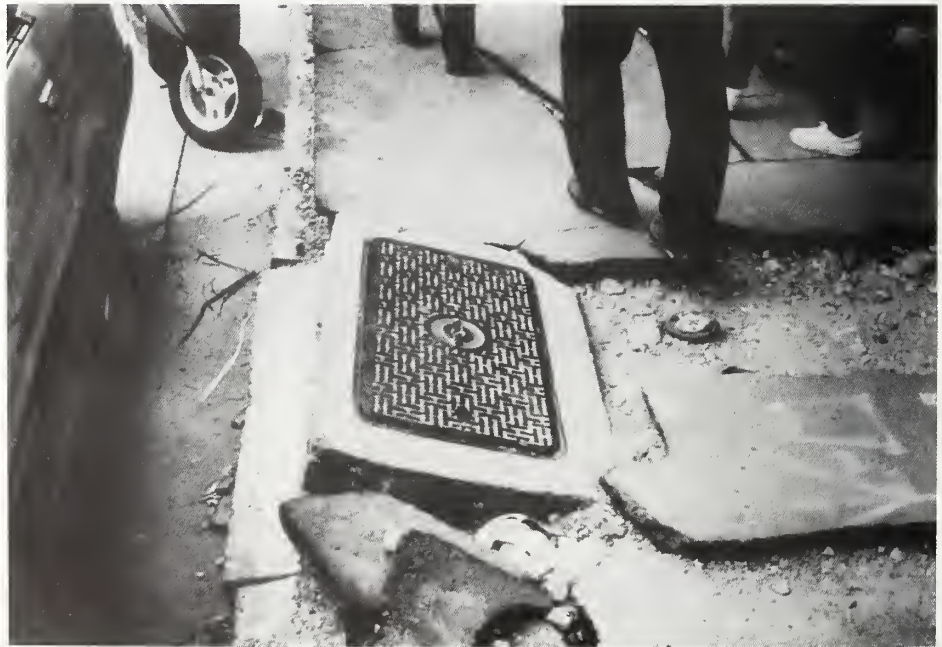
Figure 5.5.7

The entry of a manhole built by stacking rings were offset by 4 cm due to soil failure.

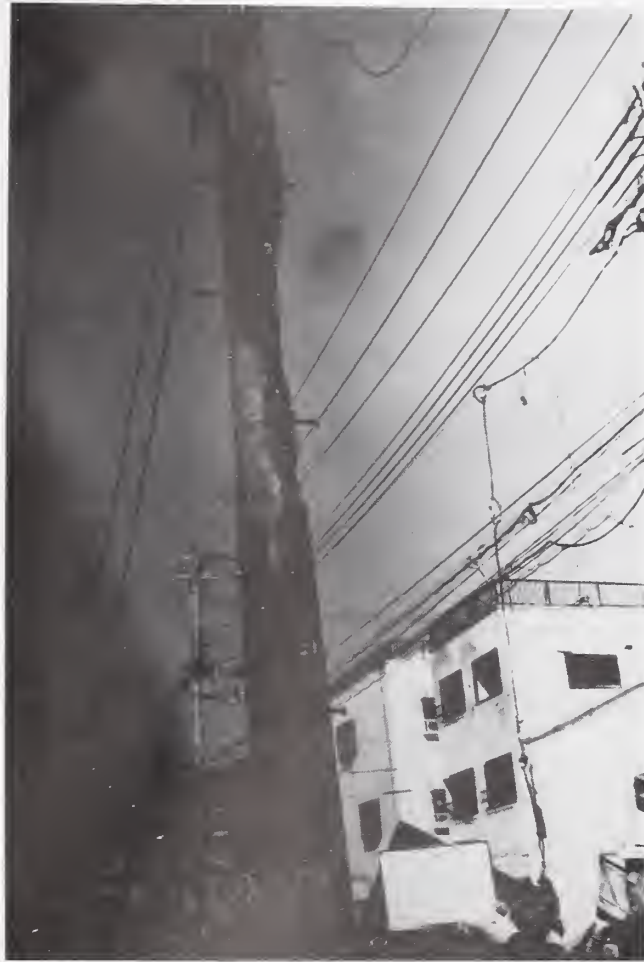
Figure 5.5.14

Fire damaged aerial lines and cables along the pole.

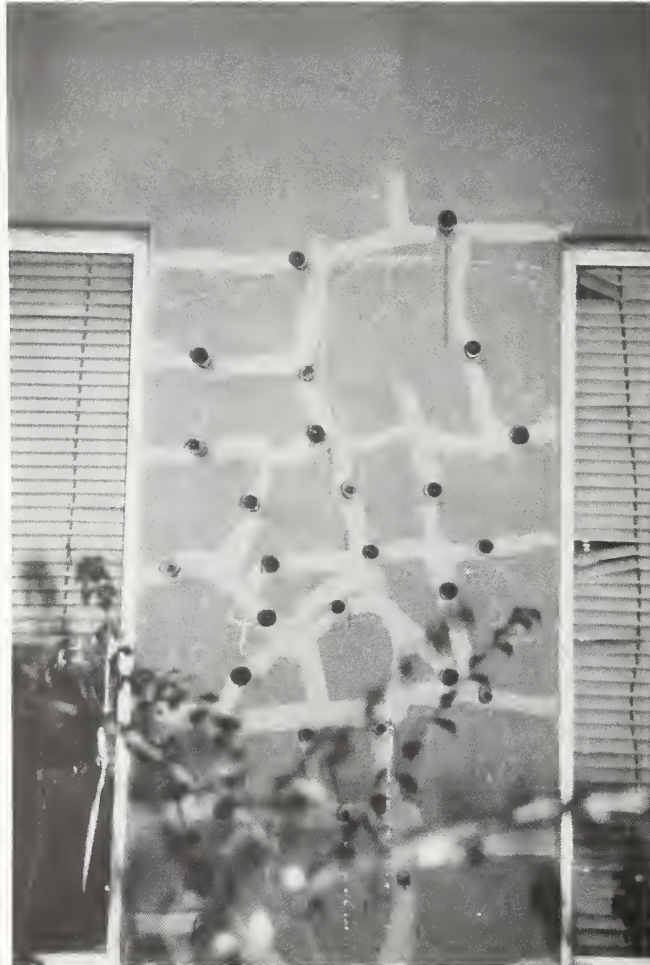
Figure 5.6.1

Column on the first floor of the old hospital being repaired with epoxy injection.

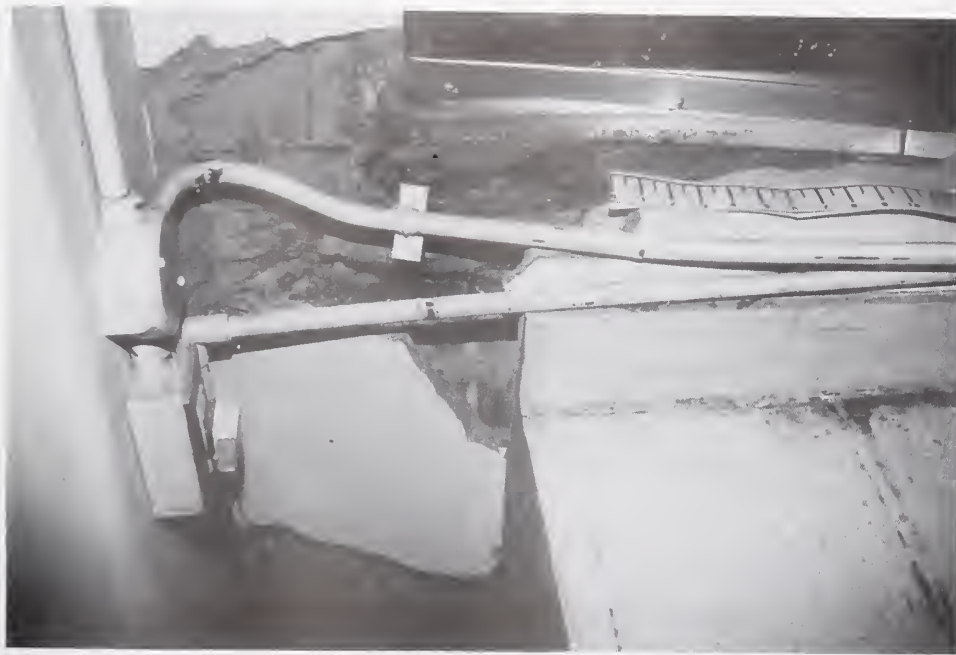
Figure 5.6.2

There appeared to be relatively little structural damage to the hospital, except as noted above. In the new wing of the hospital a section of a wall that joins the new and old wings had severe local damage due to interaction of the two buildings where the corridor connects the two buildings (Figure 5.6.2). There was some spalling of concrete adjacent to at least one seismic joint observed during the short visit to the hospital.

Beam shattered due to interaction between the two wings of the hospital at cross walks connecting the buildings.

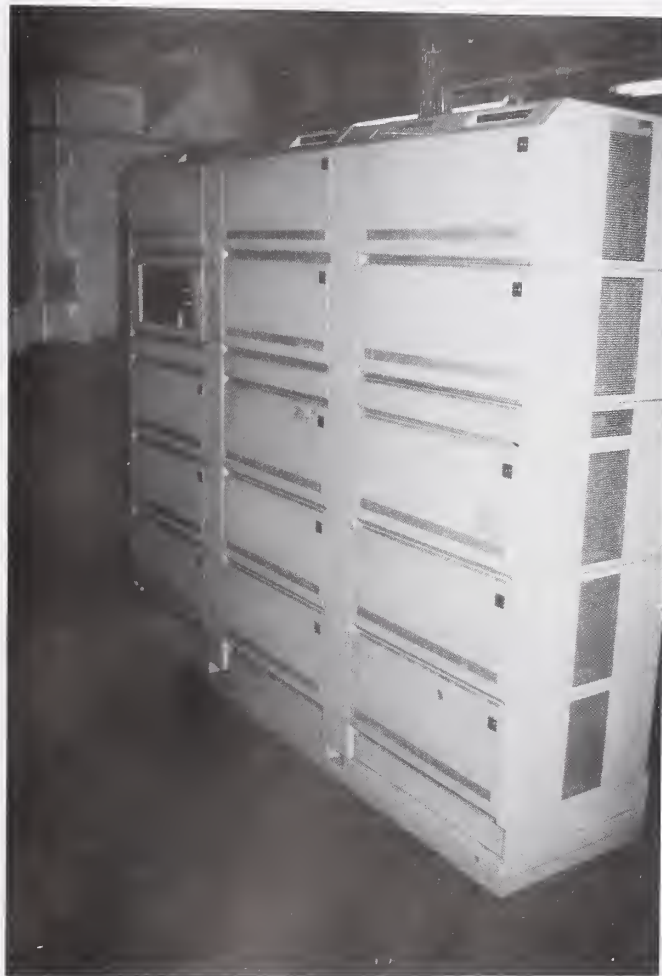
Figure 5.6.11

Battery within UPS used by the PBX. Note that cells fit snugly together, that there is a gap between the end restraint and the cell, and that the end restraint is light weight.
