PHYSICAL PROTECTION WORKBOOK

SHEPHARD SITE-PHASE III

(AR-NM-01-829) ALBUQUERQUE DISTRICT

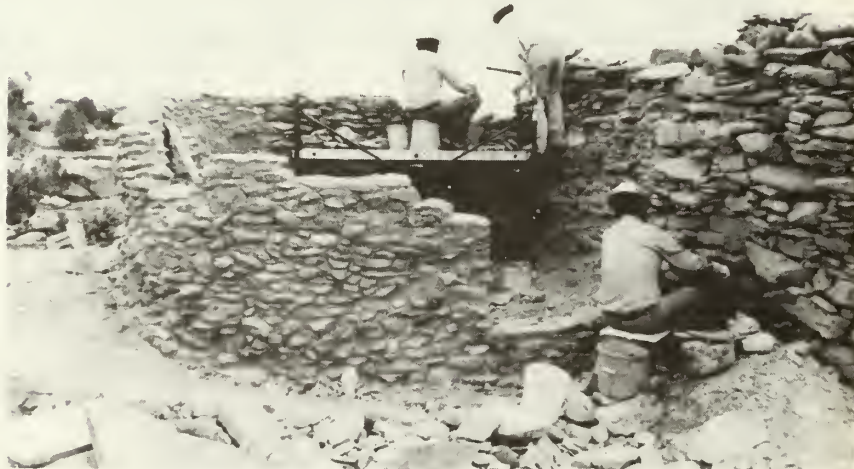
"After" stabilization; the south wall of room 3. Raymond Terrivio, Bobby Johnson, and Kee Johnson work on the room. Note the reconstructed section of wall adjacent the plugged doorway. To the left of the photo on the corner of the wall can be seen the eroded window which may have been the entrance to the room. (looking north)

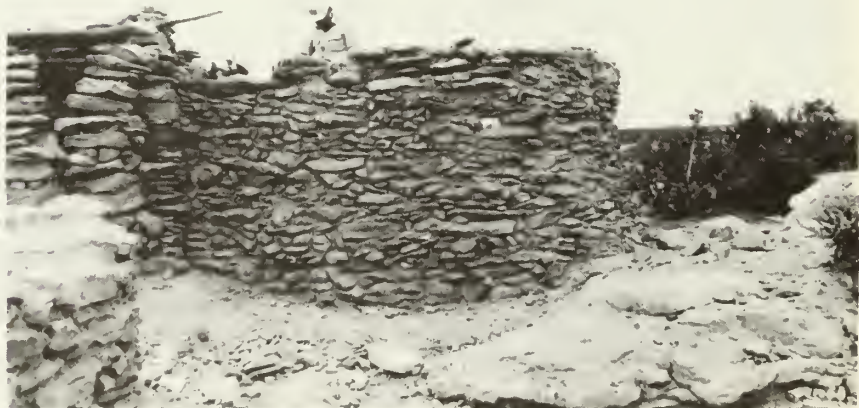
"After" stabilization; the completed north and west walls of room 3. Raymond Torrivio in photo. (looking south)

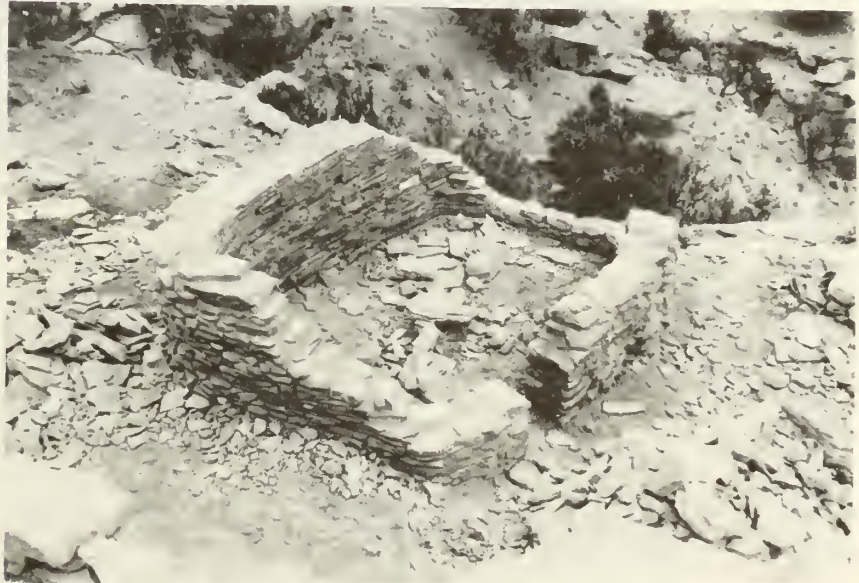
"After" stabilization; room 4.
(looking north)

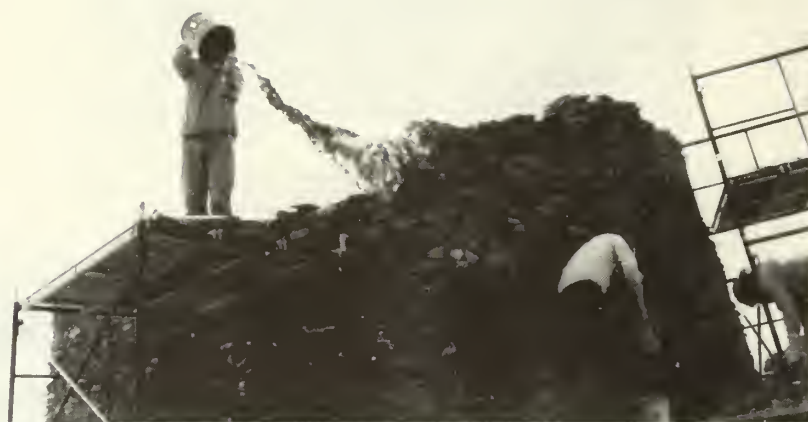
Stabilization completed.

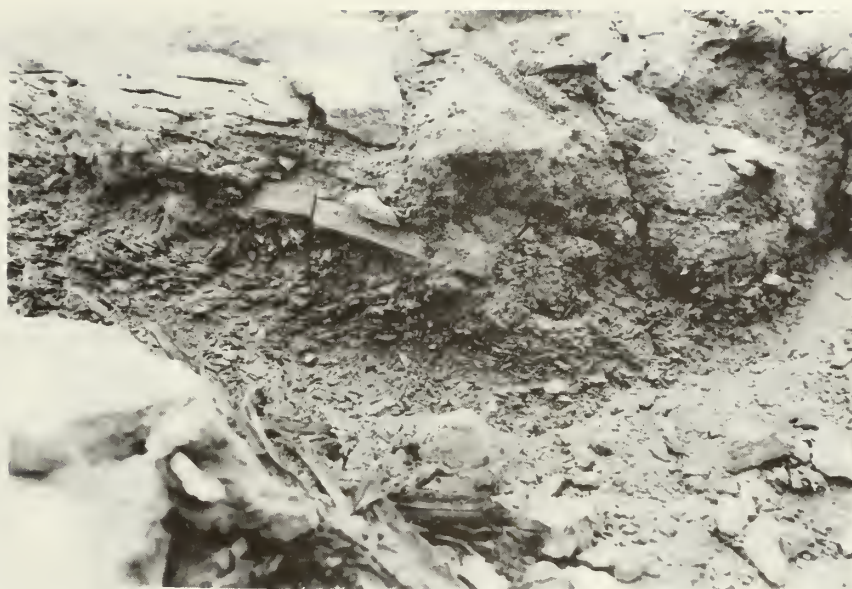
Profile of the roof construction on room 2. Wall rubble from second story of room 1 covers the surface. Next is a layer of red/buff adobe followed by an orange and gray clay. The horizontal flakes in the clay may be decomposing slabs of shale. Juniper bark is visible at the bottom of the photo covering the layer of brush shown in the photo below.

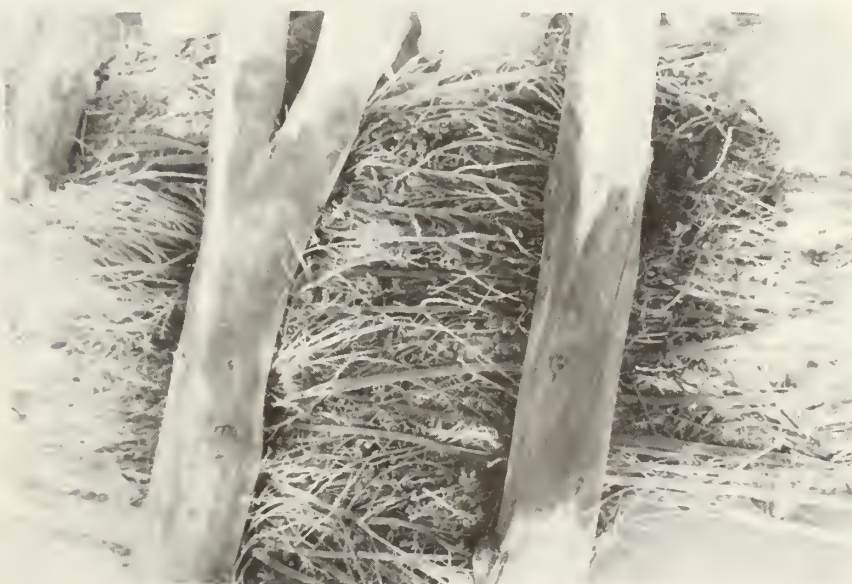
Remains of the original roof of room 2. Note the brush layed transverse to the vigas, and the smoke stains on the vigas.
