FDD #6 NAKAJIMA MUSASHINO (9)

Pack 3 PHOTO LOG - NAKAJIMA - MUSEUM

PHOTO LOC - NAKAJIMA - MUSEUM -

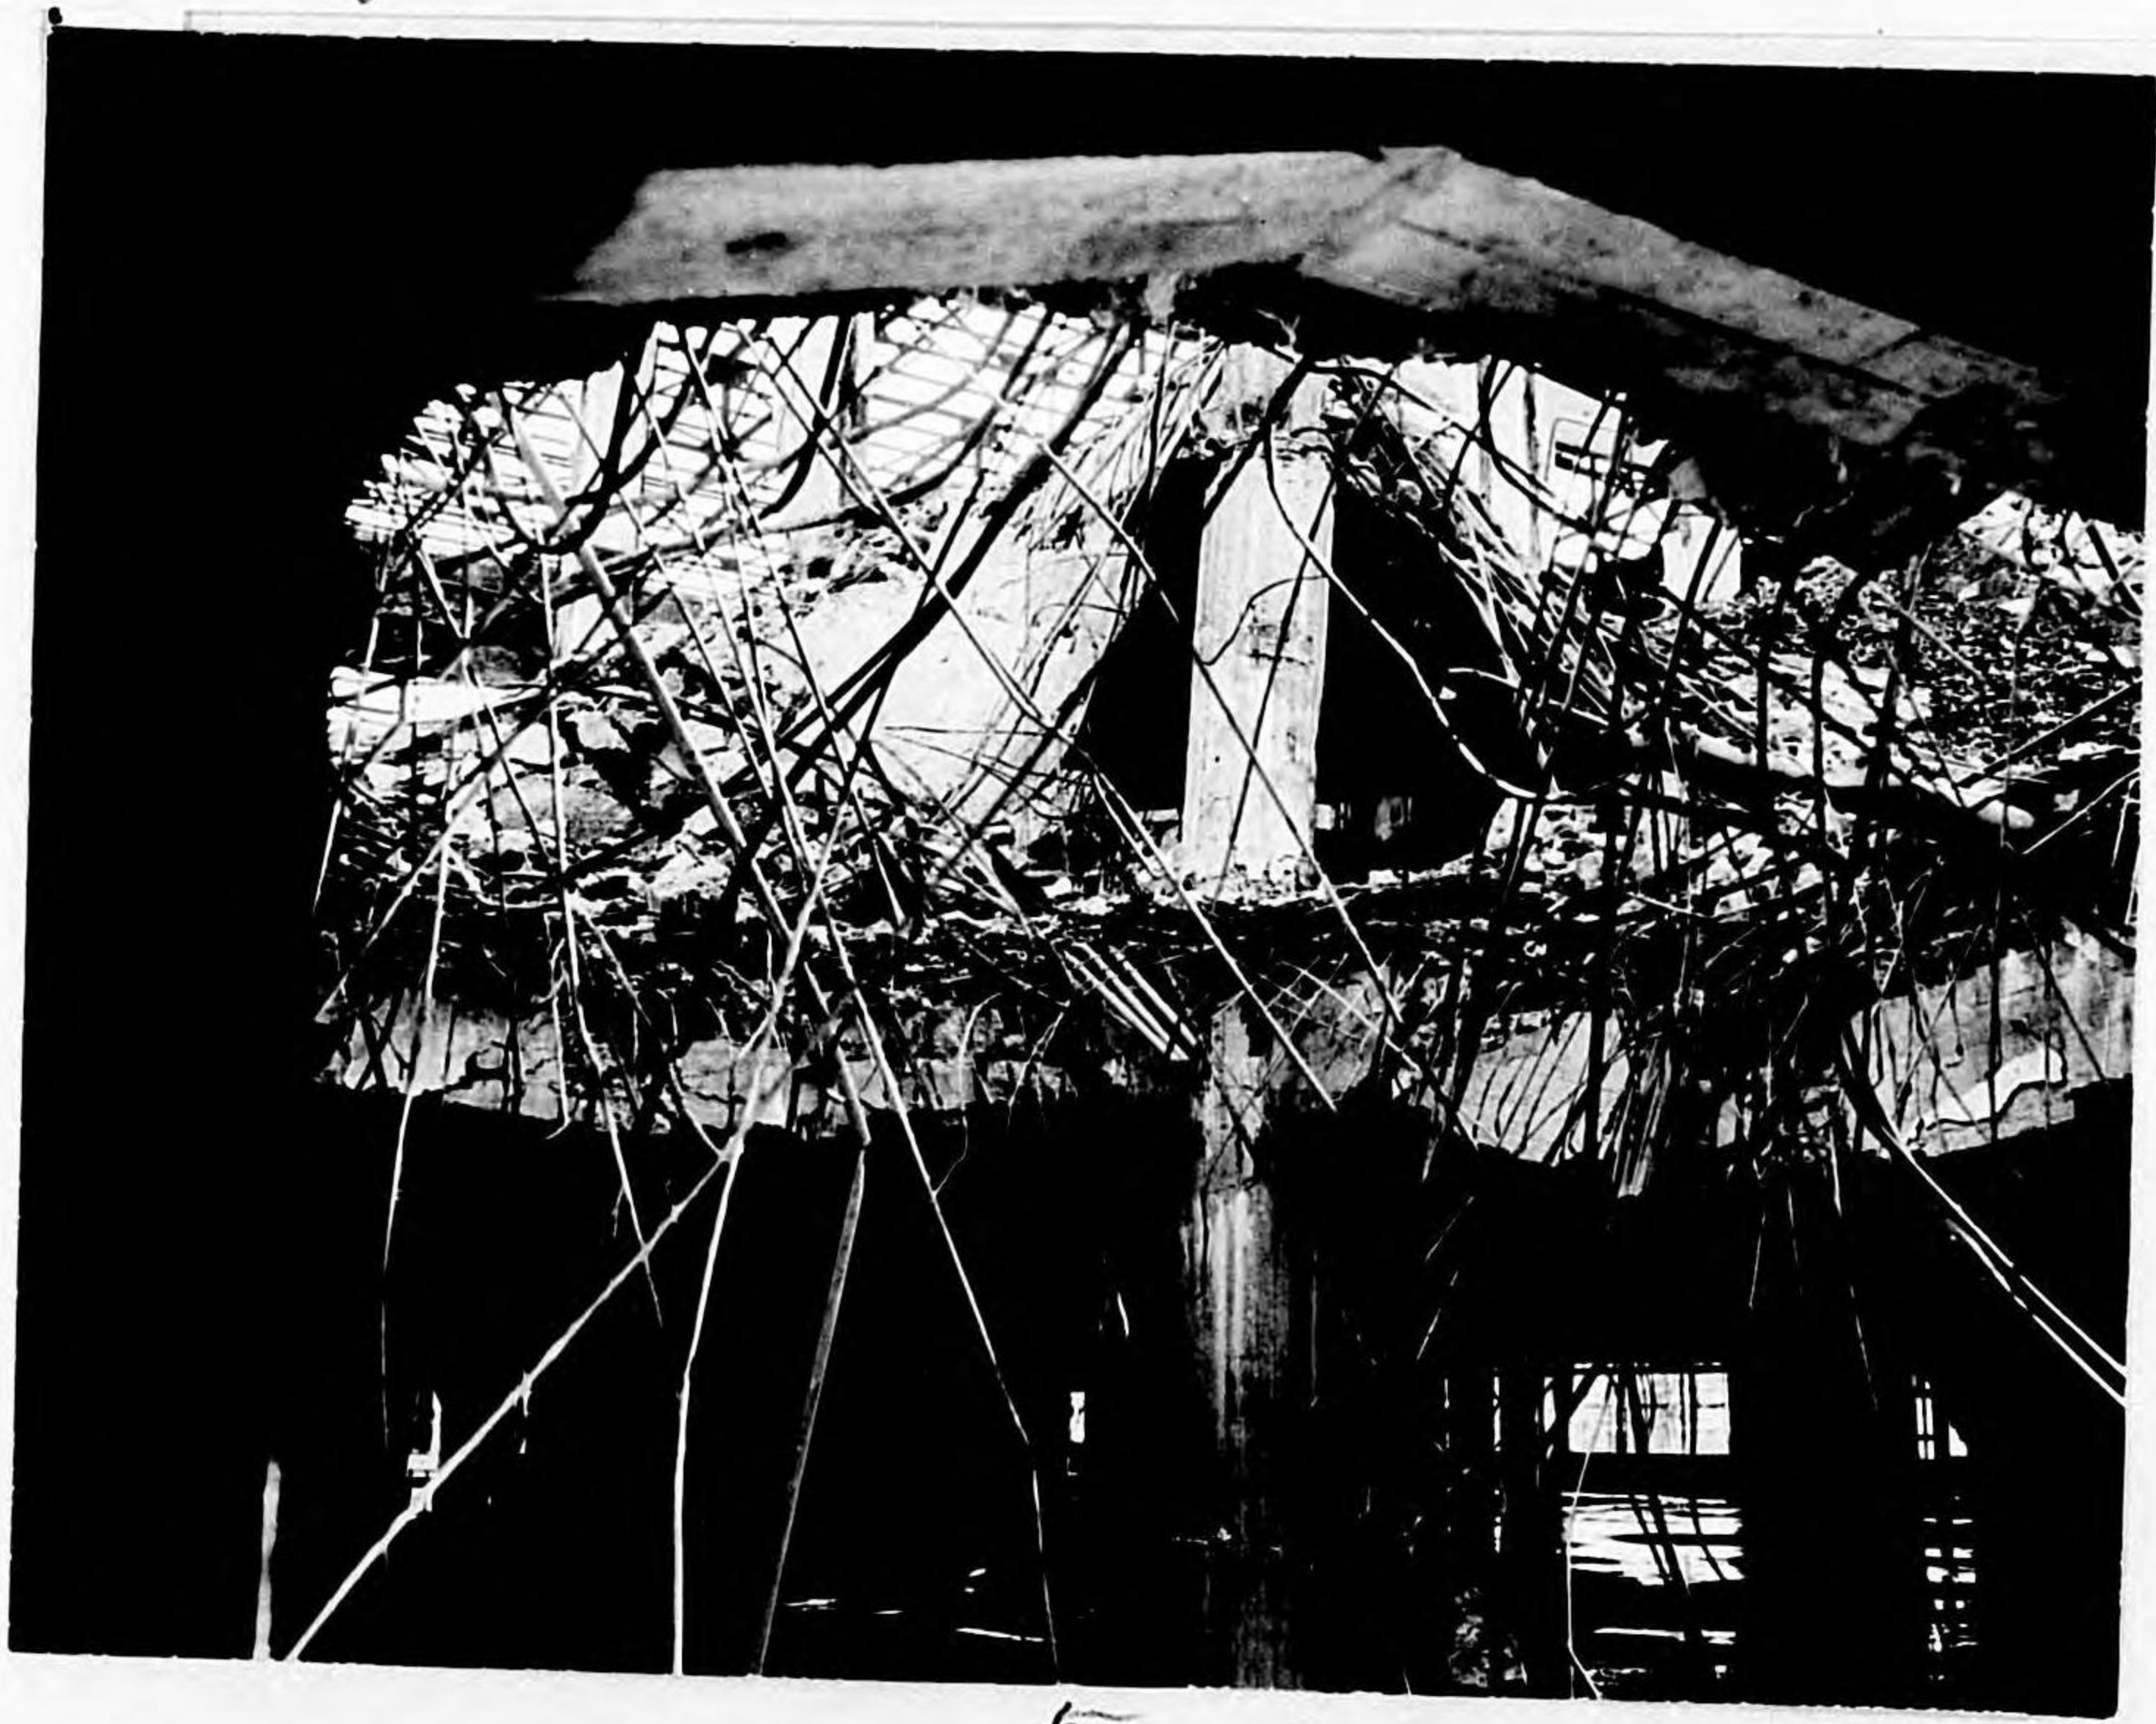
Photo 5

View looking upward through damage caused by Bomb 2.
Bldg 11, Center Section

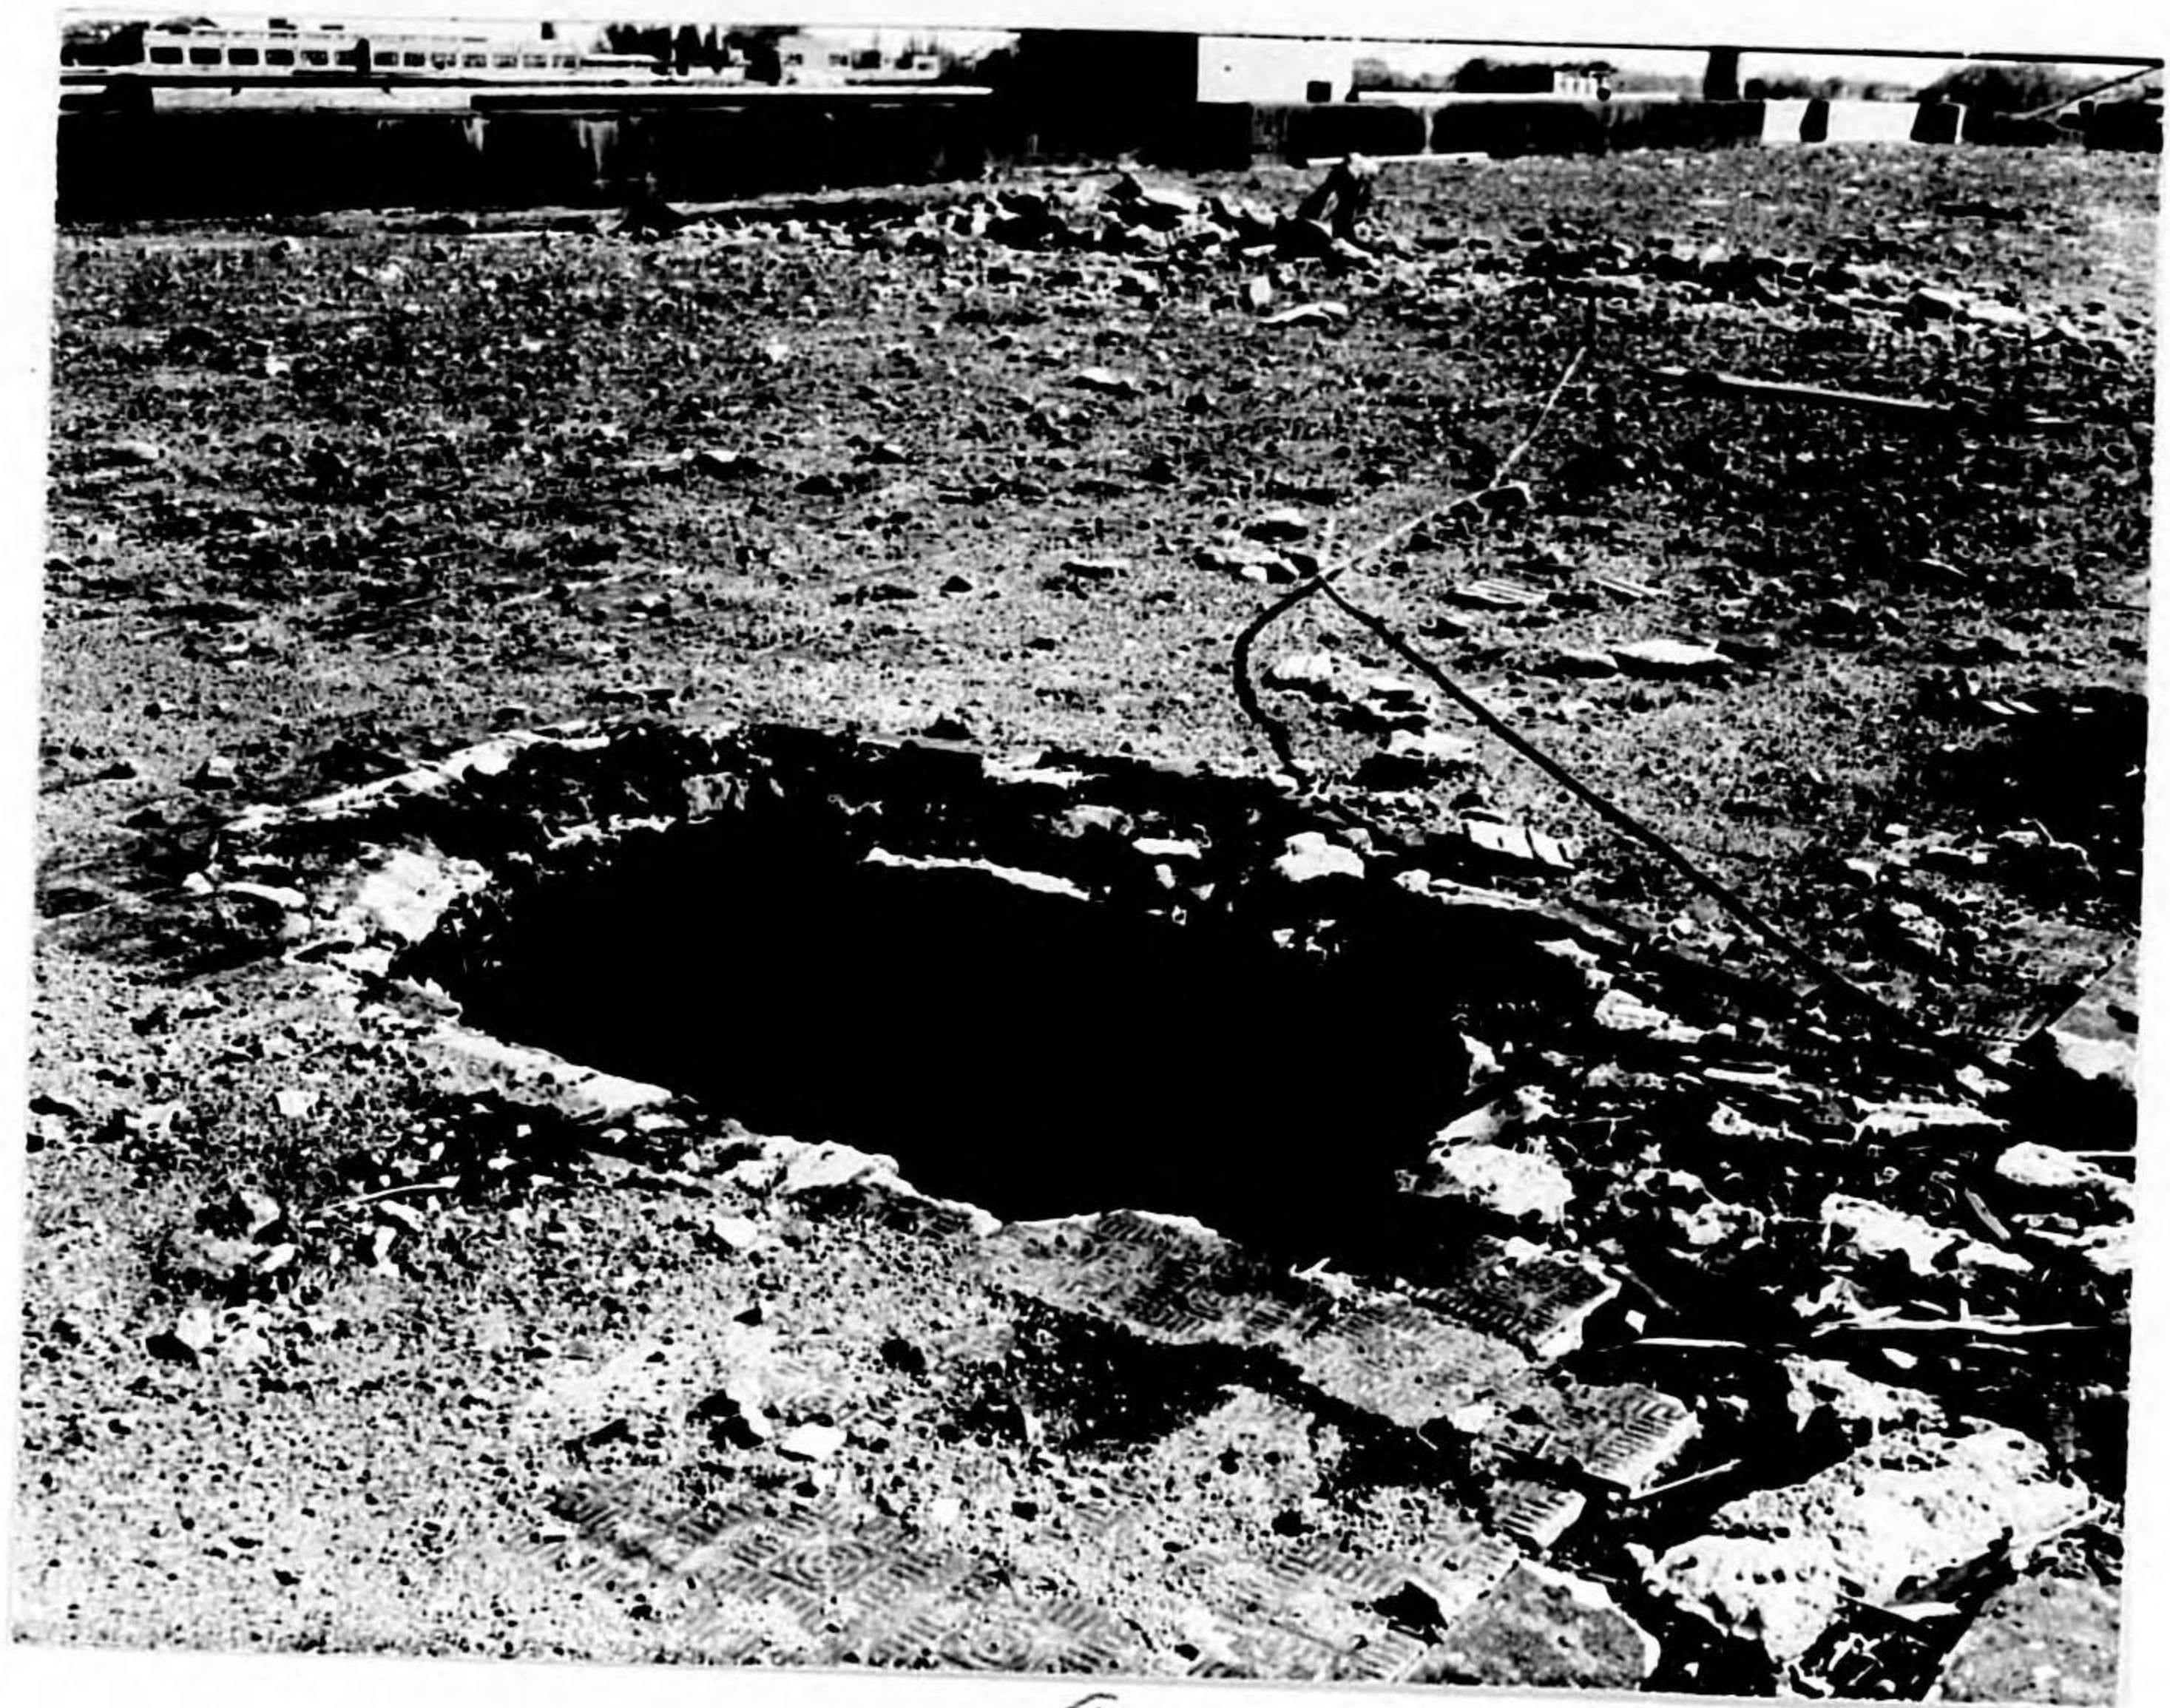
Photo 9

Entry point of ^{cap} Bomb 4 in roof of building 11-E. Note oblong hole. This low order bomb evidently struck flat, and the damage was very limited.

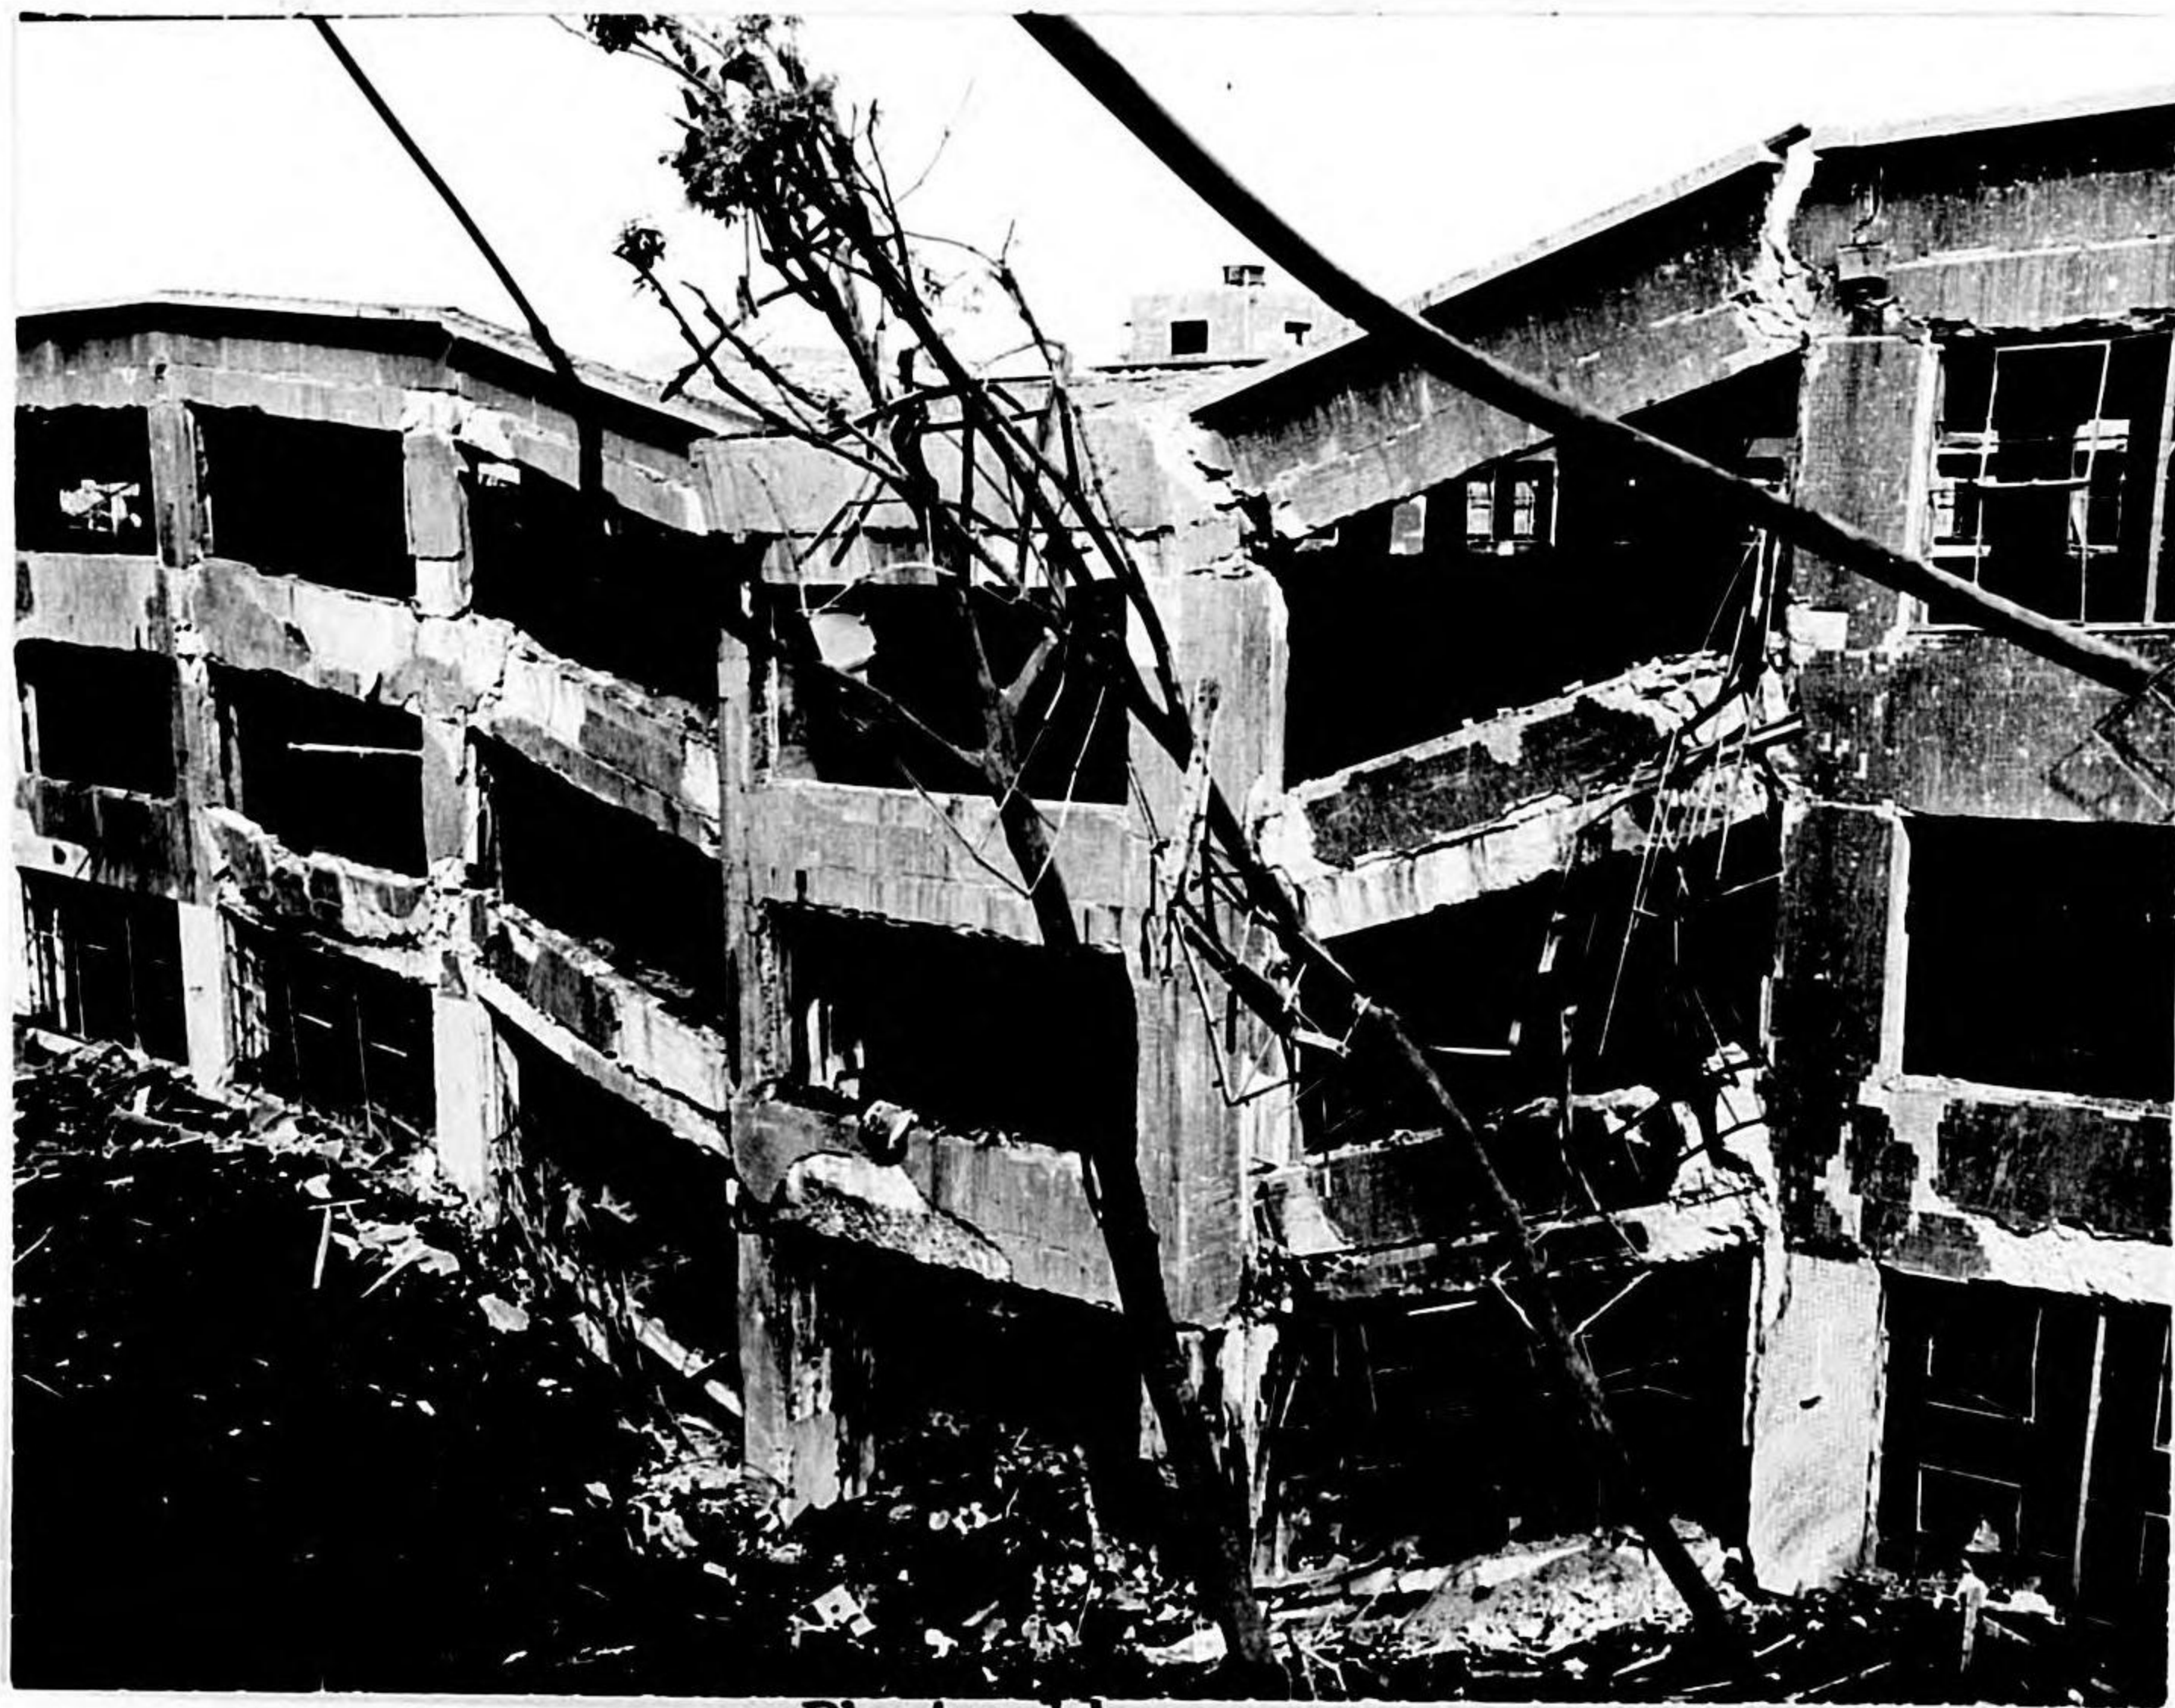
Photo 11

Same as photo 10 from a different angle.

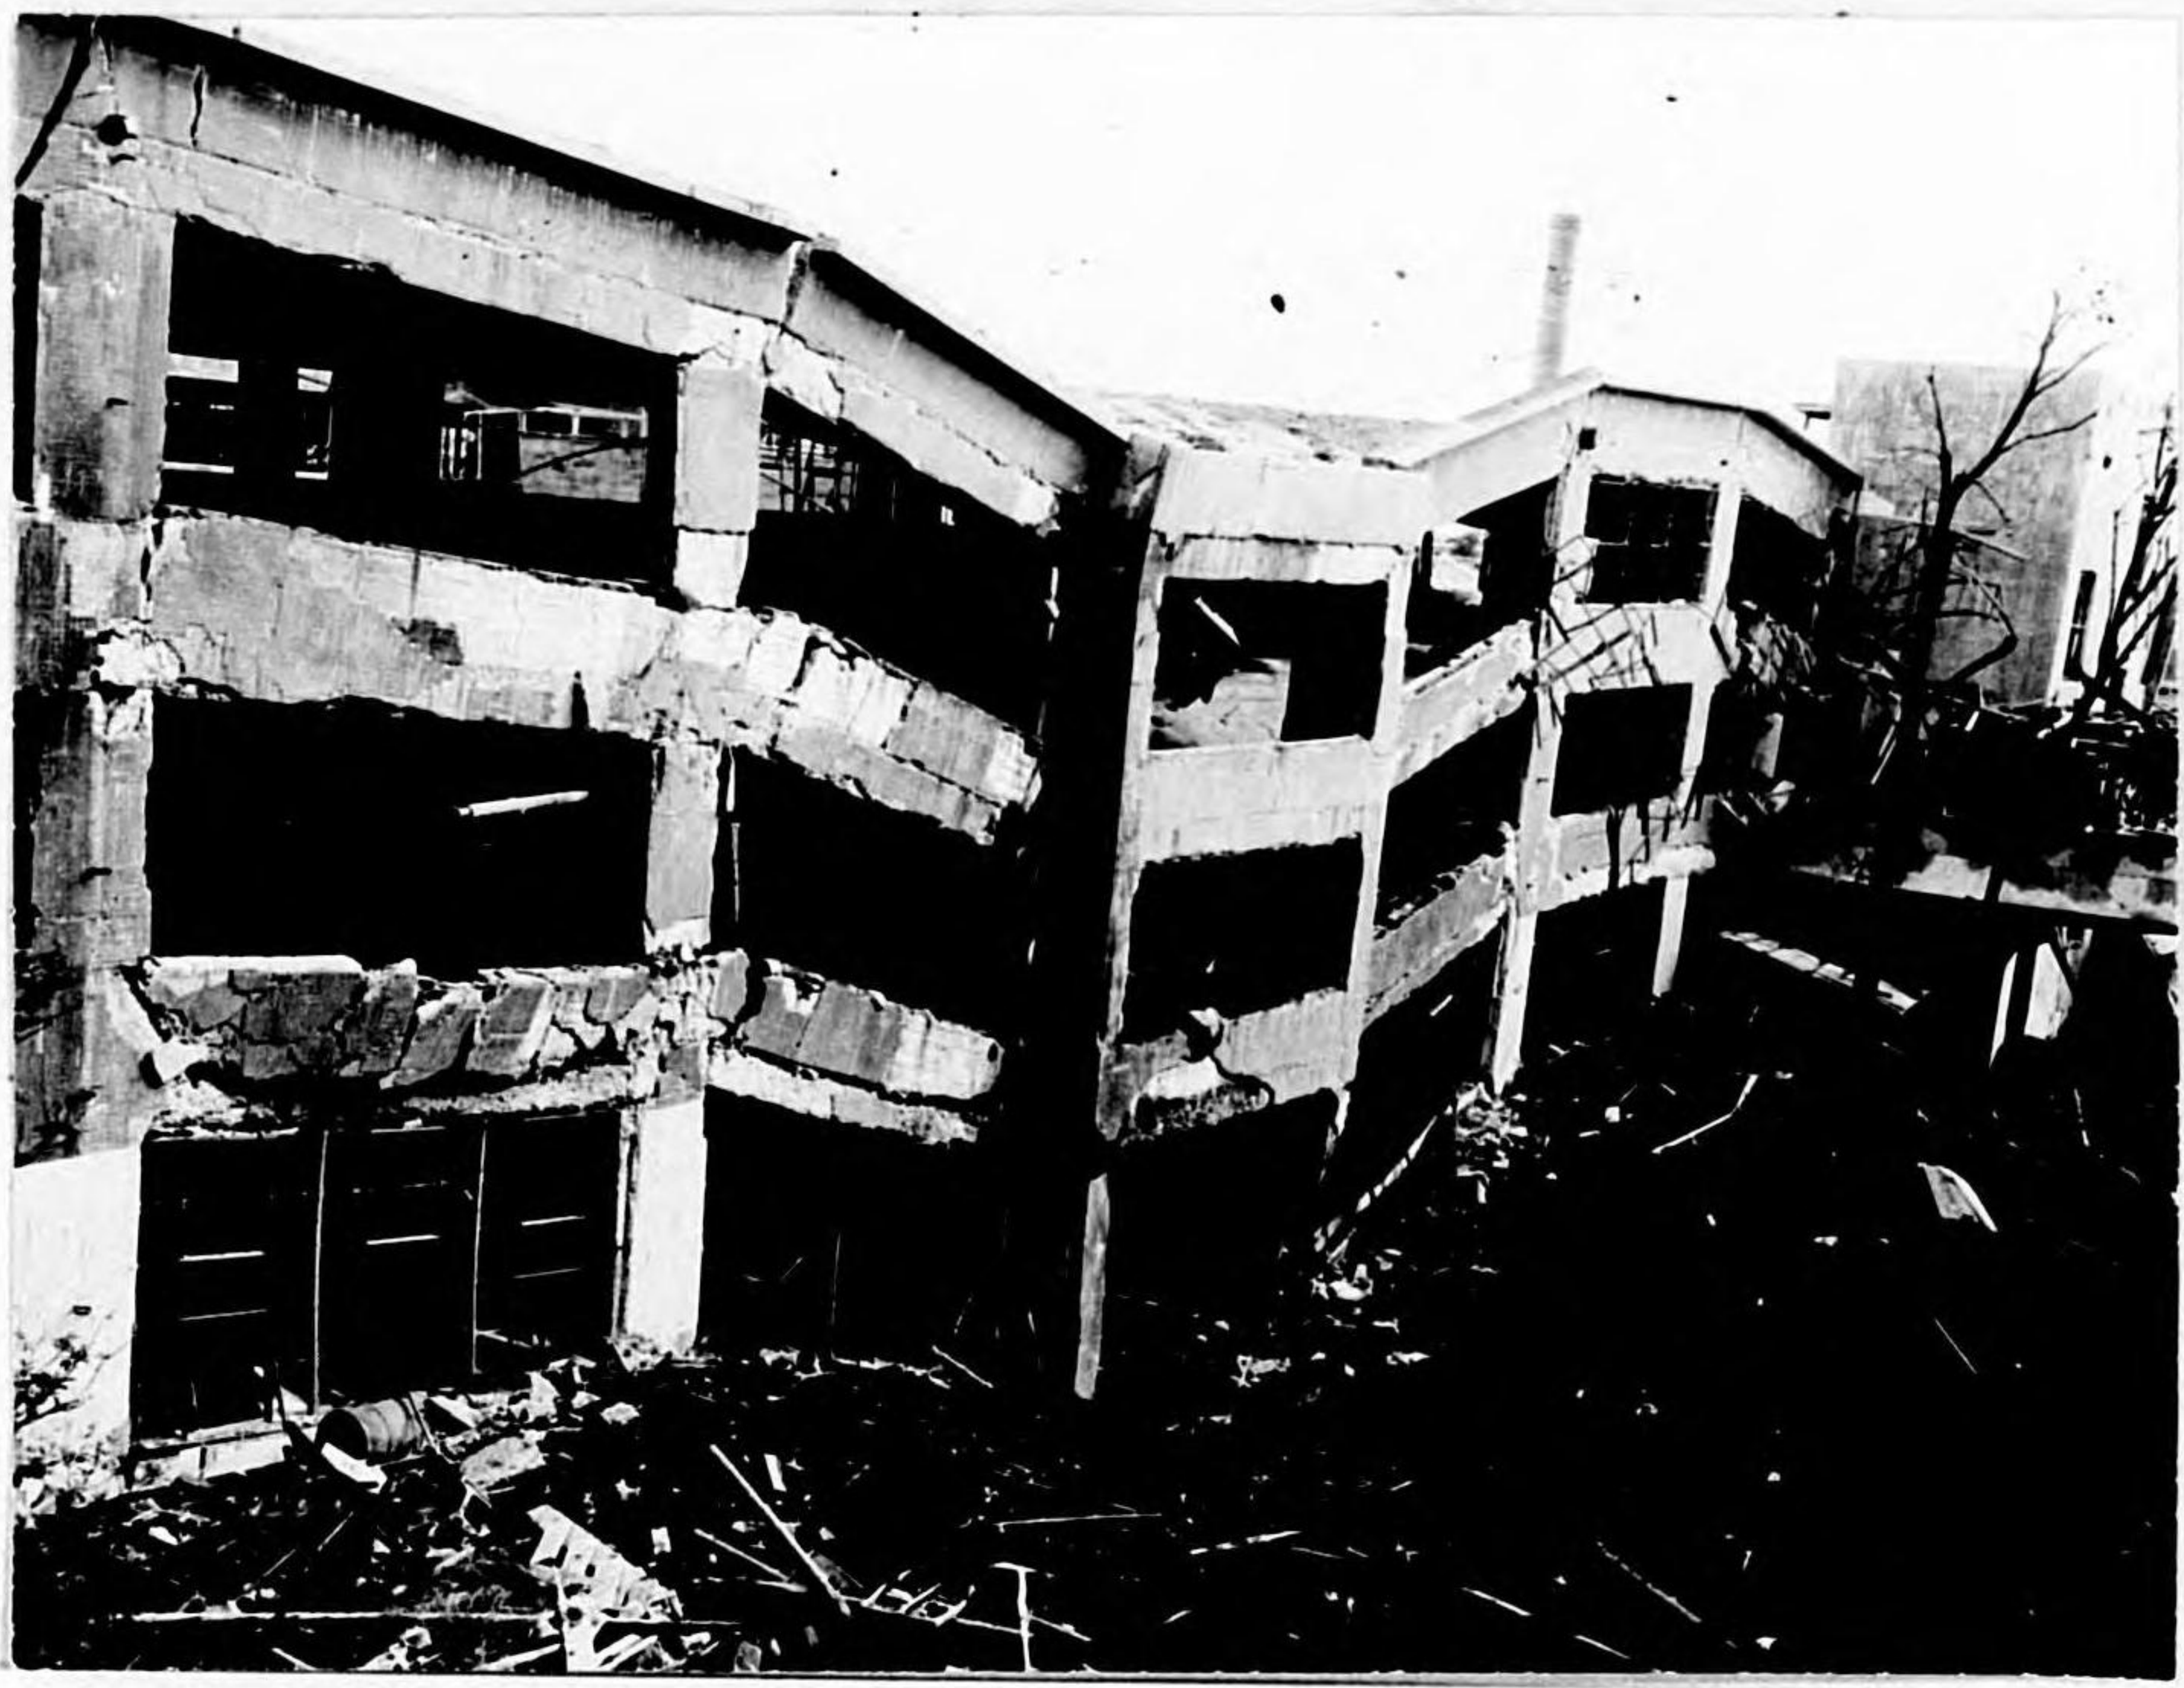
Photo 12

View of south elevation of building 11-E. Note one bay in foreground which has dropped in Bomb 6 crater. Also, note line of parapet which indicates that stair well section, shown at right of picture, has dropped into crater of bomb 7 without distorting construction of stair well.

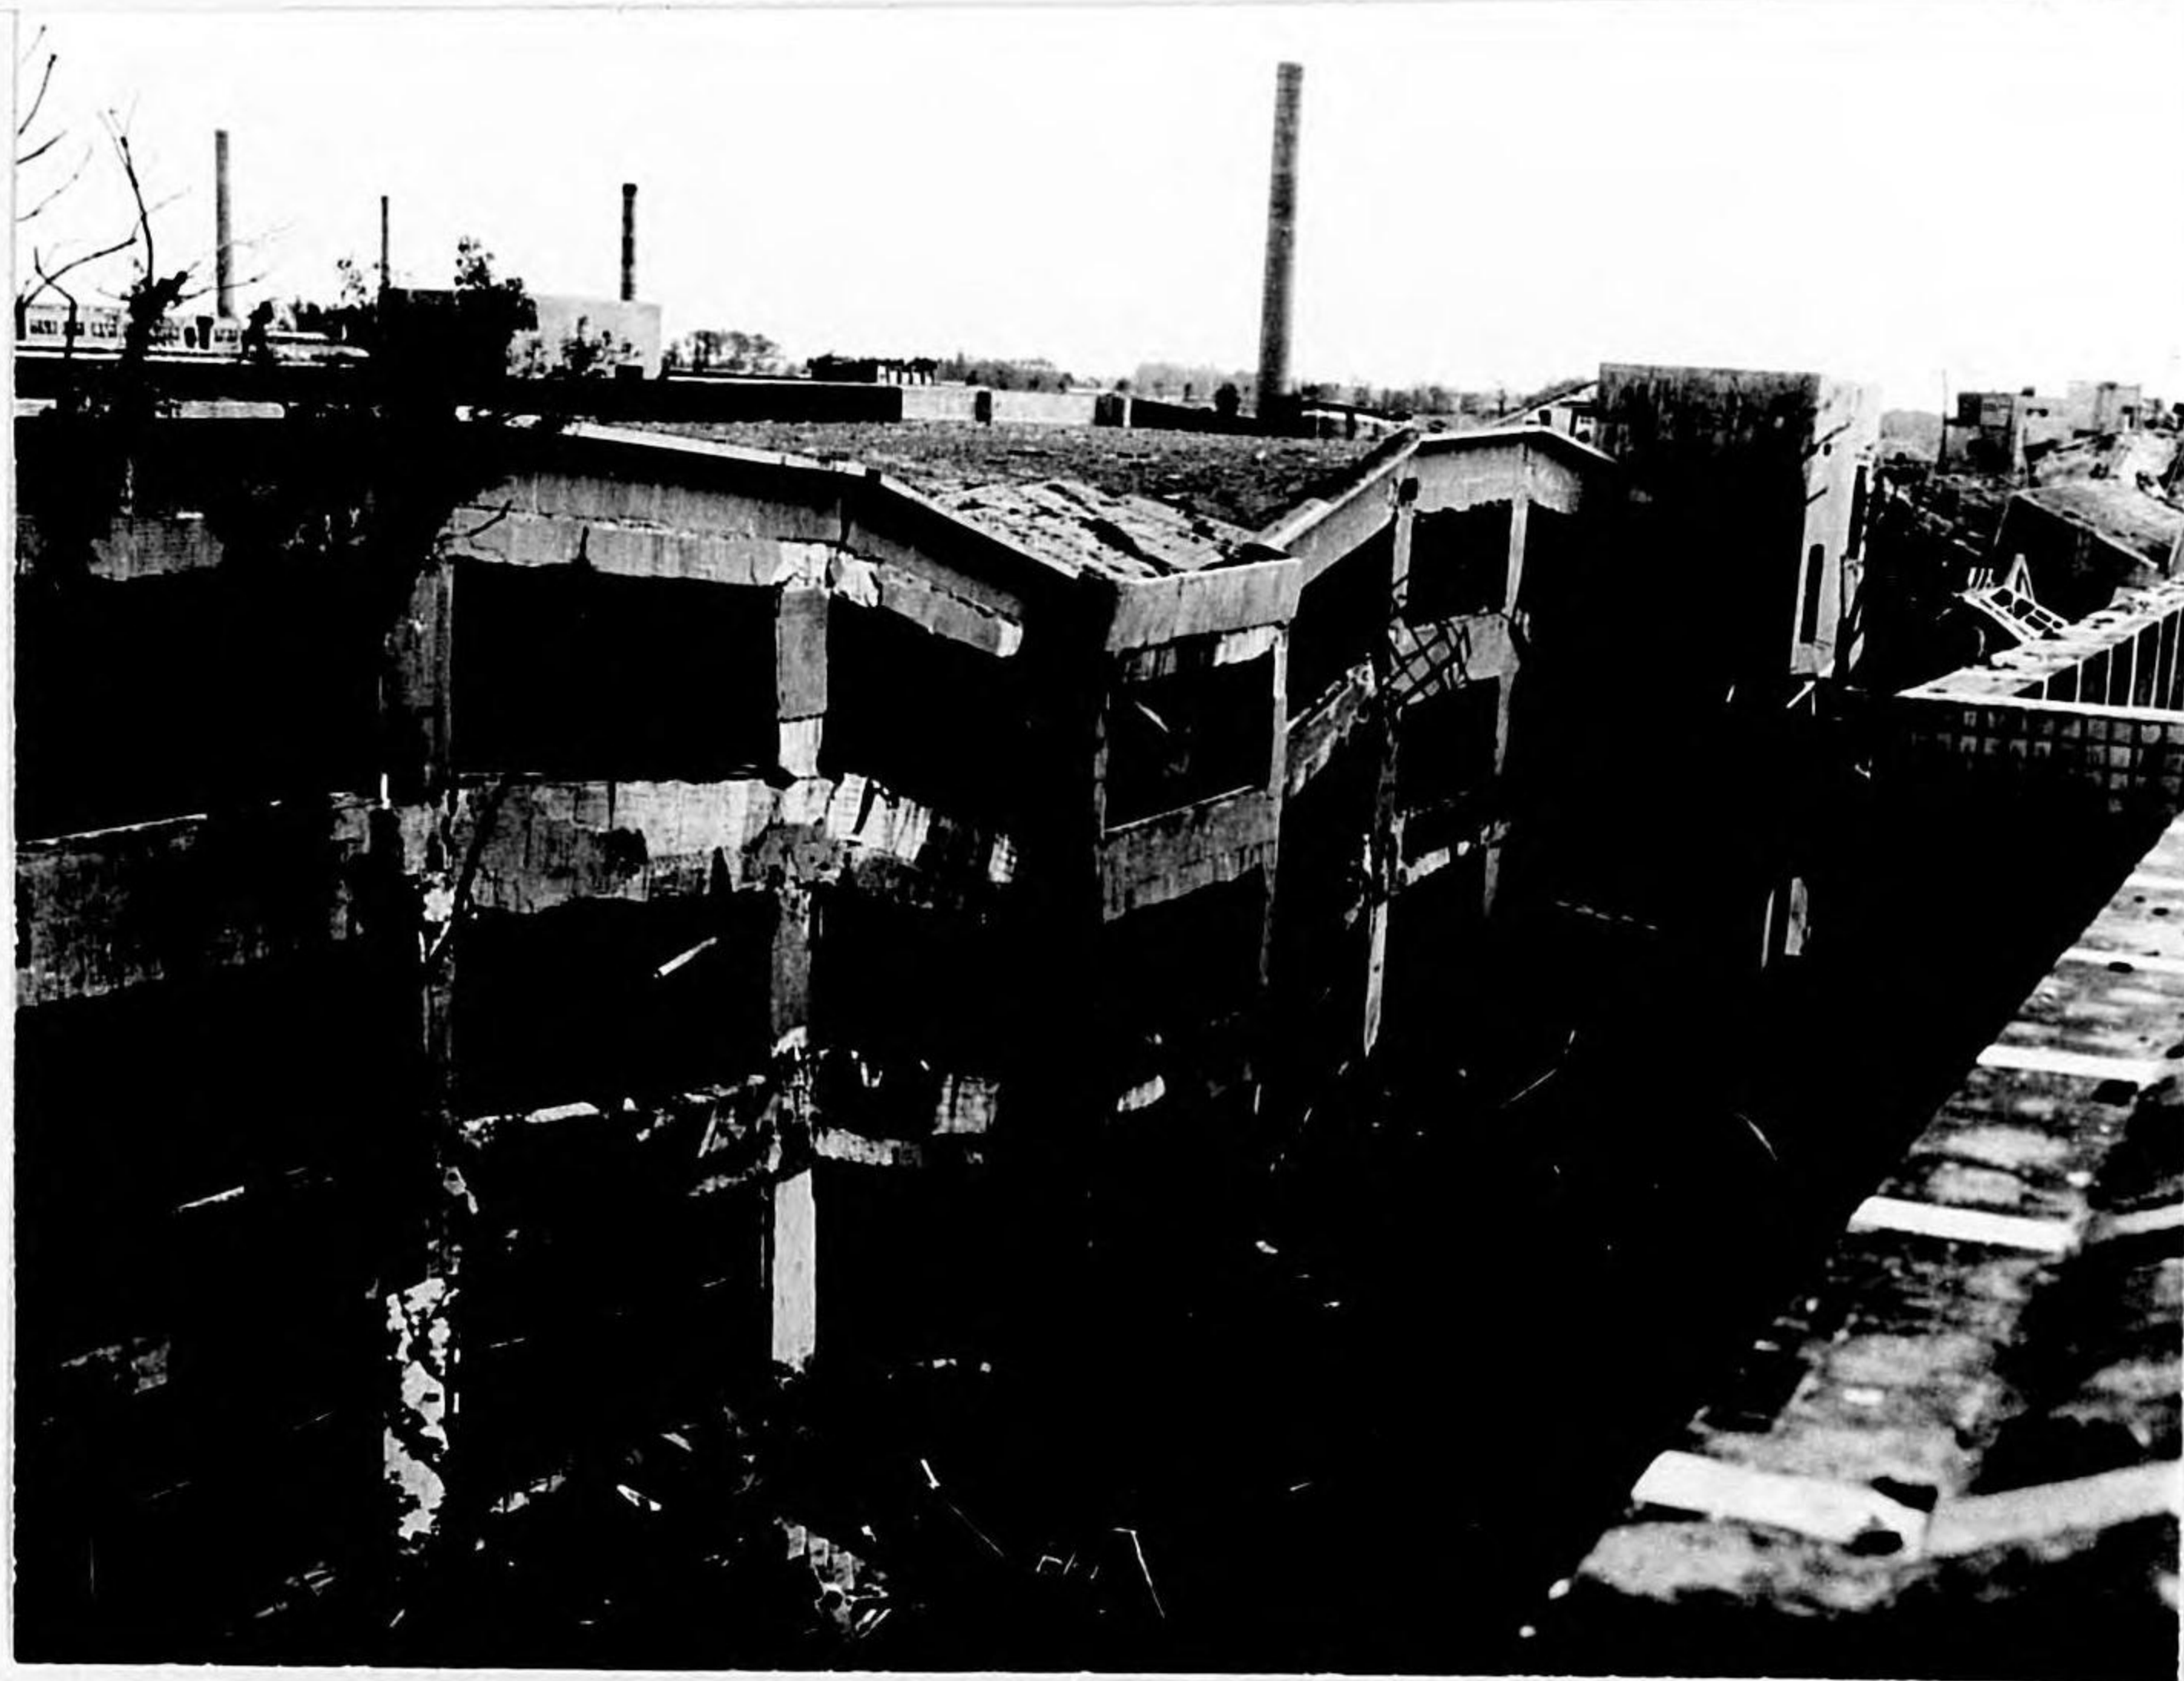
Photo 13

Same view as photo 12 from different angle.

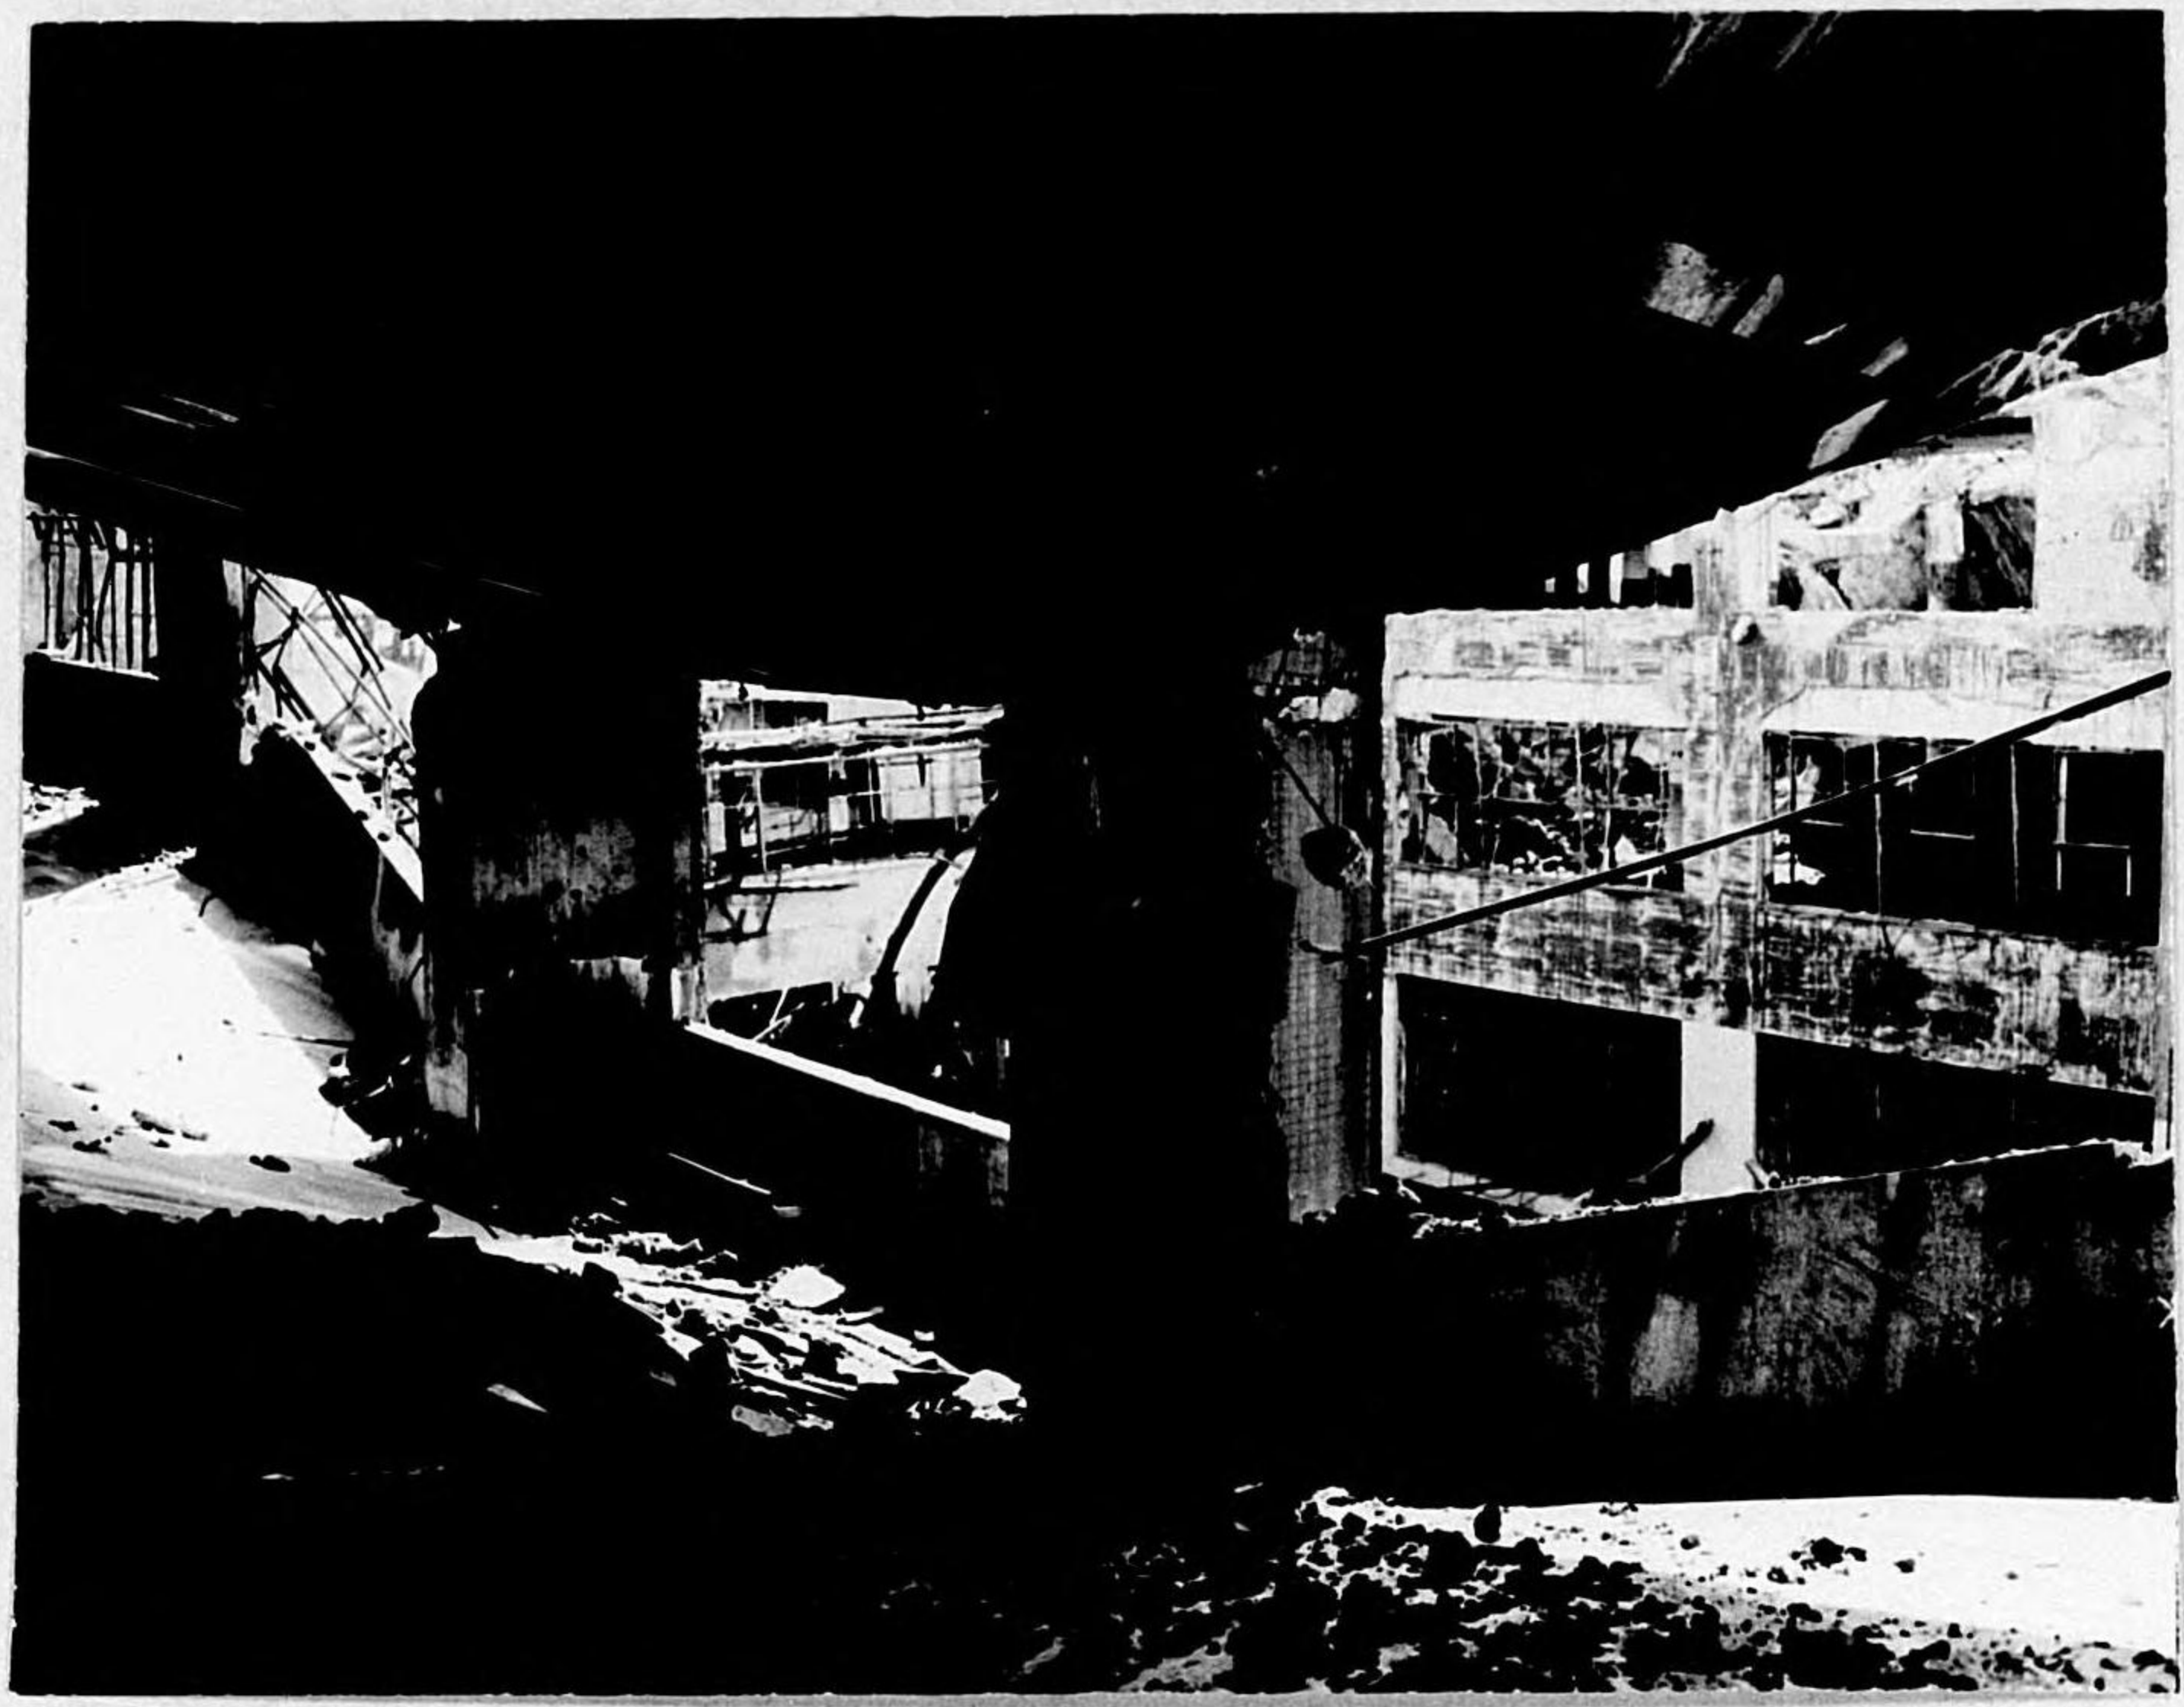
Photo 14

Interior view of failure of columns caused by section dropping into crater of bomb 6.
