FDD #6 NAKAJIMA MUSASHINO (9)

Pack 3 PHOTO LOG - NAKAJIMA - MUSEUM

PHOTO LOC - NAKAJIMA - MUSEUM -

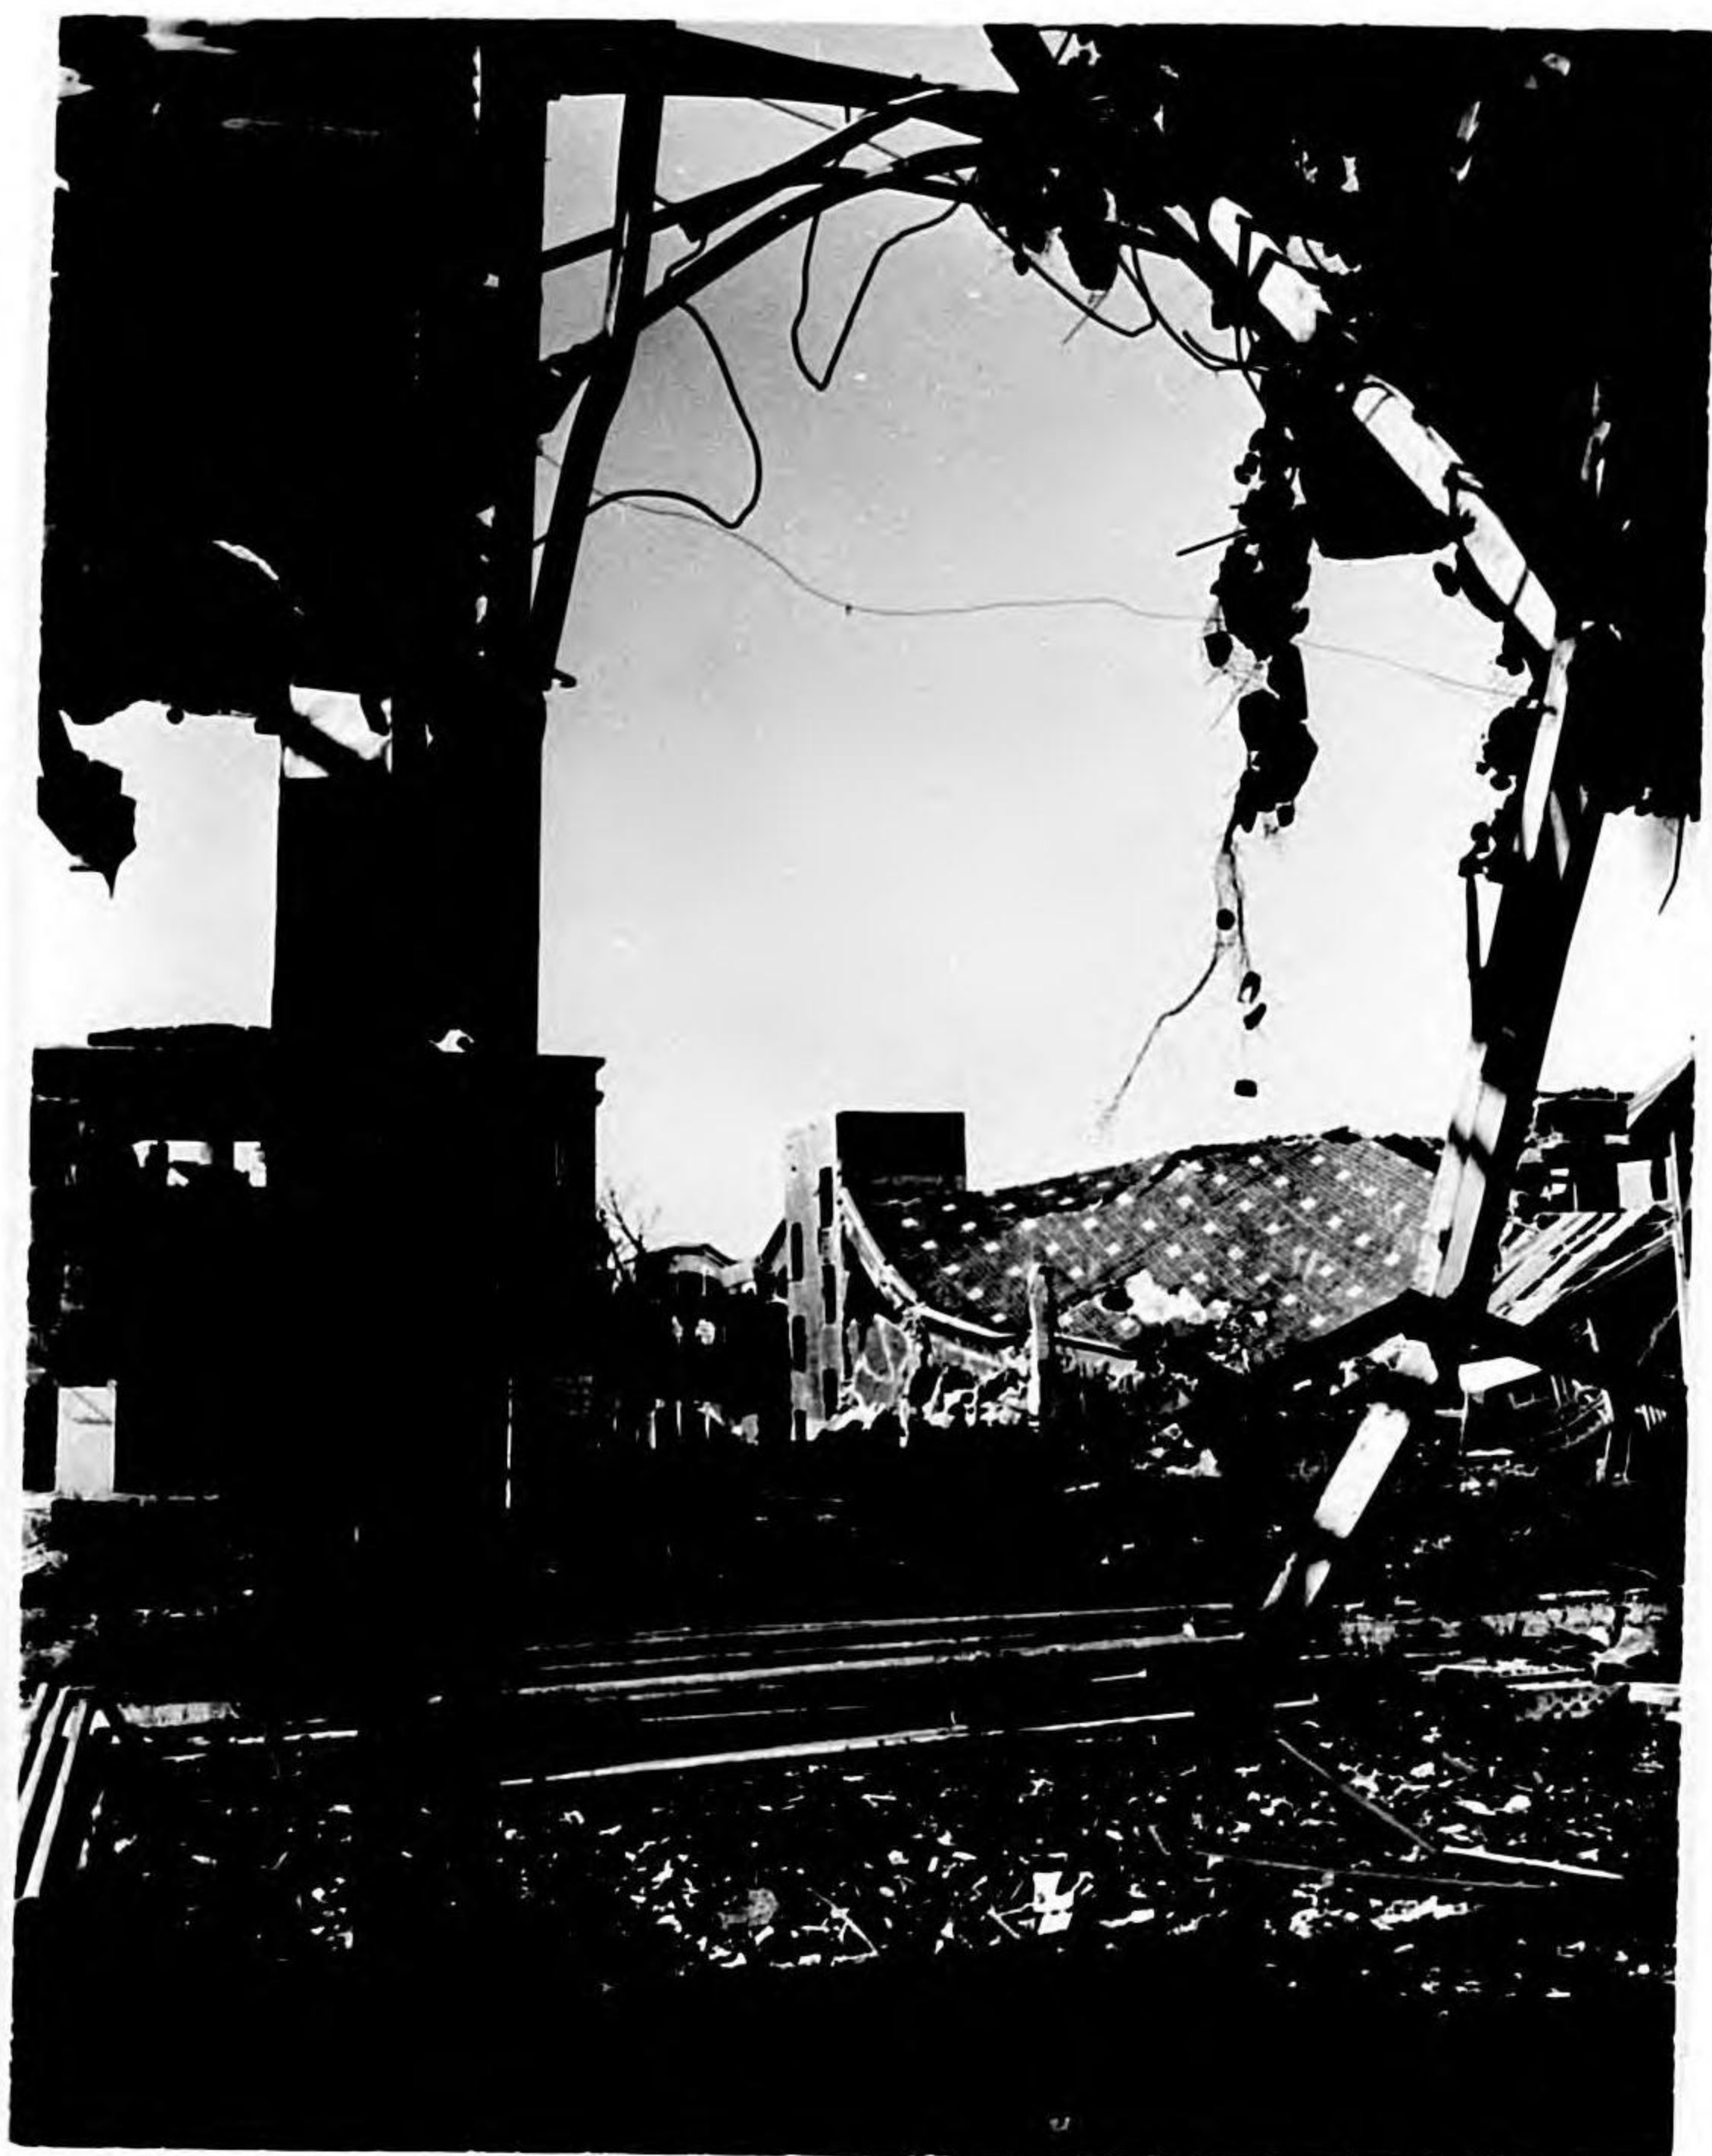
Photo 17

View of building 11-E. Entry point of Bomb 8 in center of picture.

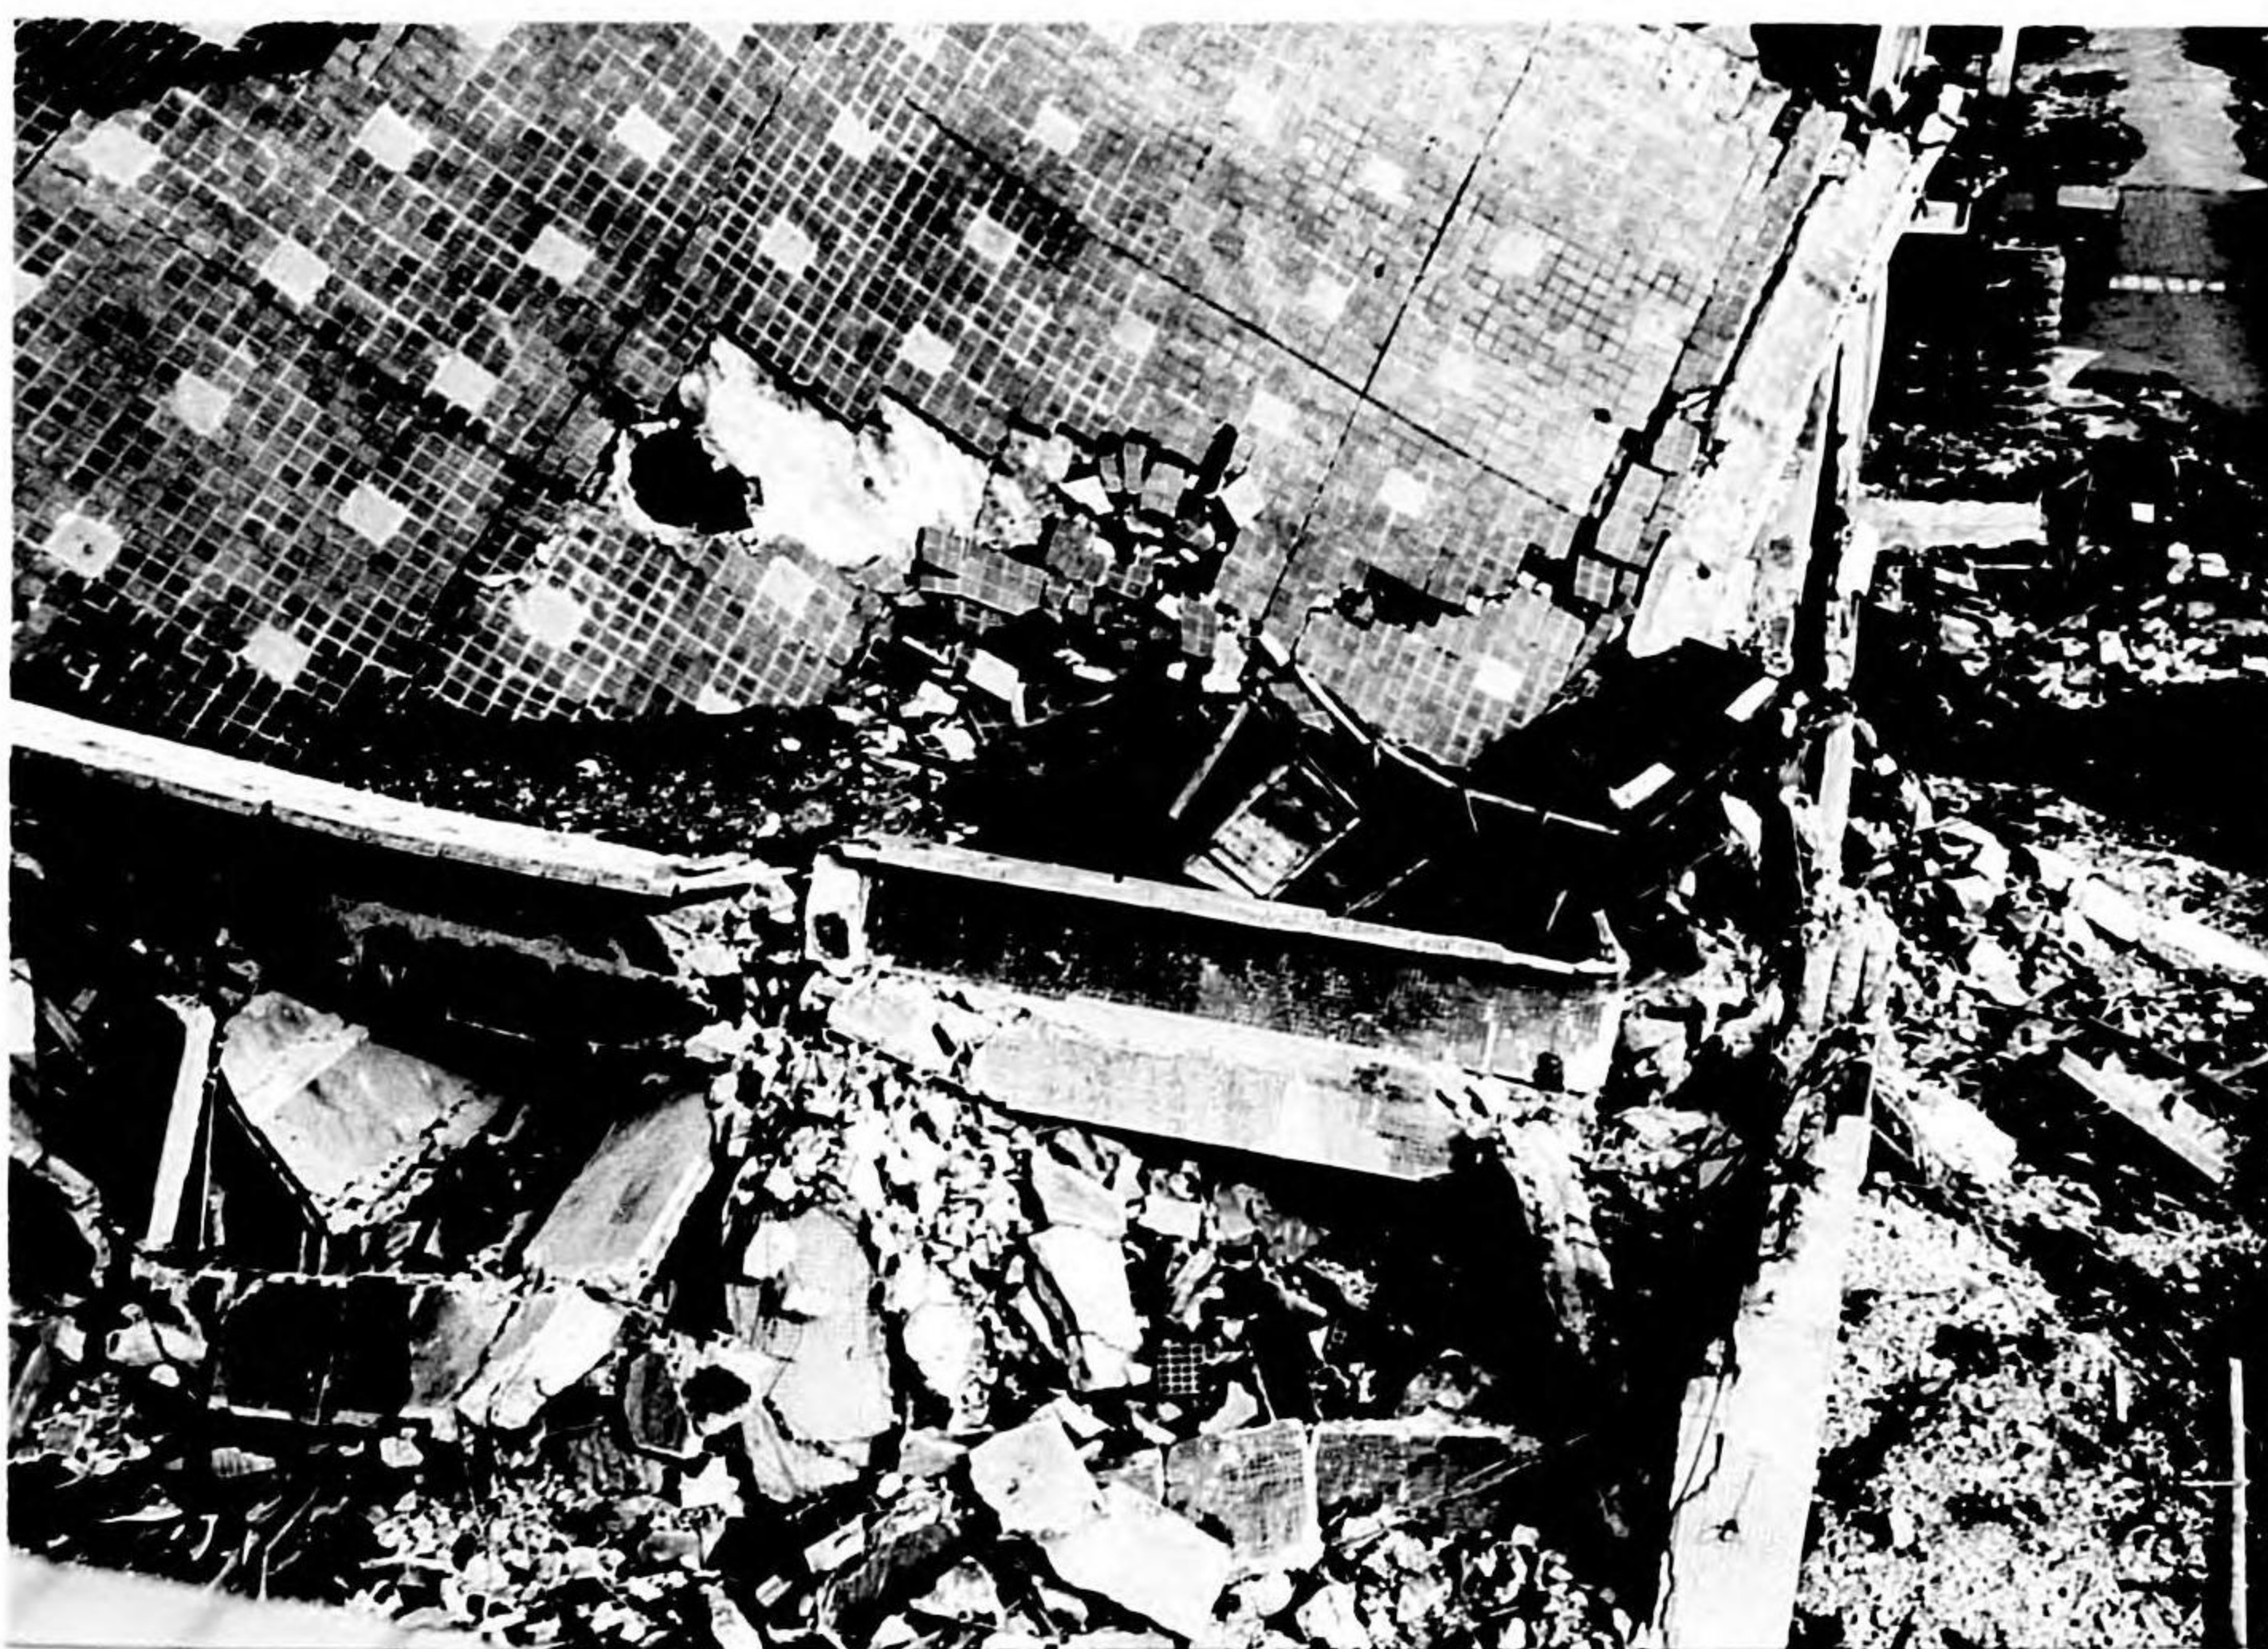
Photo 18

Entry point of Bomb 8 in collapsed roof.

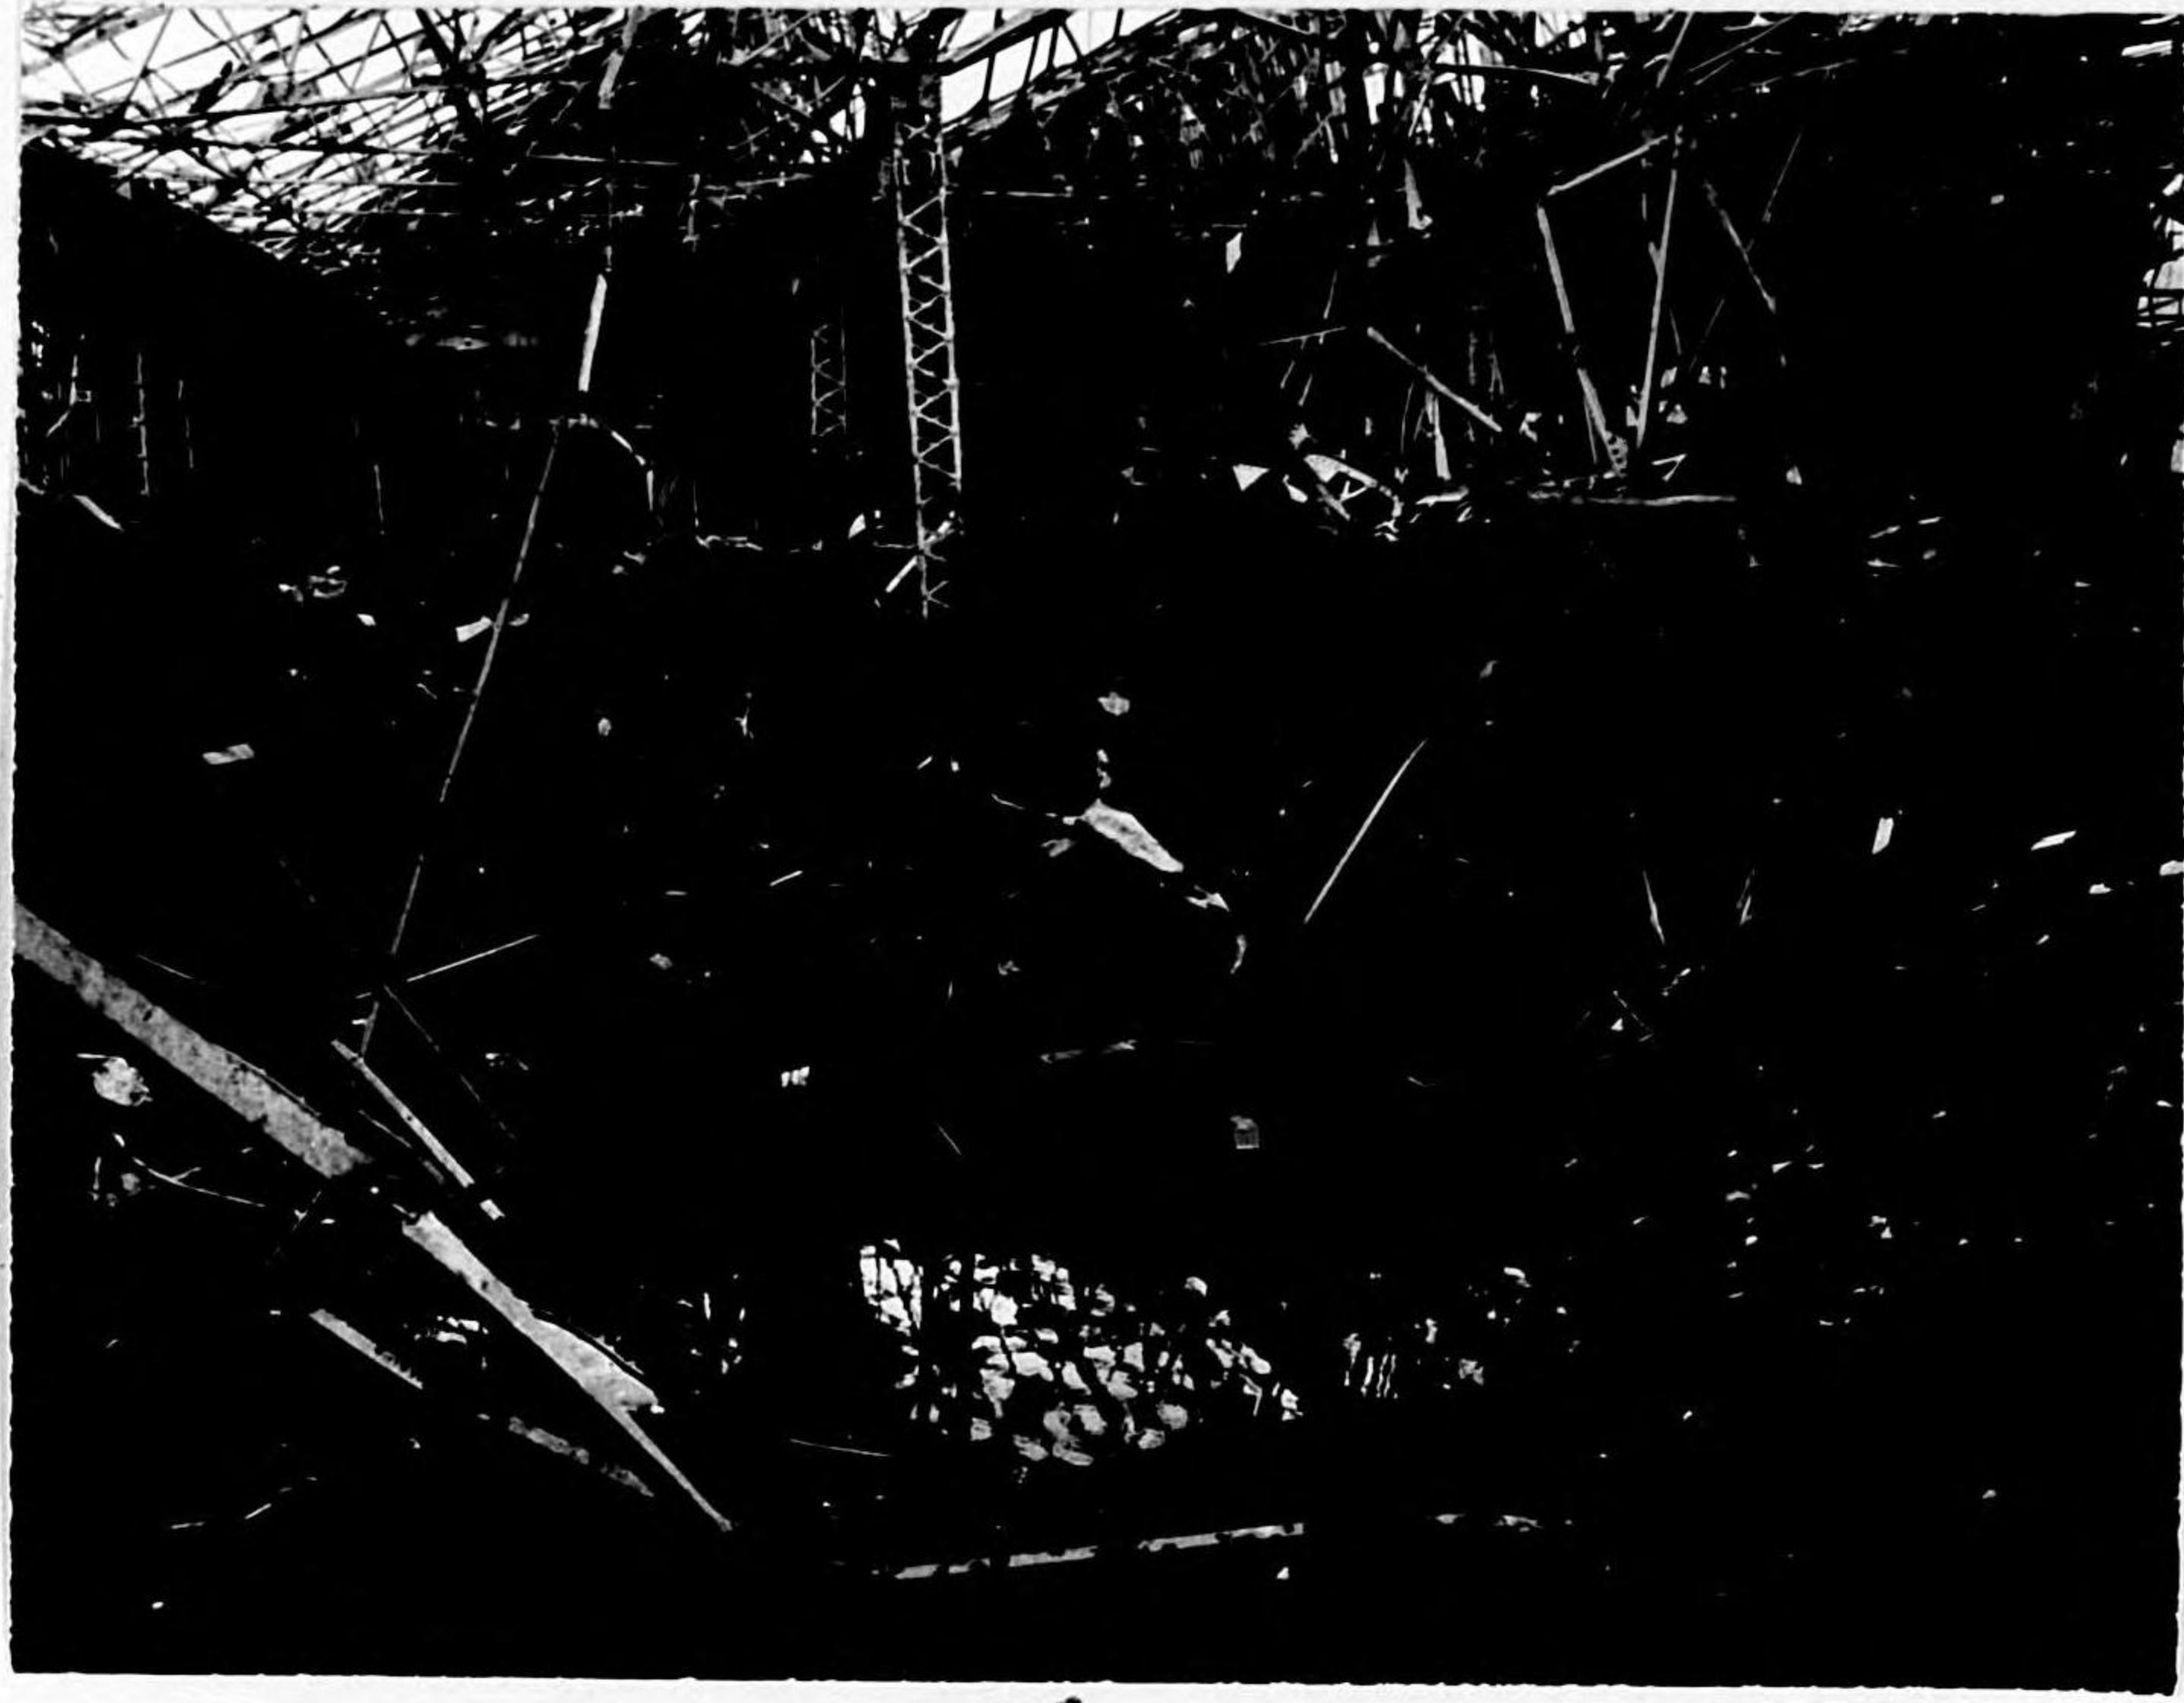
Photo 19
Bomb 9 crater in Building 27.

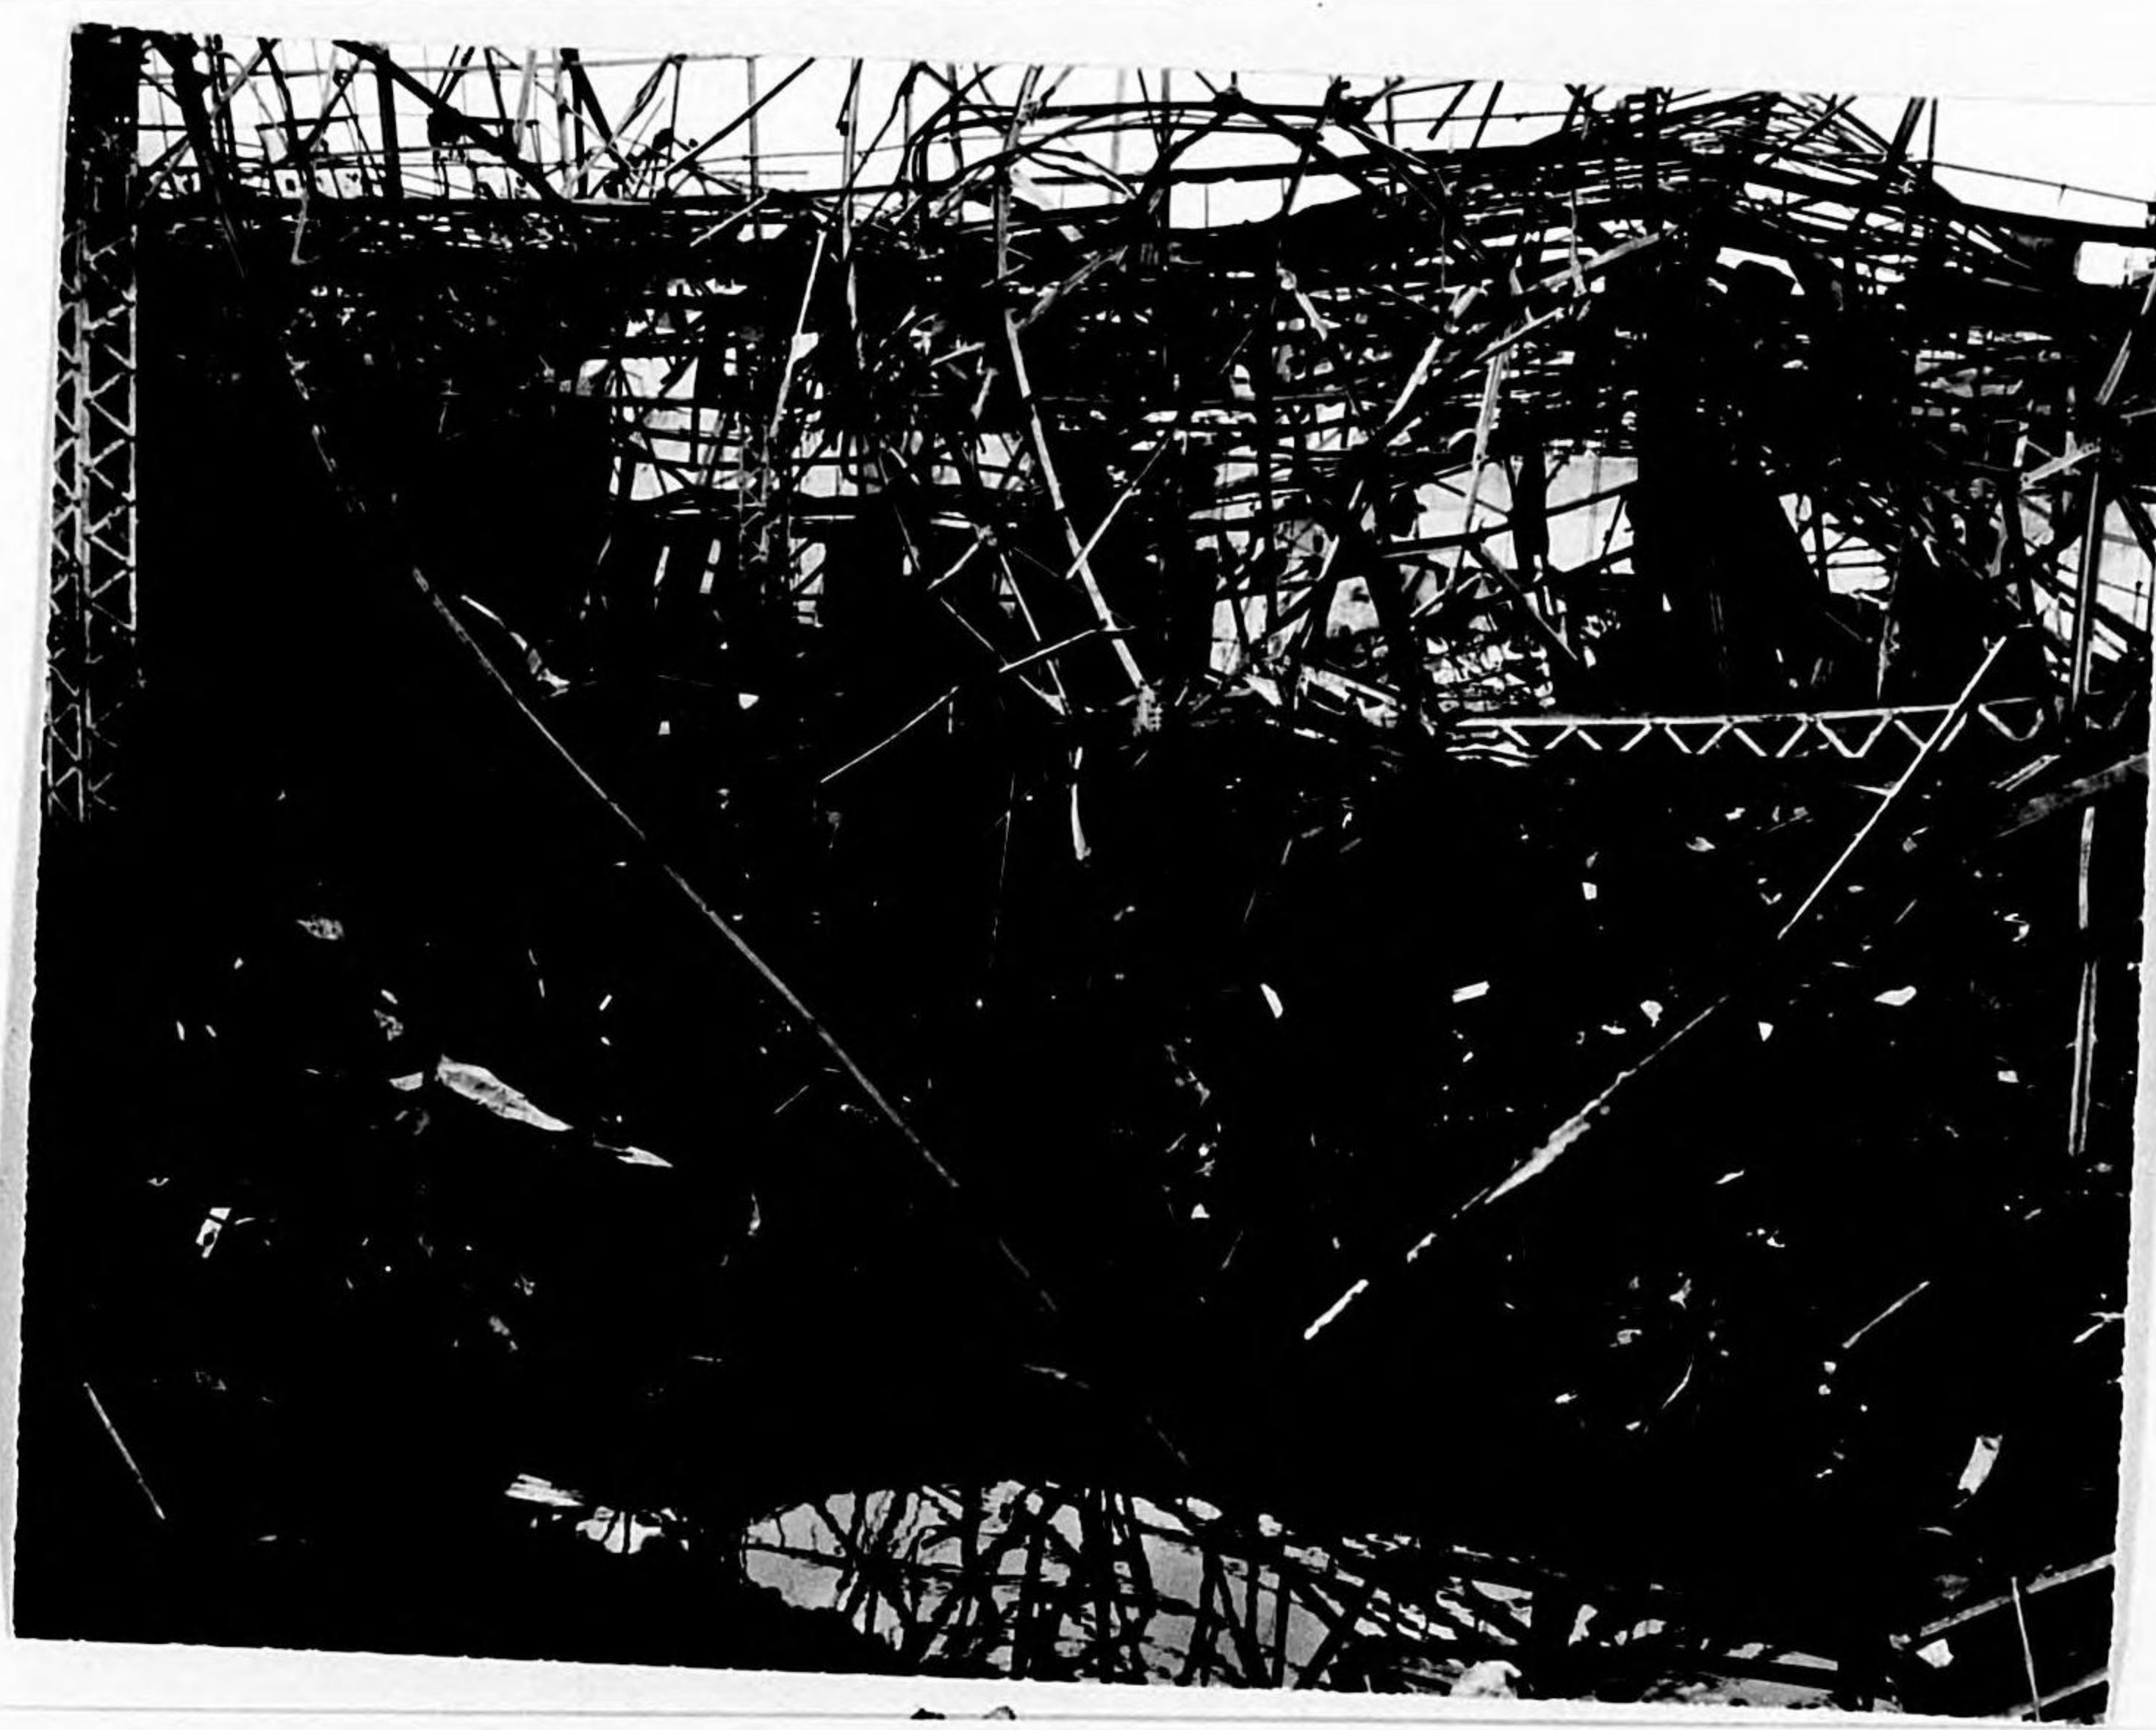
Photo 20
Same as Photo 19 from different angle.

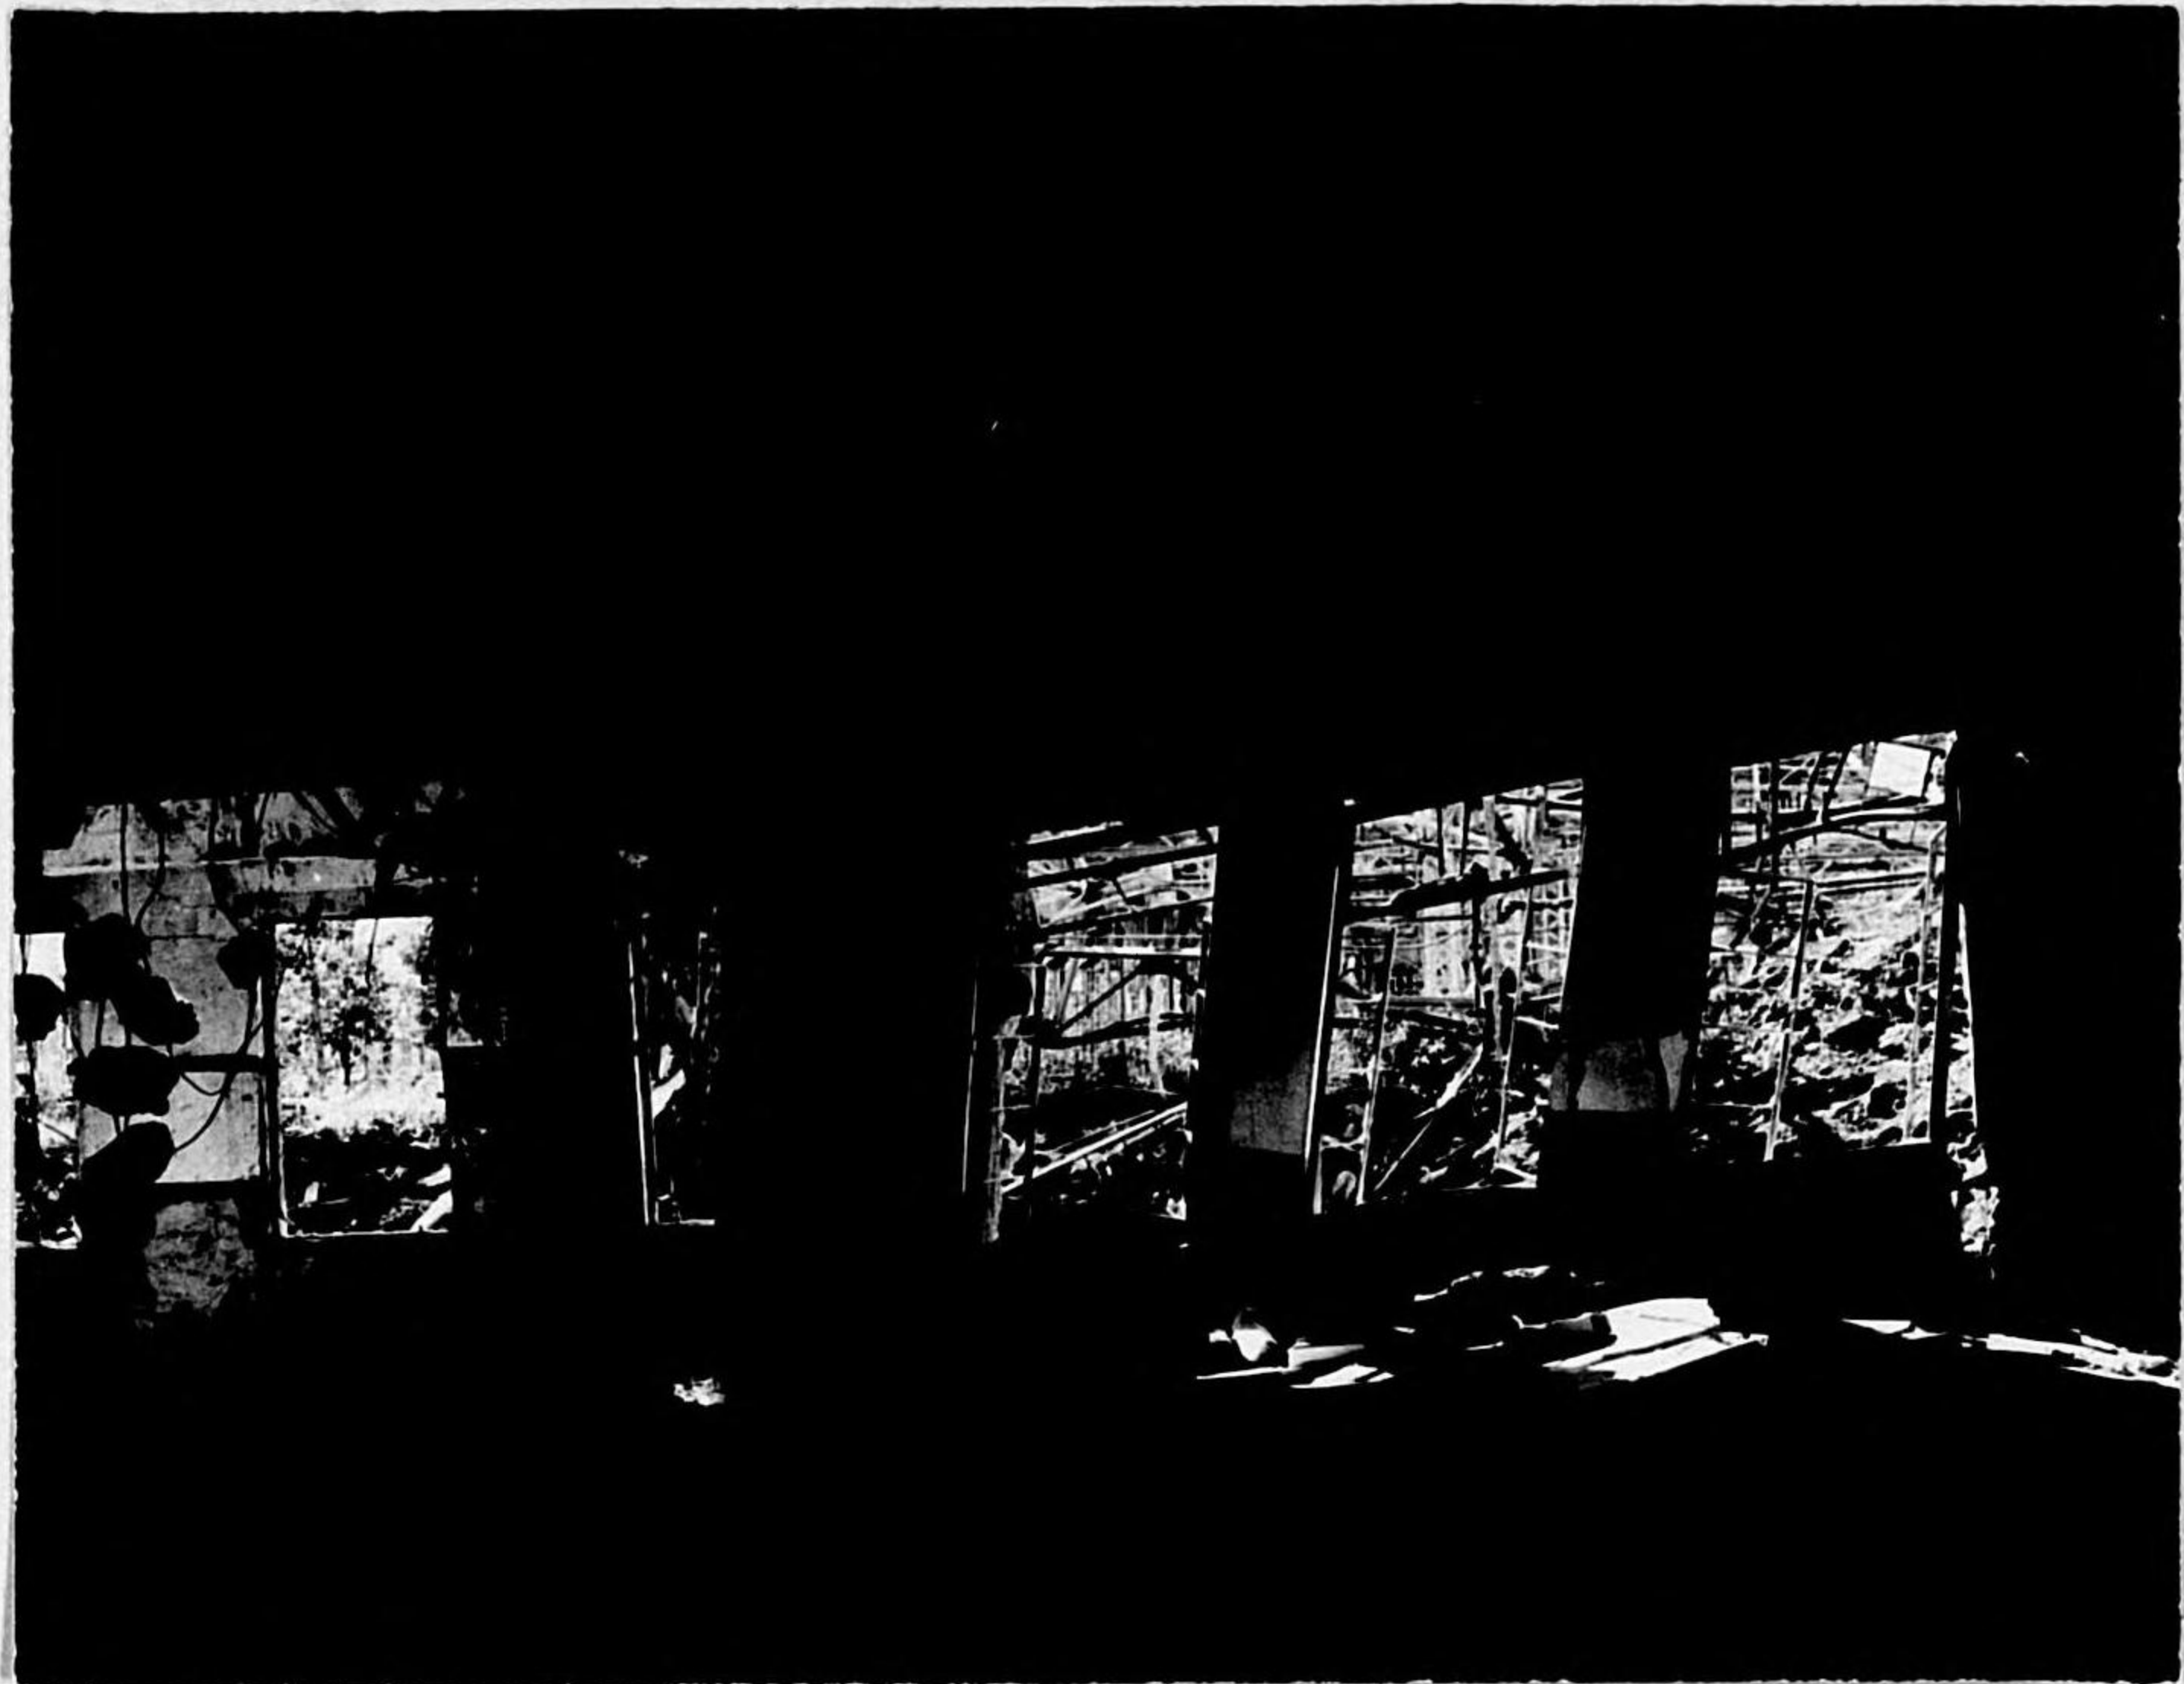
Photo 21

View of inside of south wall of building 28 showing
section dropped in crater of Bomb 10.

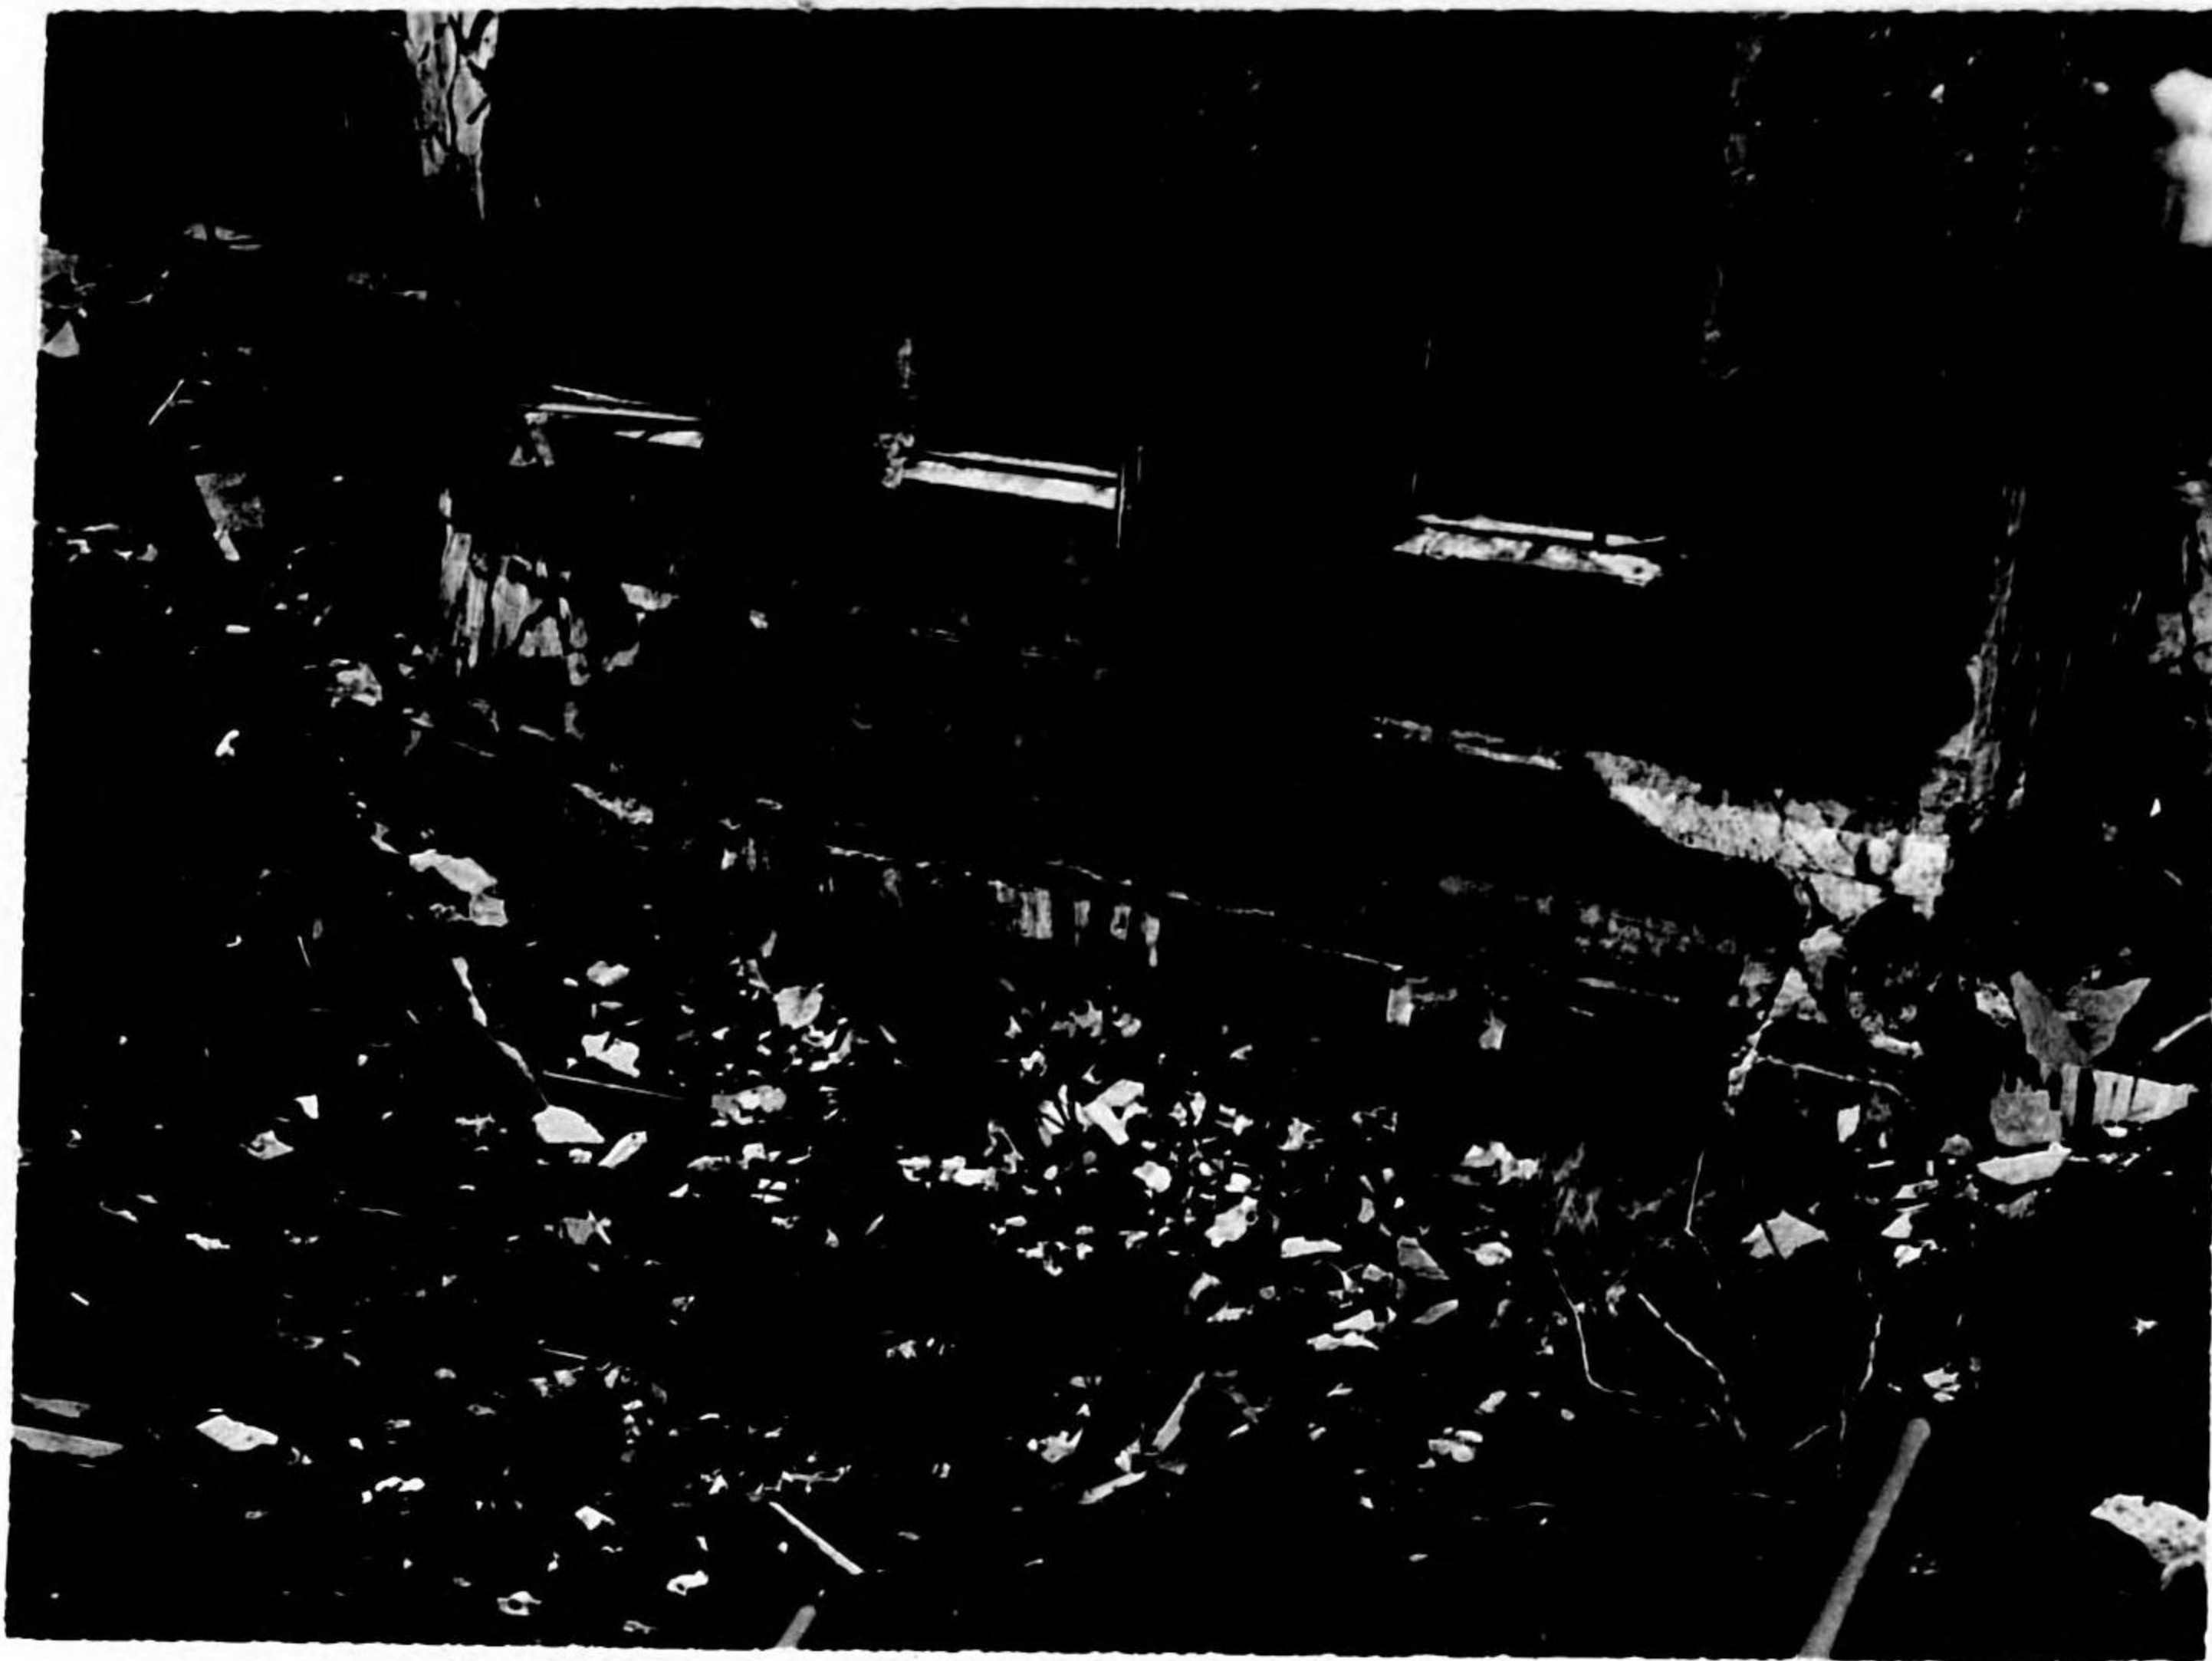
Photo 22

Showing crater of Bomb 10. Note that bomb fell on outside of building and tunneled under grade beam before exploding.
