FDD #6 NAKAJIMA MUSASHINO (9)

Pack 3 PHOTO LOG - NAKAJIMA - MUSEUM

PHOTO LOC - NAKAJIMA - MUSEUM -

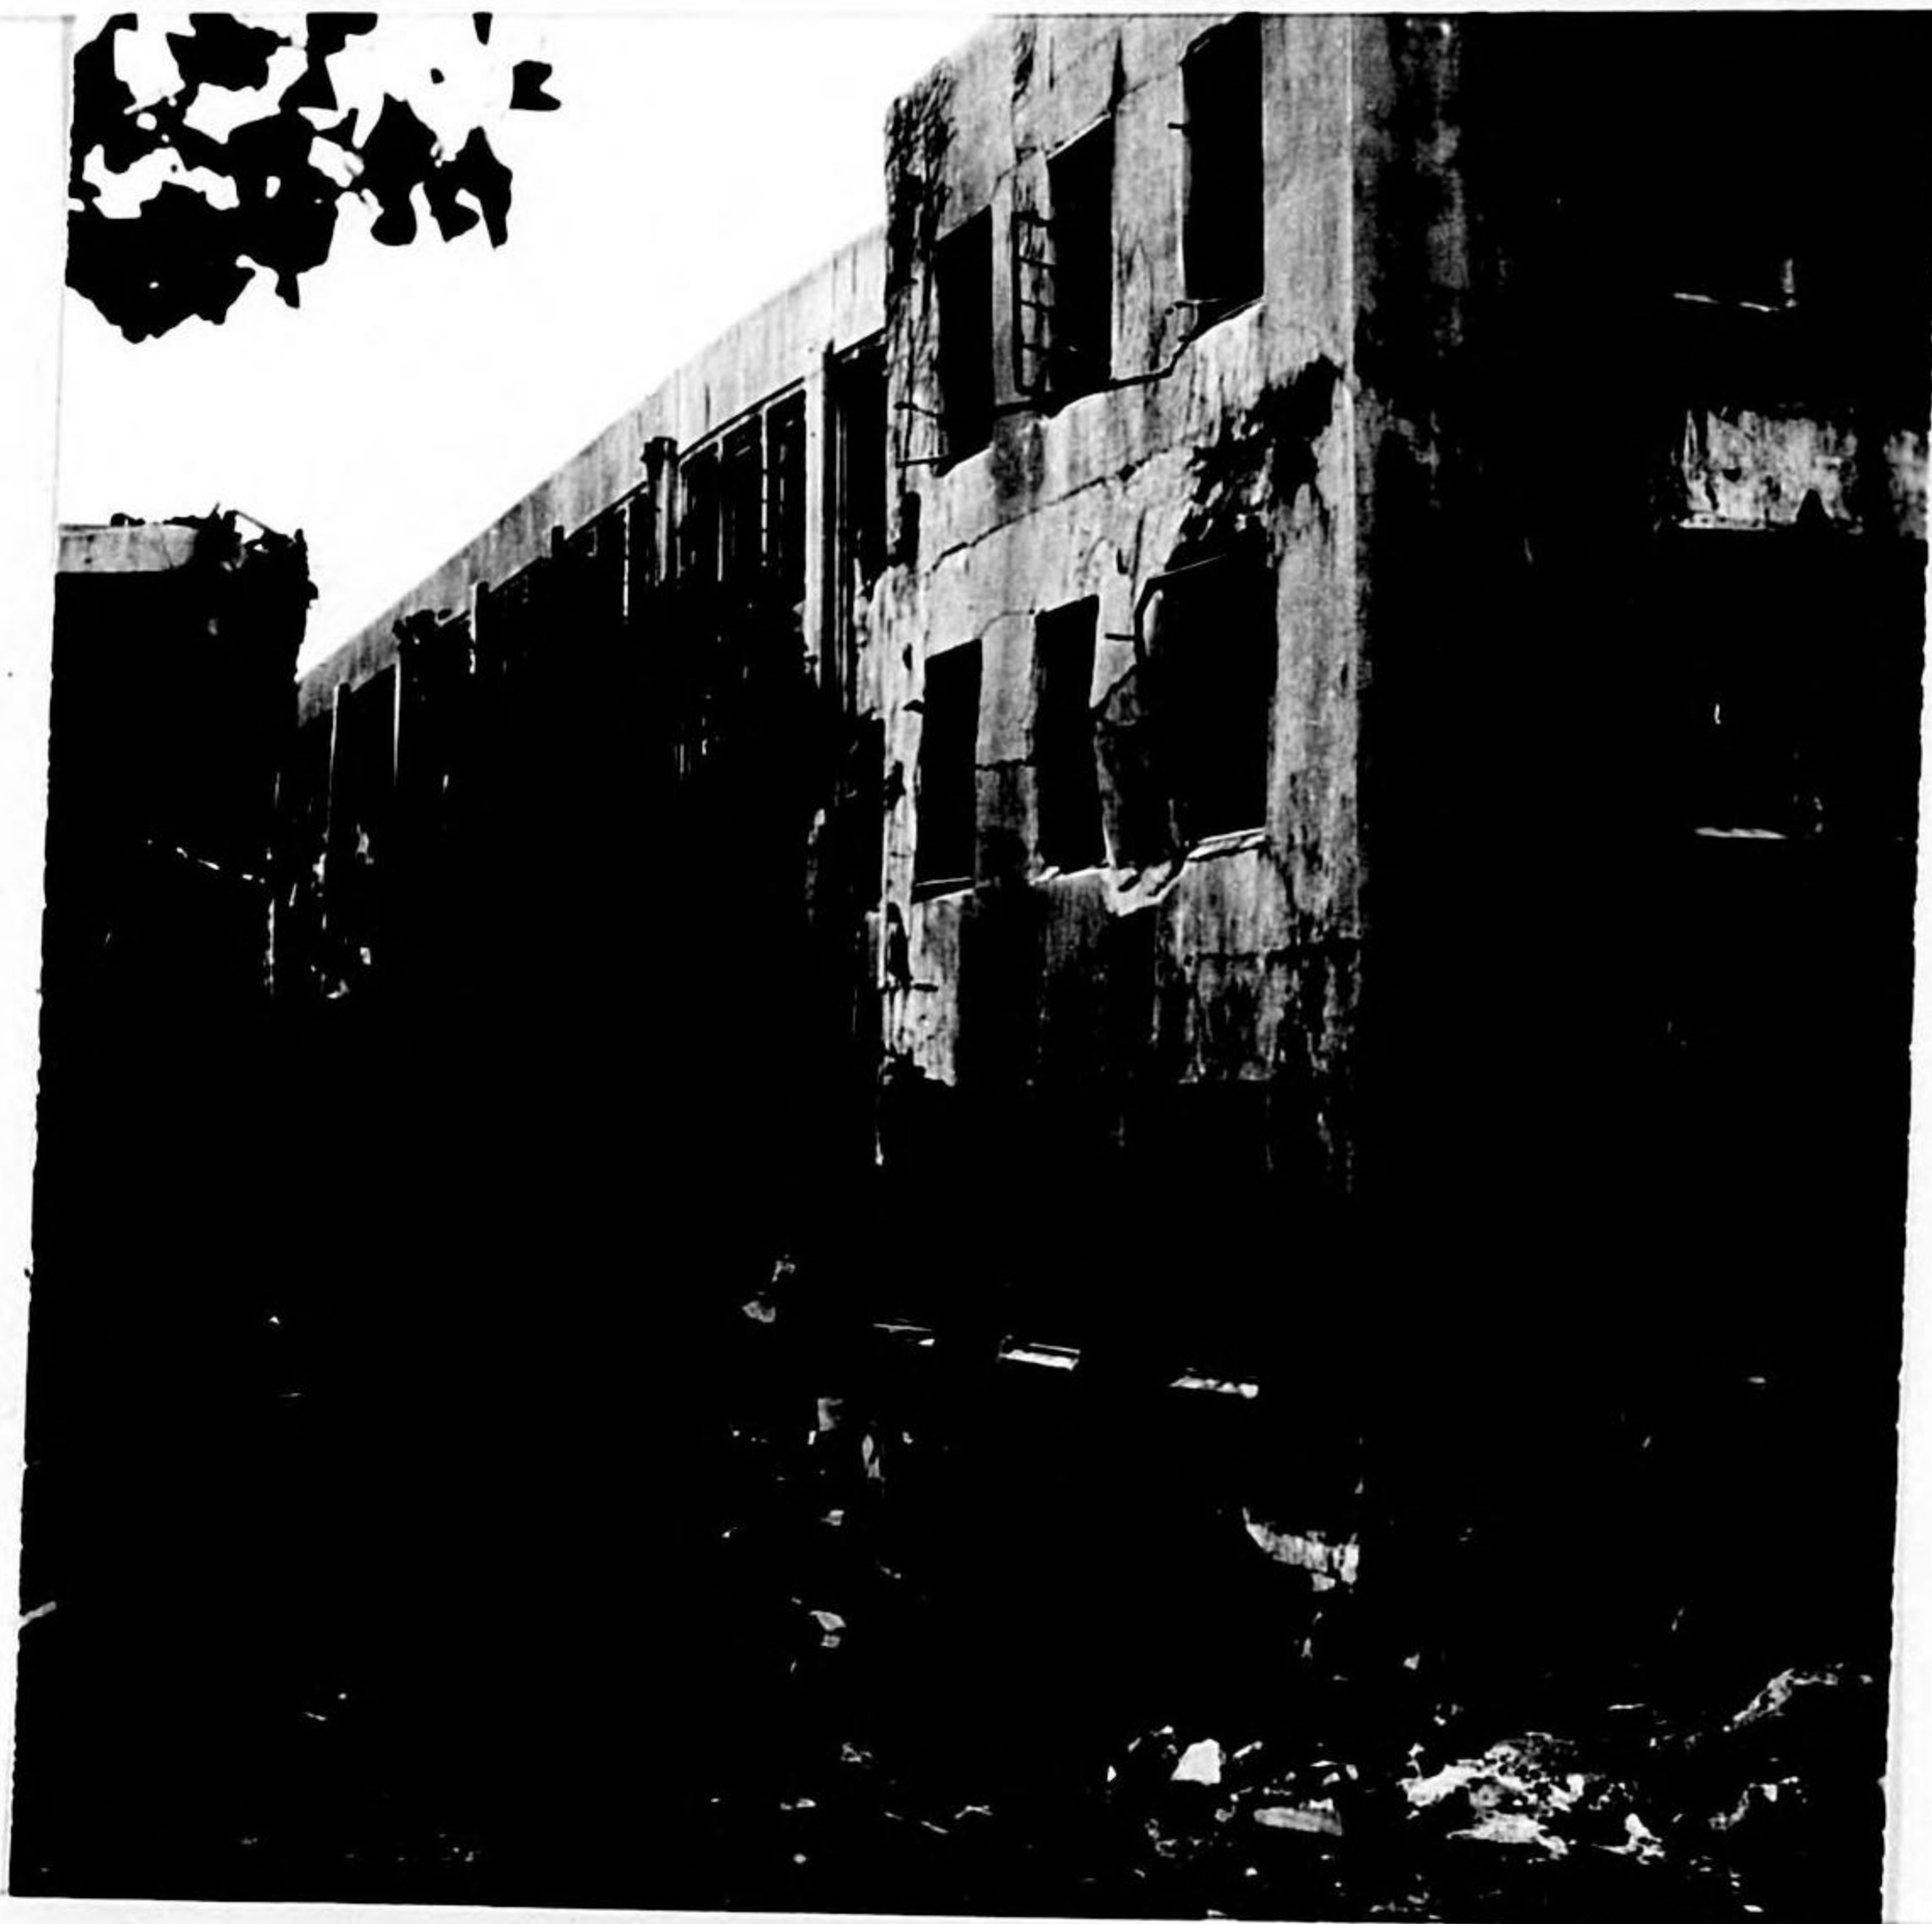
Photo 23

View showing south wall of Building 28 above crater of Bomb 10.

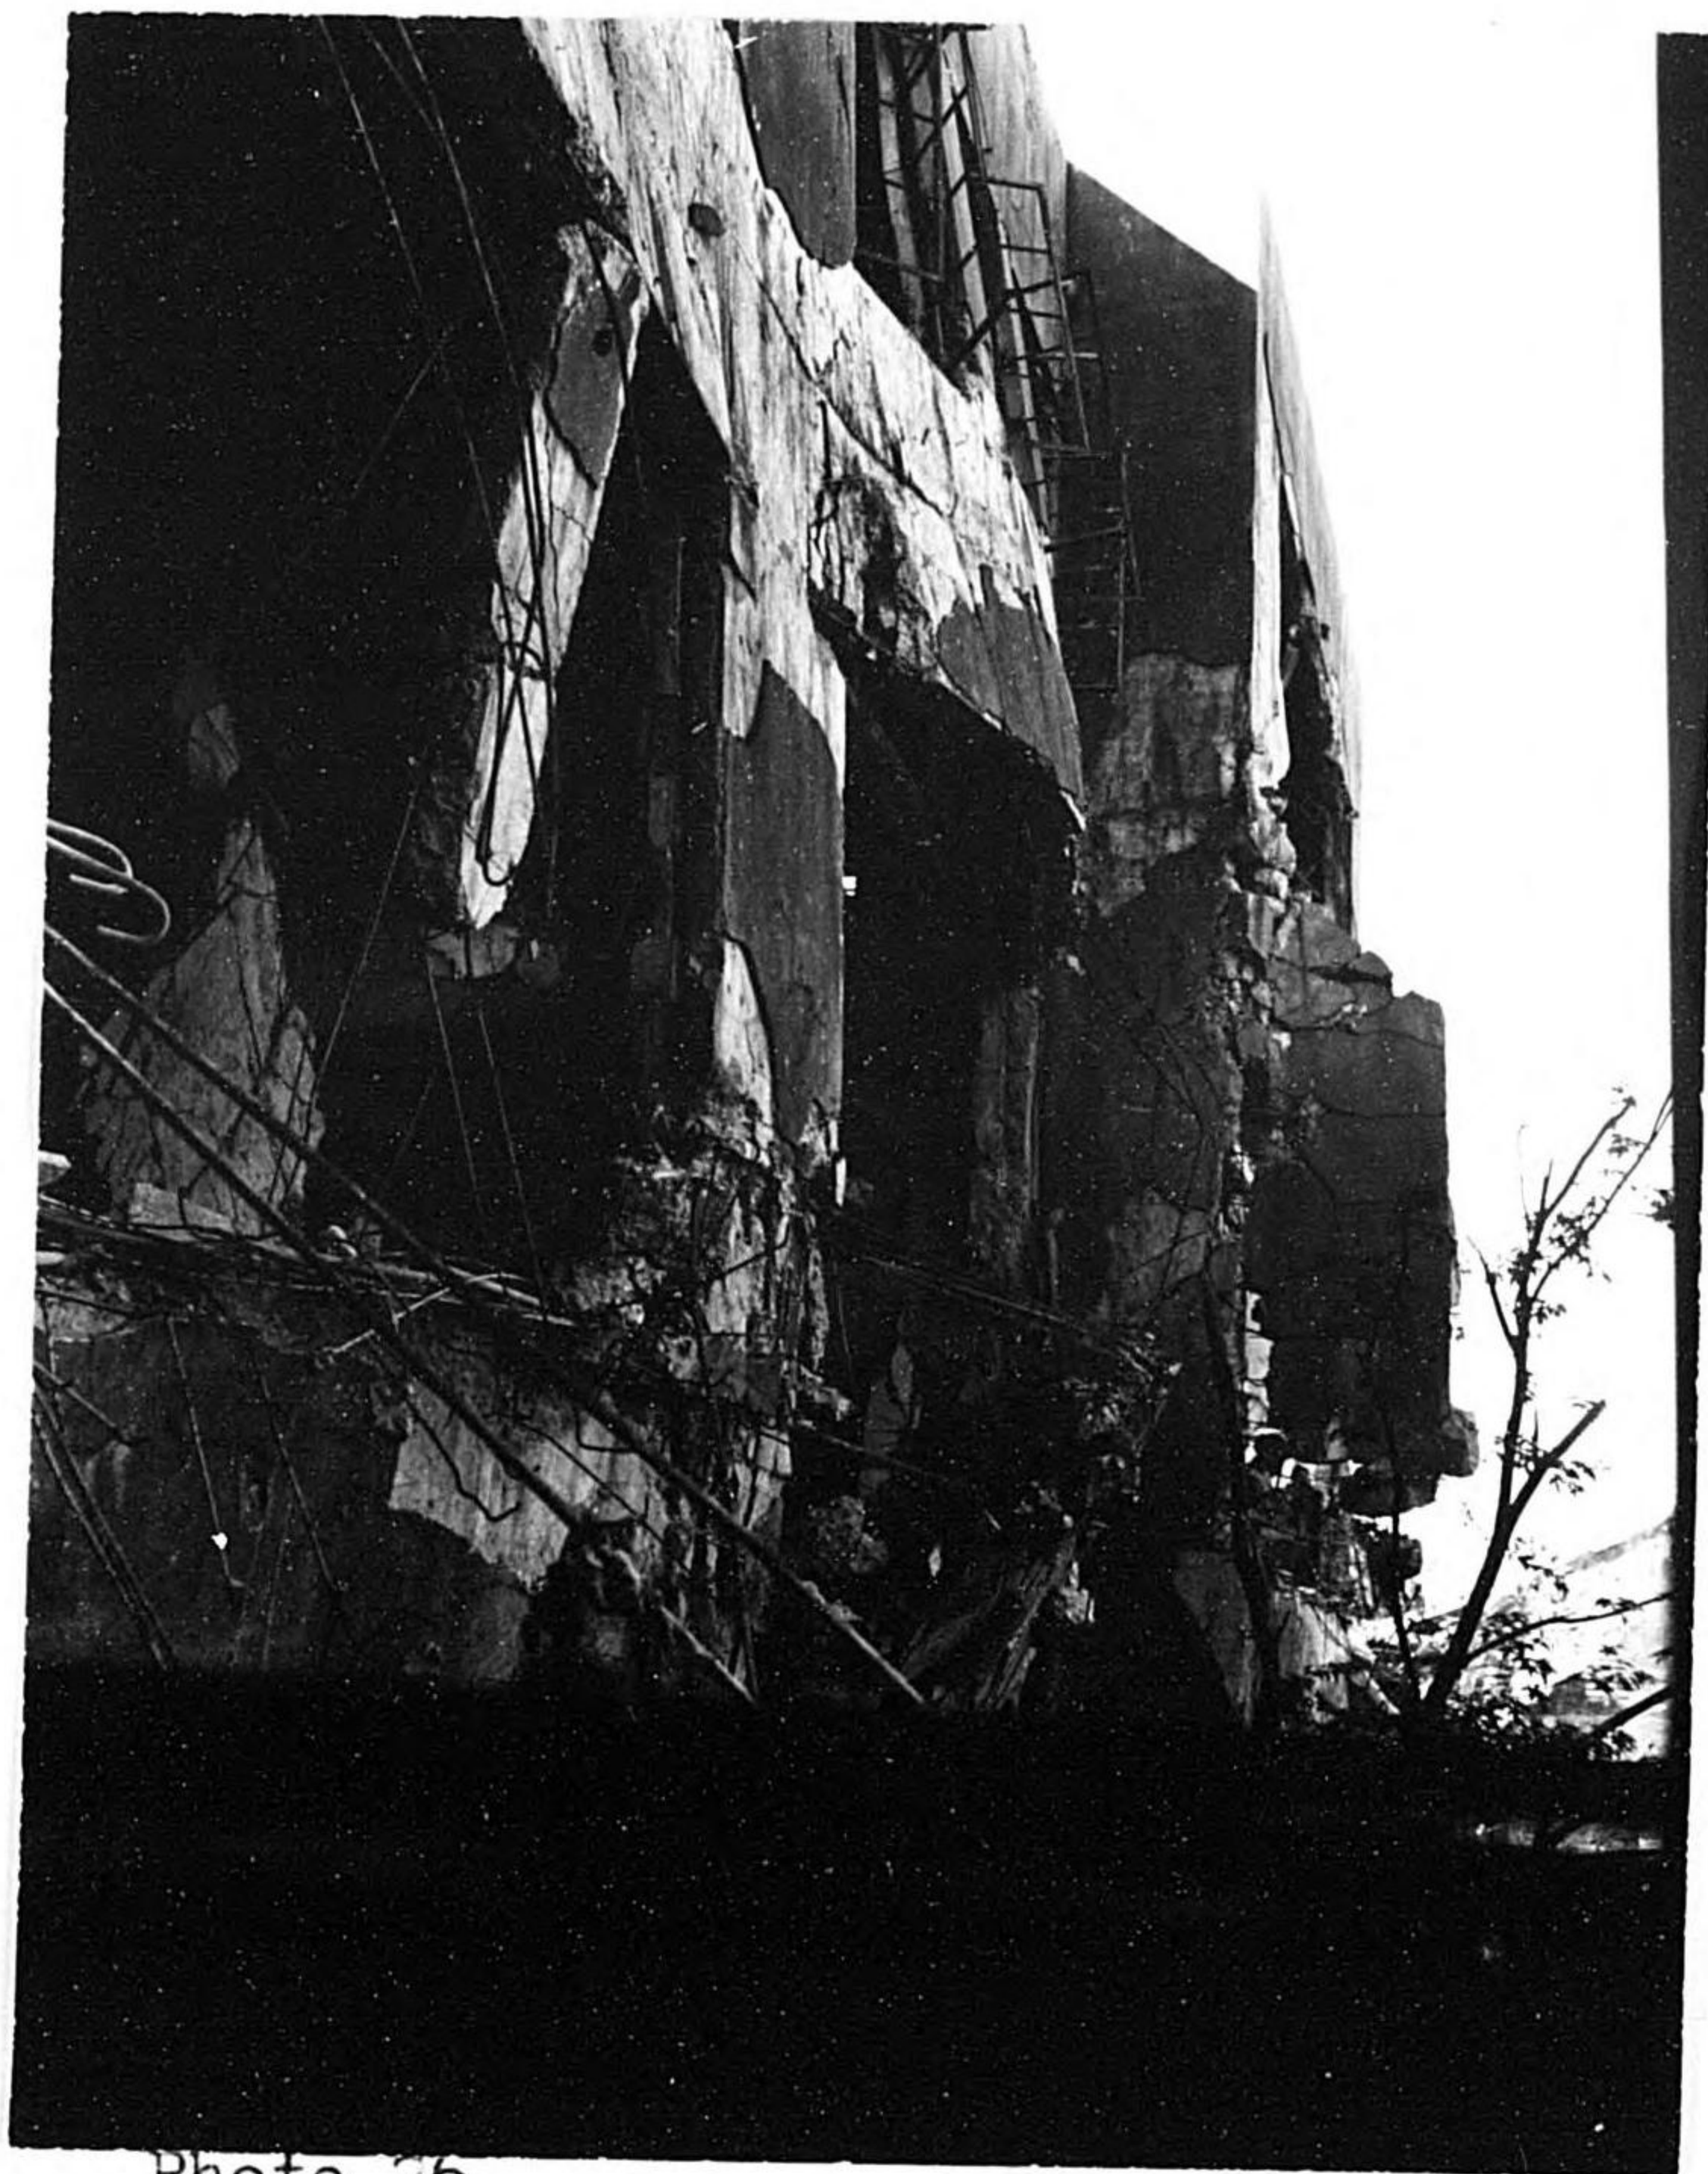
Photo 26

Outside view of same wall shown in photo 25.

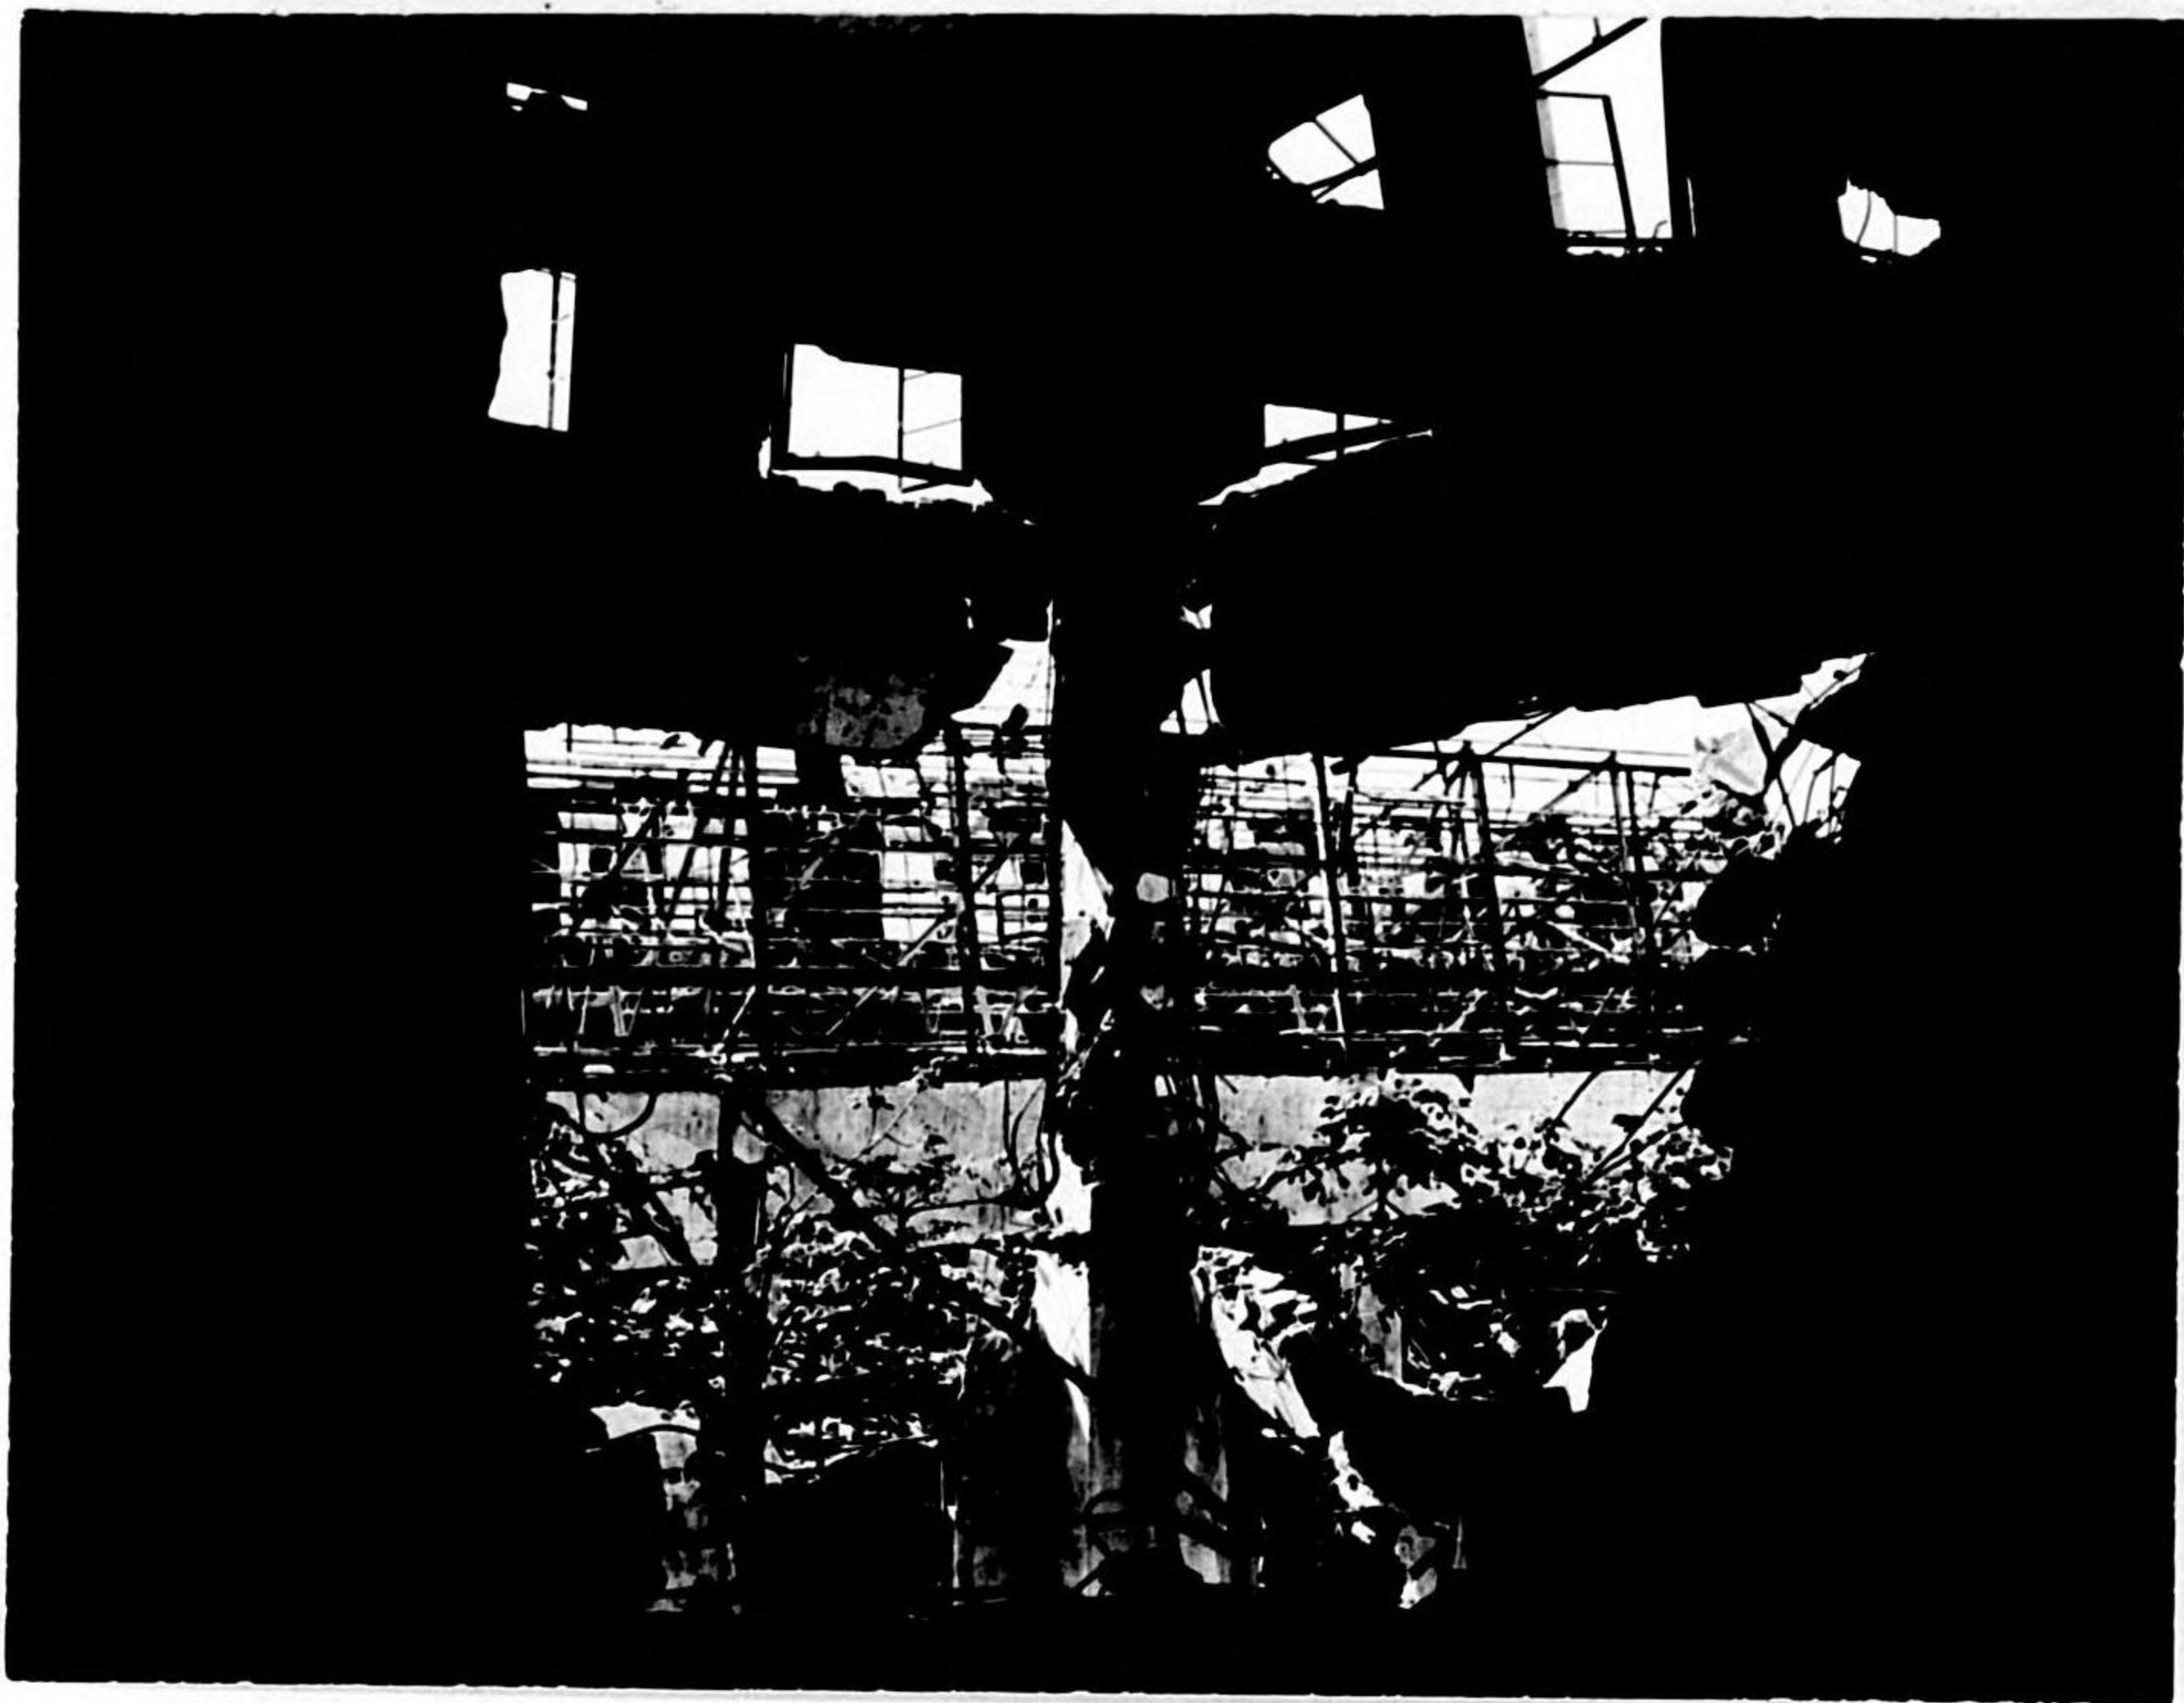
Photo 33

Interior view of southwest corner of Building 28.

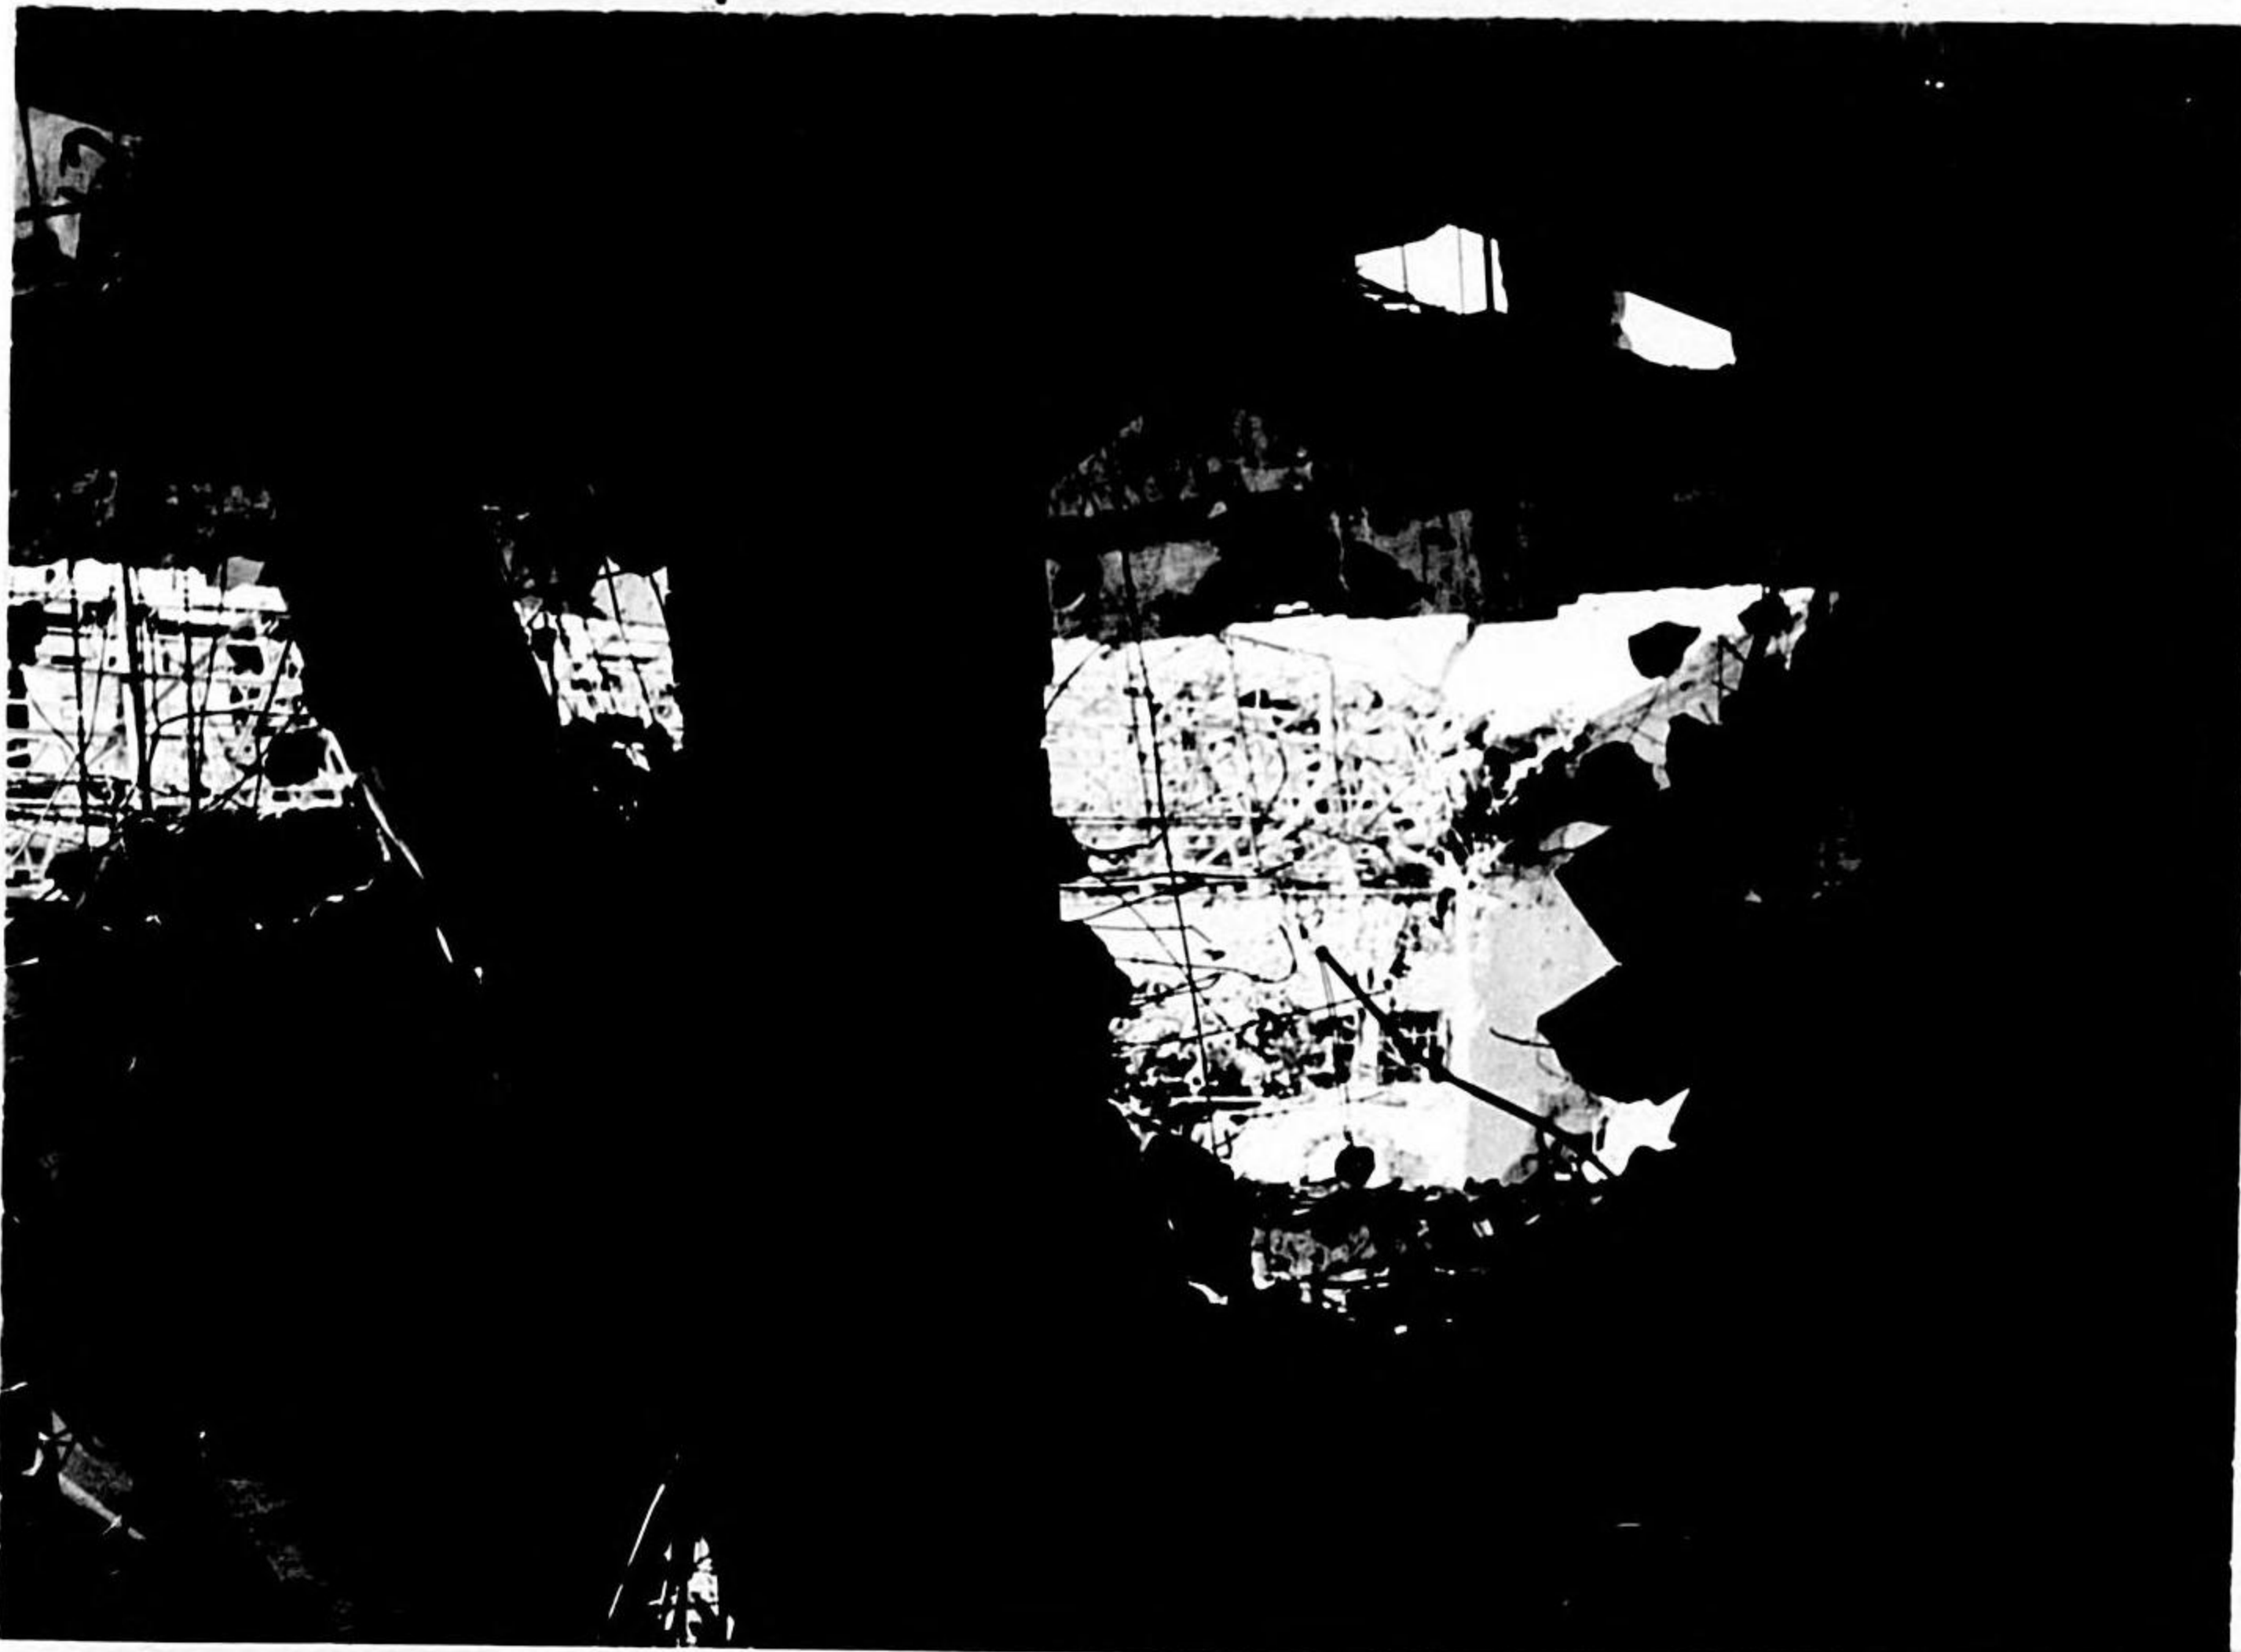
Photo 34

View of columns immediately west of the two entirely removed as shown in Photo 30.

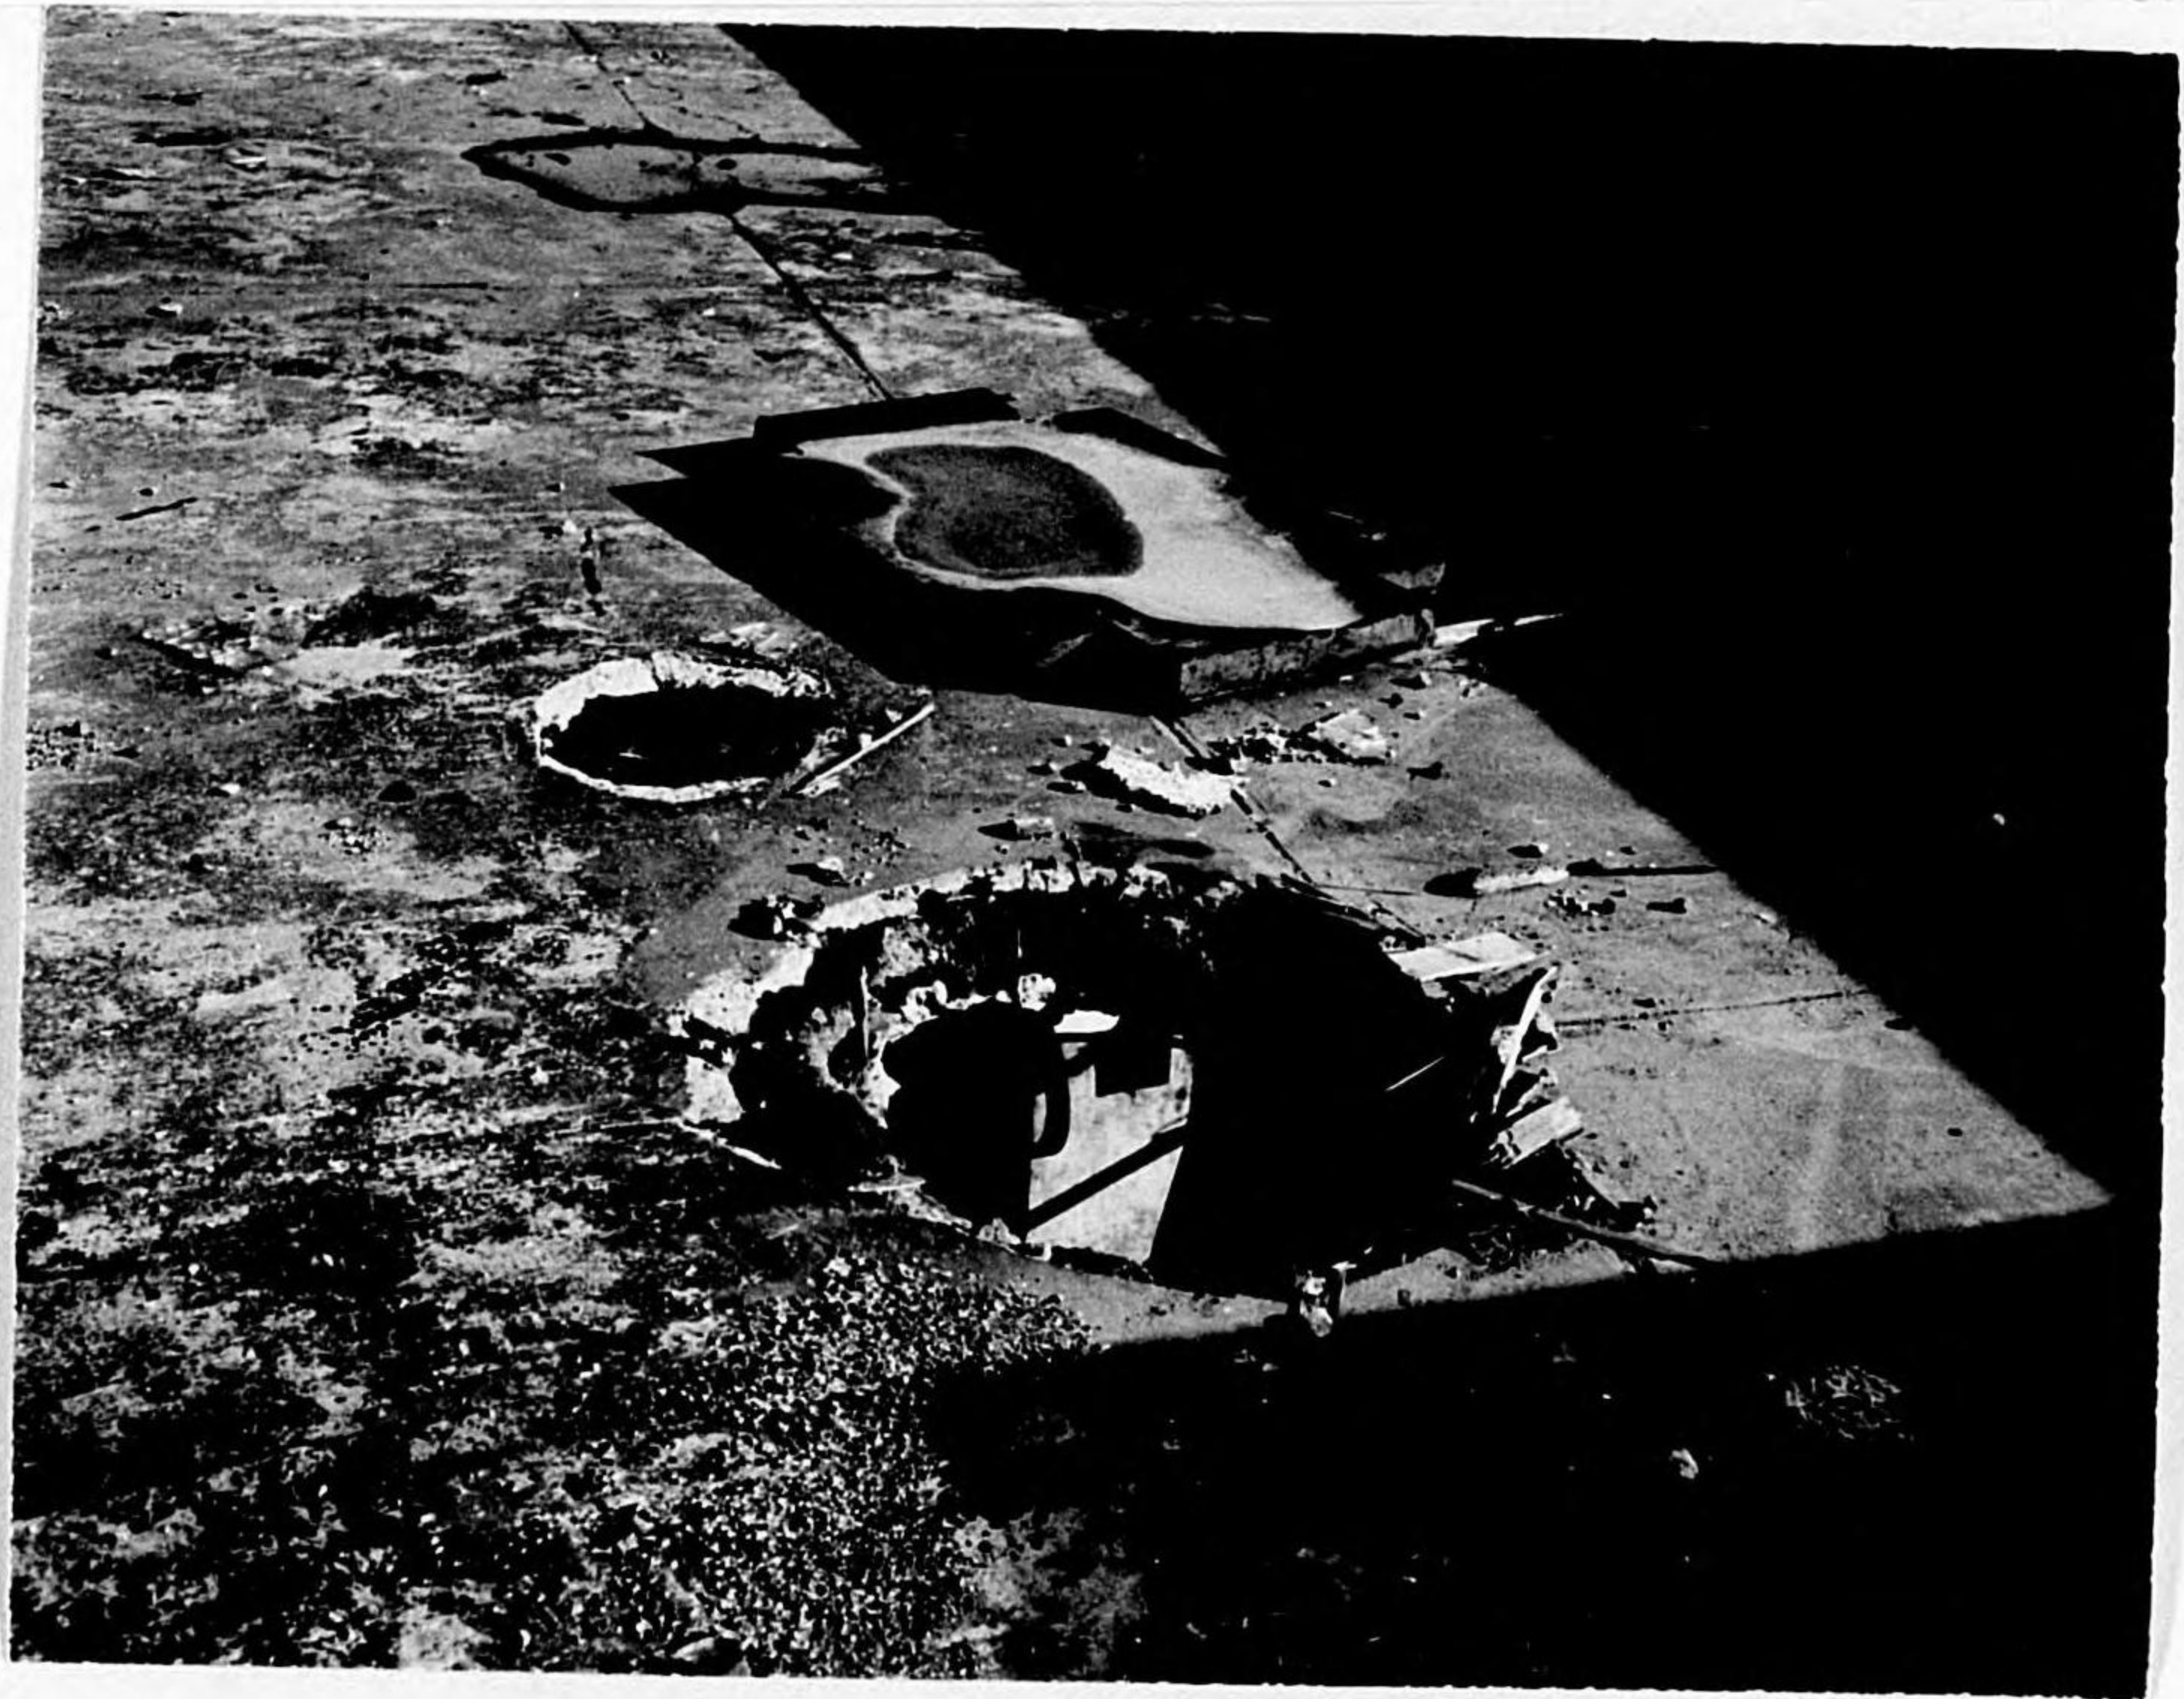
Photo 36

View of Bomb 13 passage hole.

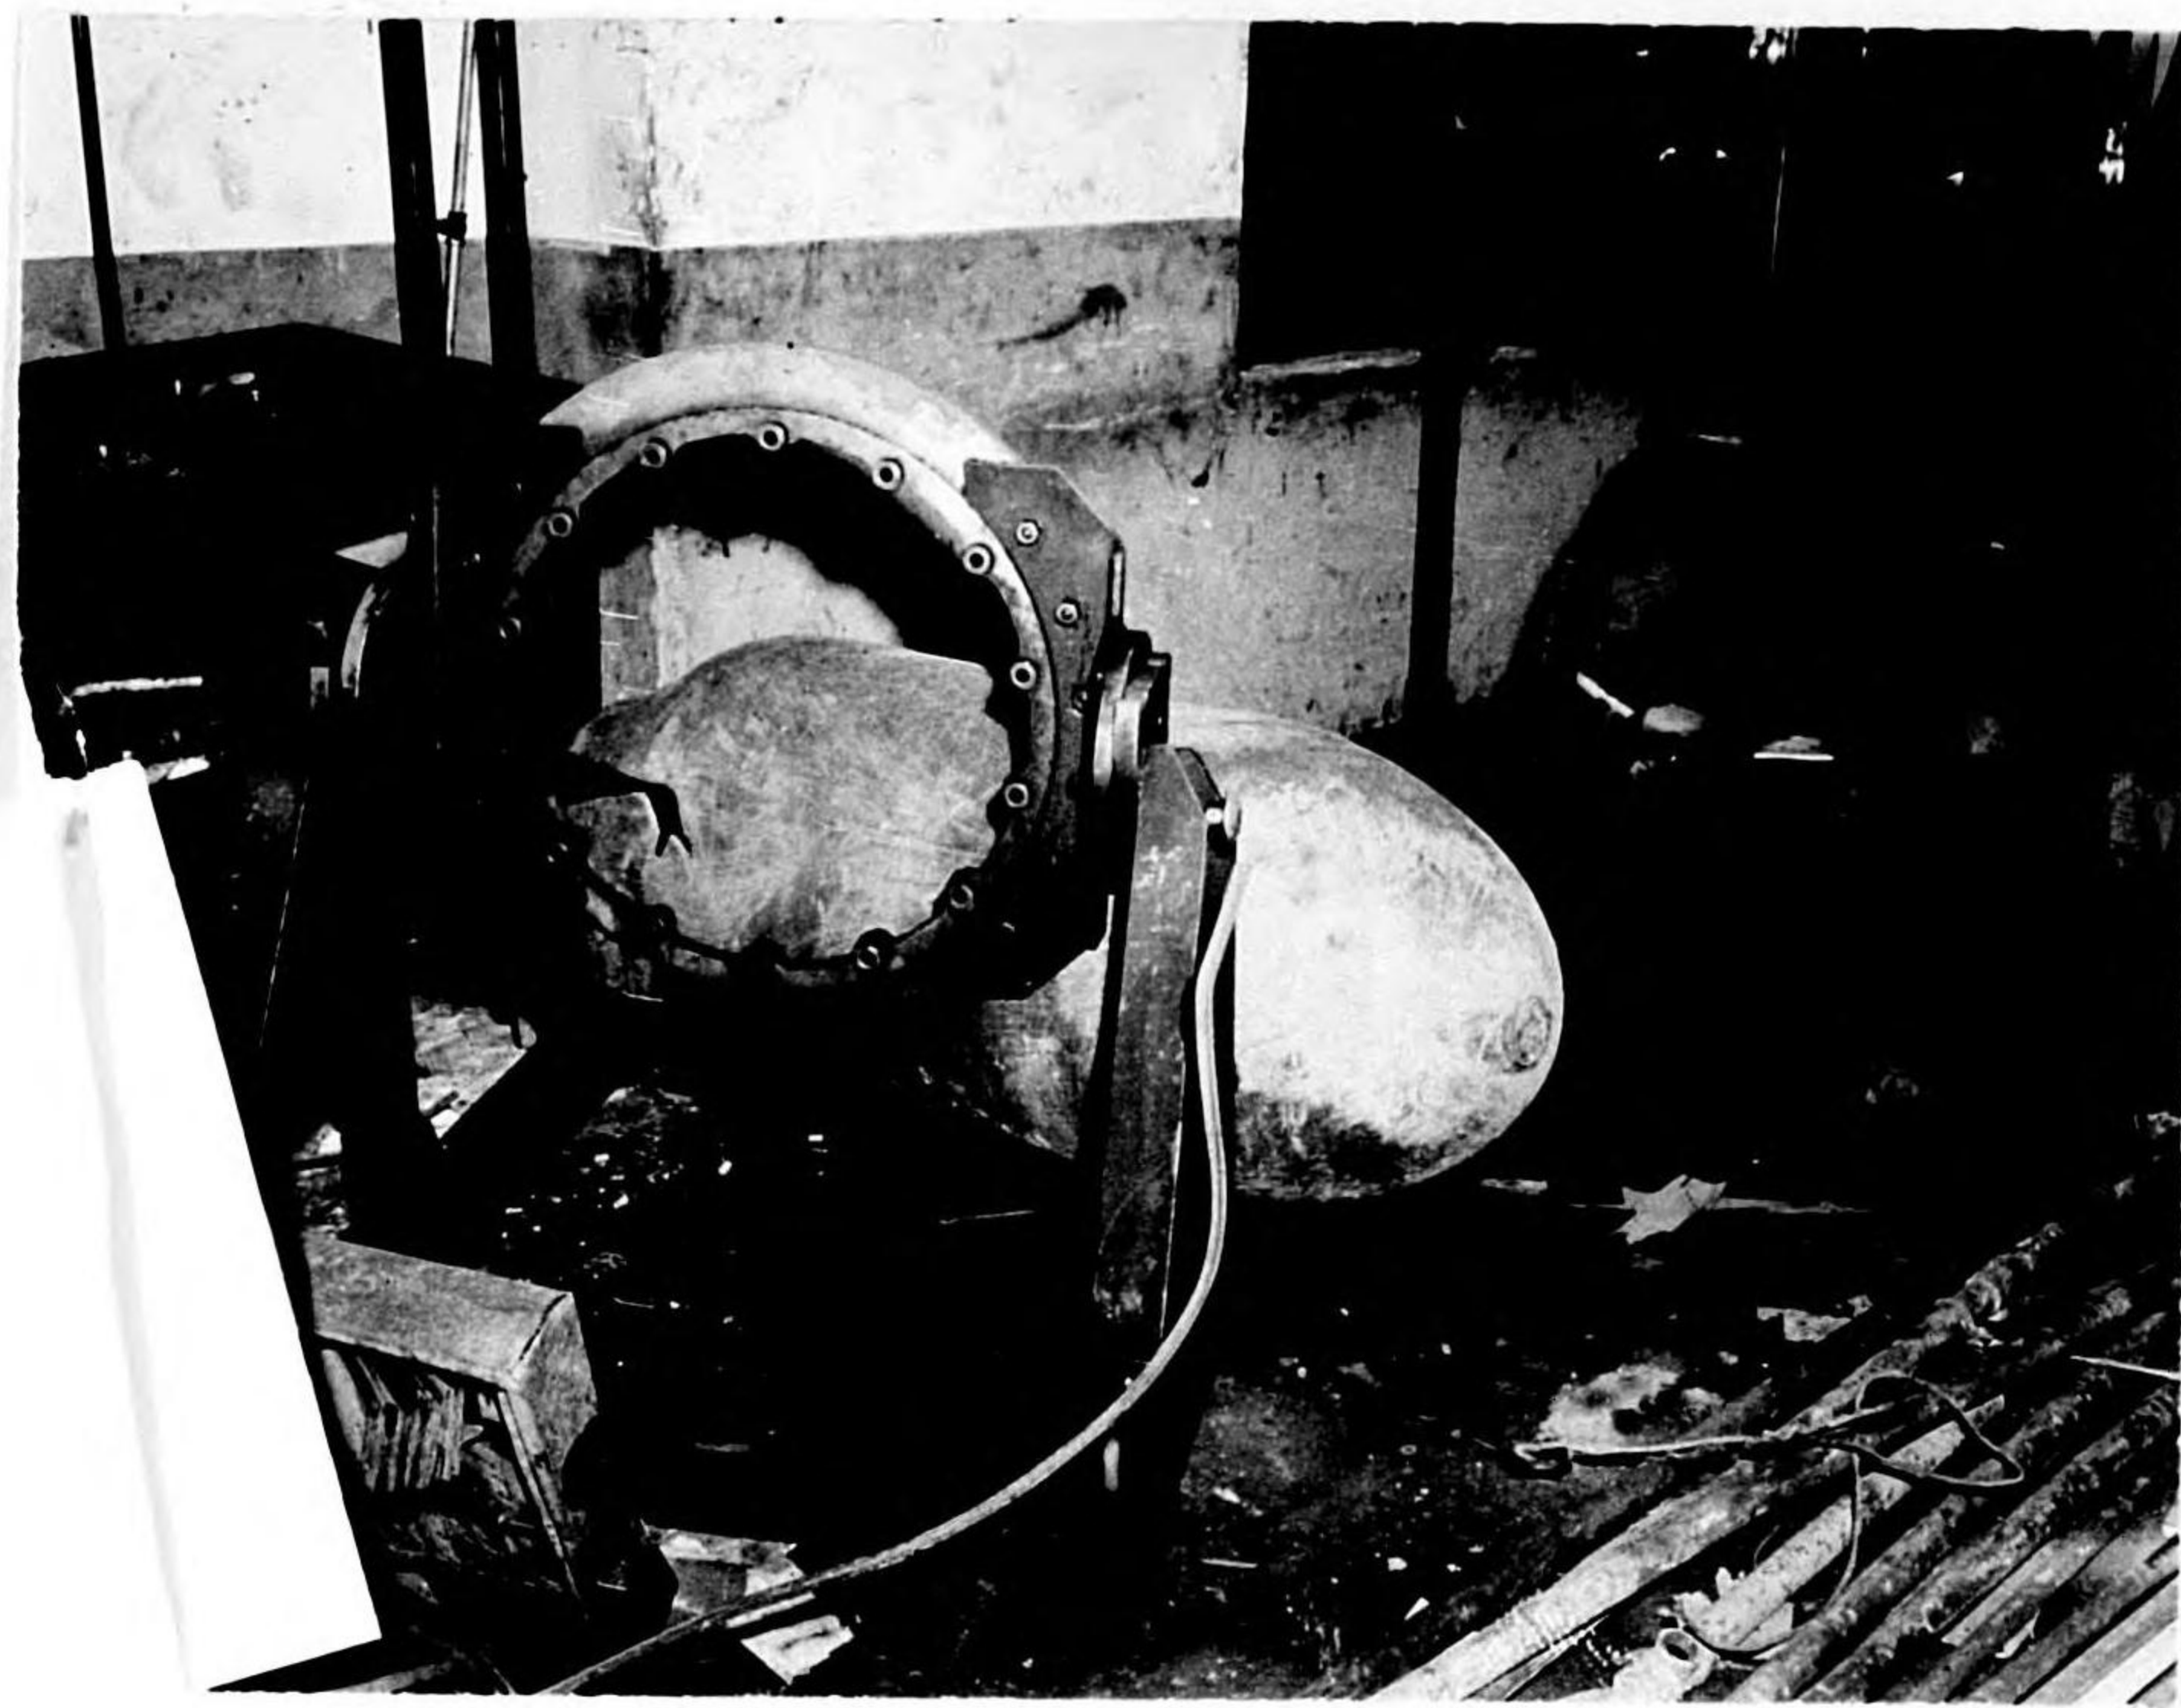
Photo 37

View of dud on first floor passage, Building 35.
