FDD #6 NAKAJIMA MUSASHINO (9)

Pack 3 PHOTO LOG - NAKAJIMA - MUSEUM

PHOTO LOC - NAKAJIMA - MUSEUM -

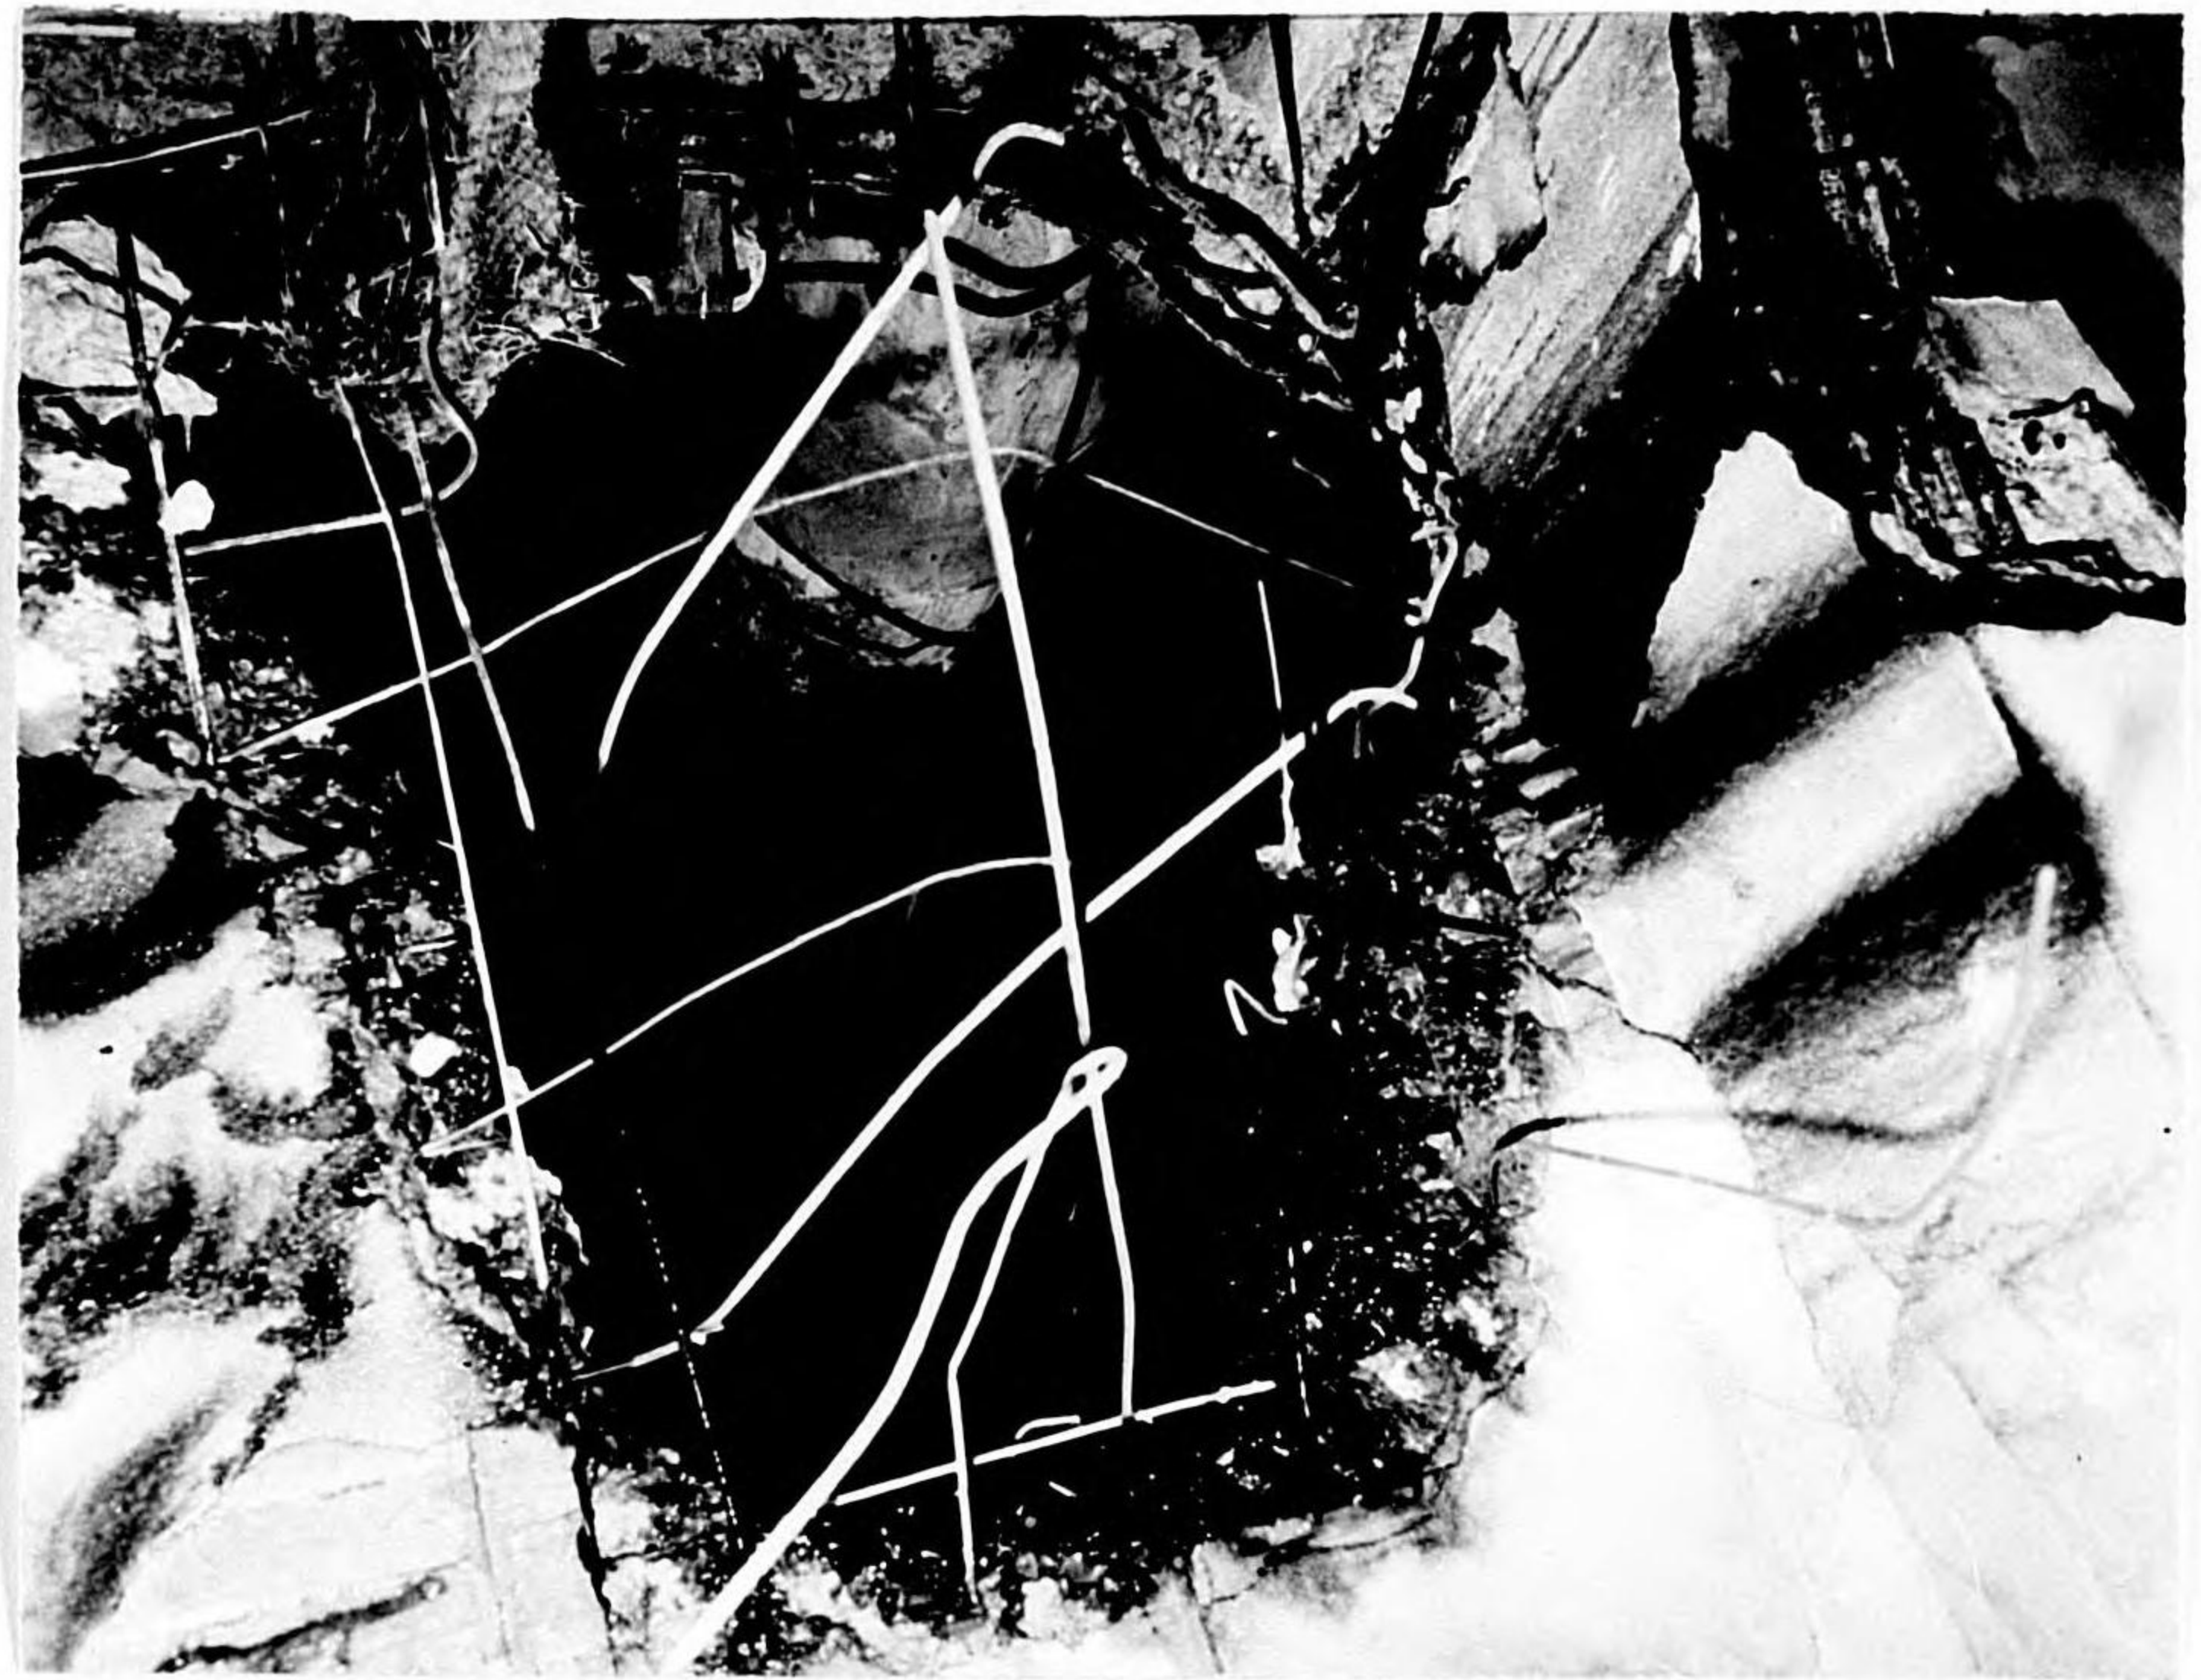
Photo 38

Looking up at dud bomb passage hole, Building 35.
