PHYSICAL PROTECTION WORKBOOK

dittert site

SEPTEMBER, 1978

DITTERT SITE
(AR-NM-02-085)

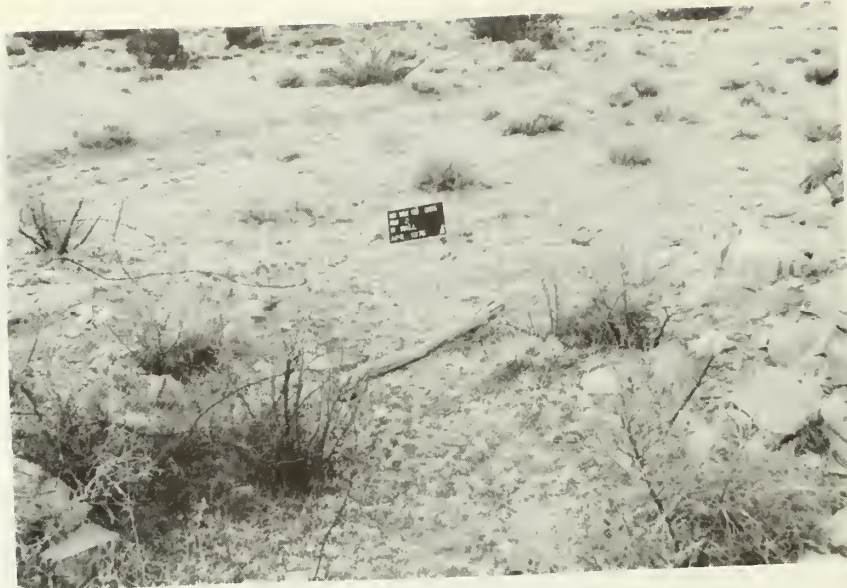
Room 2, west wall: before
stabilization

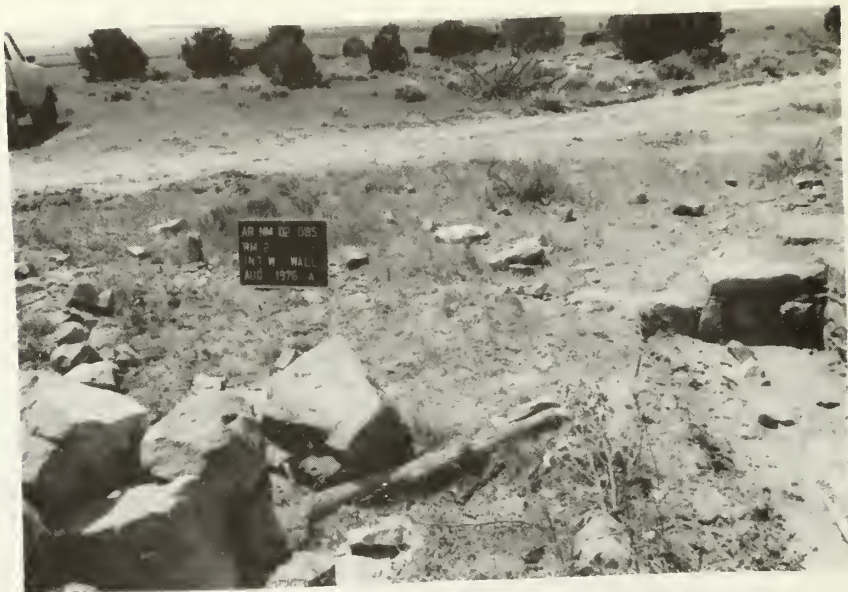
Room 2, west wall: after
stabilization

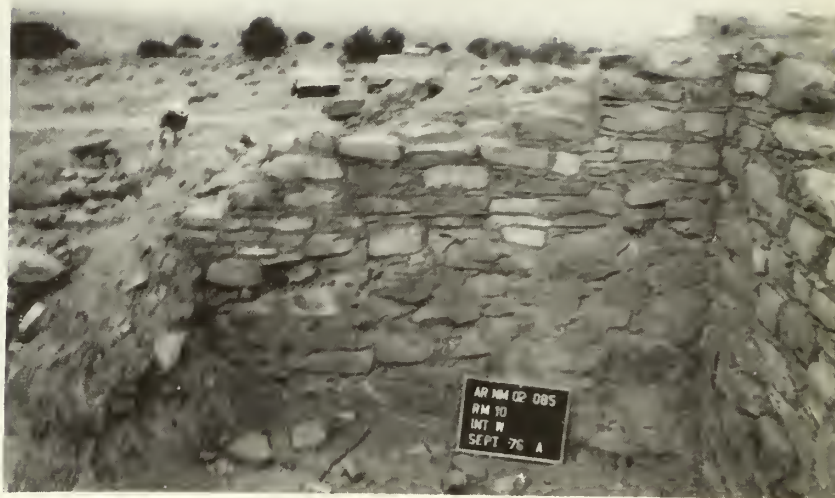
Room 10, west wall: after
stabilization

Note that the print is not sharp.
This is an infrequent but
disturbing characteristic of
commercially processed prints that
would be avoided by maintaining
our own darkroom.

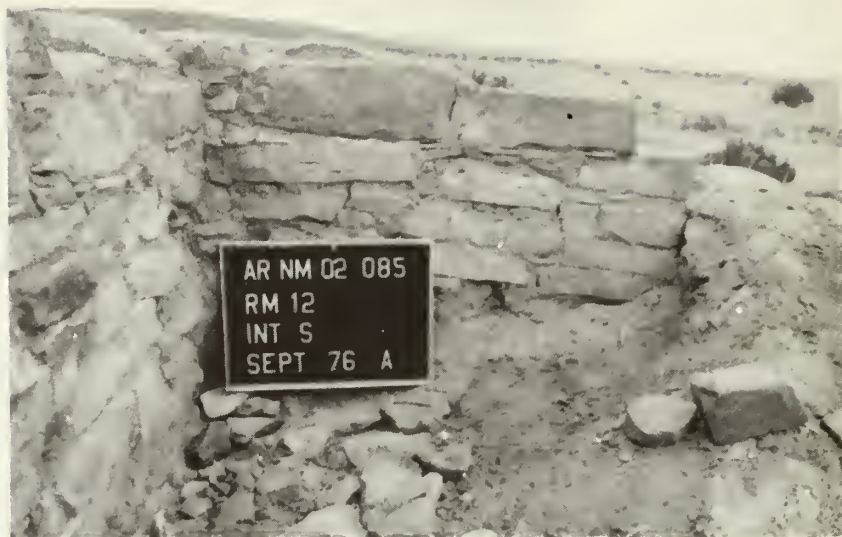
Room 12, south wall: after
stabilization

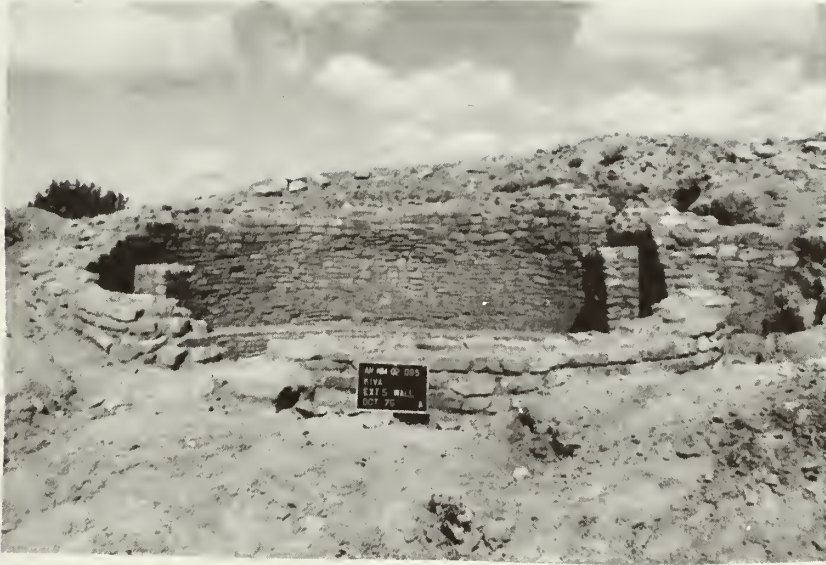
Wall segment abutting south wall of
kiva after stabilization.
